Preliminary Hand- Held Air Monitoring Locations | ITC Deer Park Tank Fire

Reading Date
7/7/2019 11:00:00 PM to 7/8/2019 12:00:00 AM

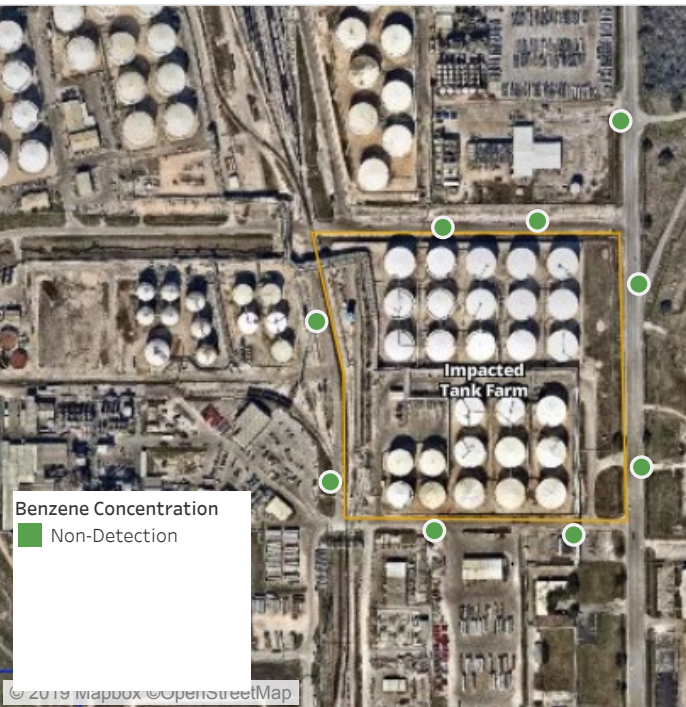
Reading Date
7/8/2019 12:00:00 AM to 7/8/2019 1:00:00 AM

Preliminary Hand- Held Air Monitoring Locations | ITC Deer Park Tank Fire

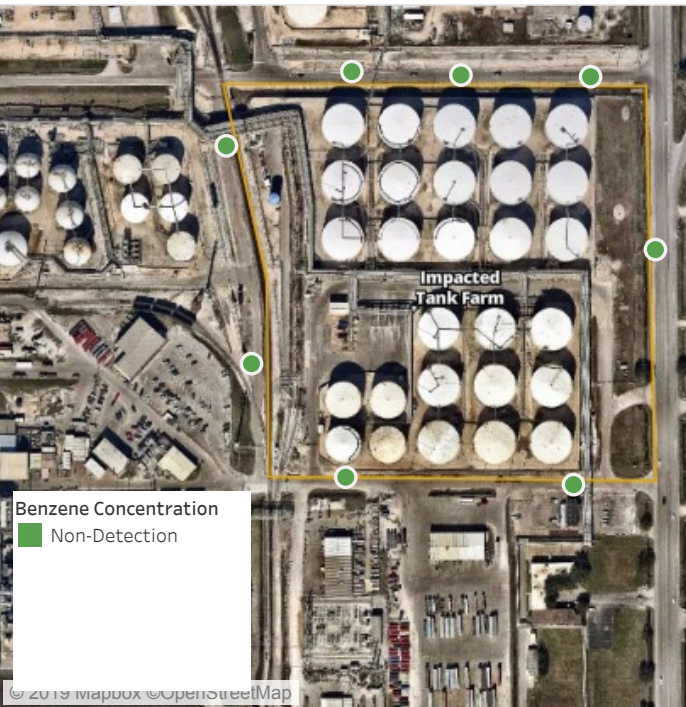
Reading Date
7/8/2019 1:00:00 AM to 7/8/2019 2:00:00 AM

Preliminary Hand- Held Air Monitoring Locations | ITC Deer Park Tank Fire

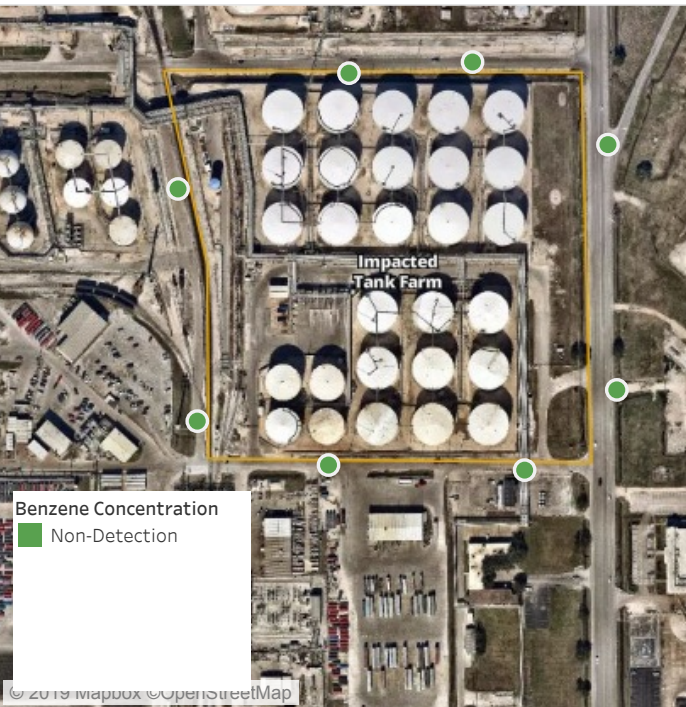
Reading Date
7/8/2019 2:00:00 AM to 7/8/2019 3:00:00 AM

Preliminary Hand- Held Air Monitoring Locations | ITC Deer Park Tank Fire

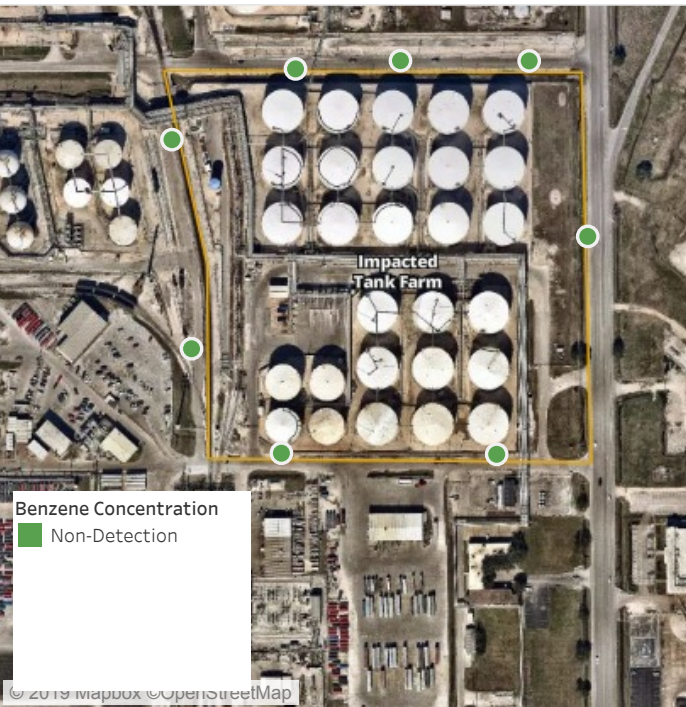
Reading Date
7/8/2019 3:00:00 AM to 7/8/2019 4:00:00 AM

Preliminary Hand- Held Air Monitoring Locations | ITC Deer Park Tank Fire

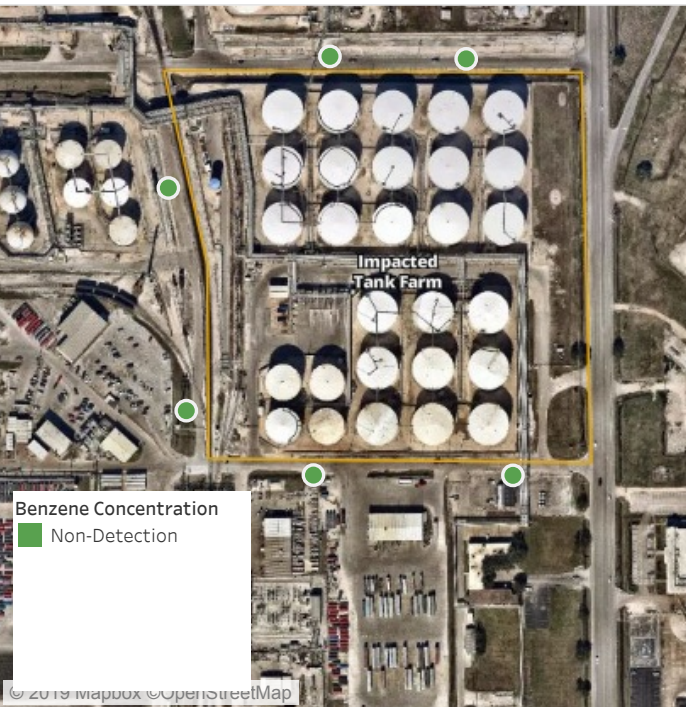
Reading Date
7/8/2019 4:00:00 AM to 7/8/2019 5:00:00 AM

Preliminary Hand- Held Air Monitoring Locations | ITC Deer Park Tank Fire

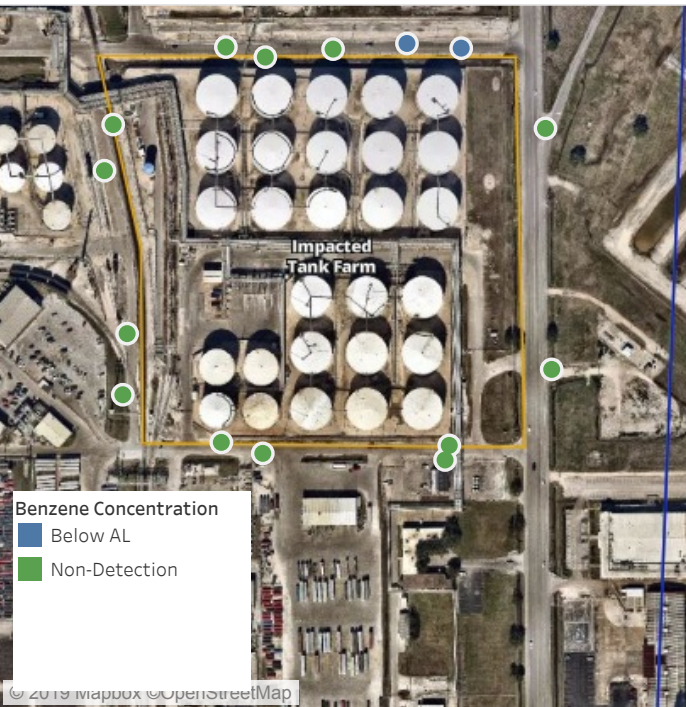
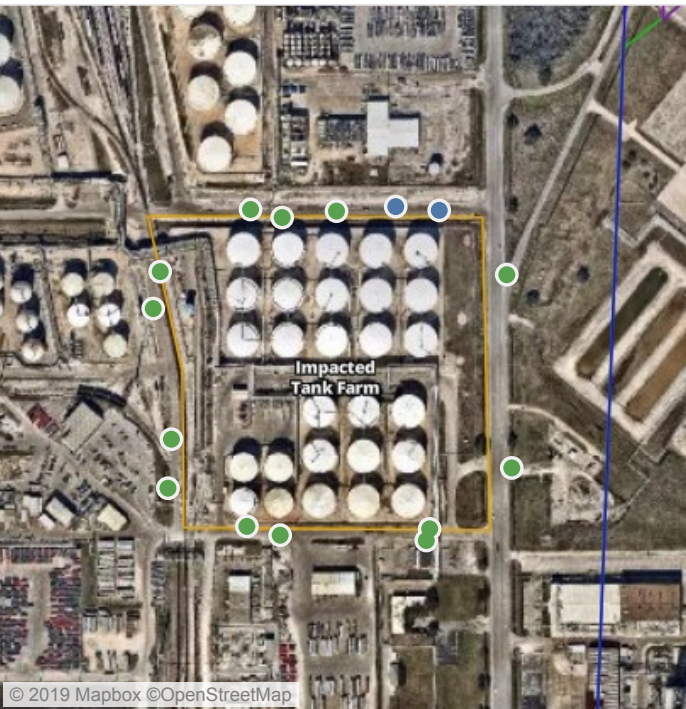
Reading Date
7/8/2019 5:00:00 AM to 7/8/2019 6:31:03 AM

Location Category	Reading Date	Range of Detections
Division E	7/8/2019 05:43:09	0.04000 ppm
	7/8/2019 06:07:54	0.04000 ppm

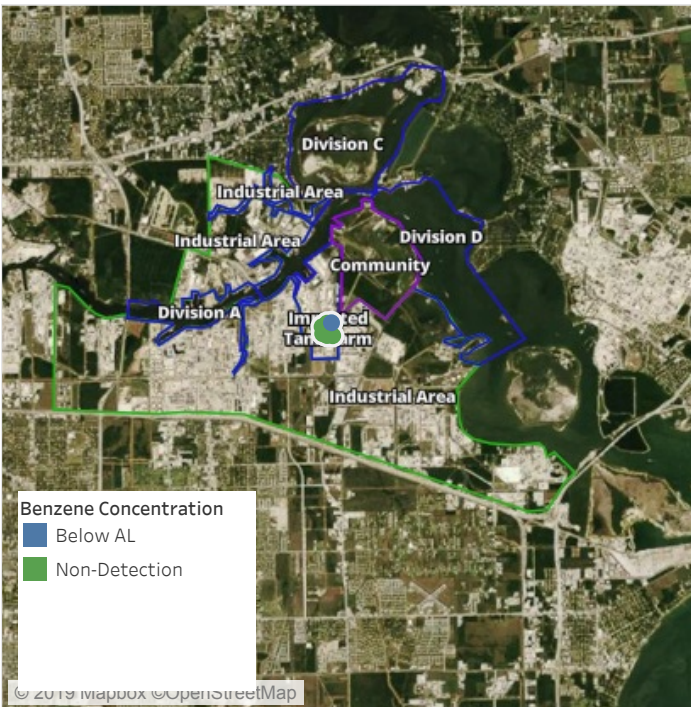
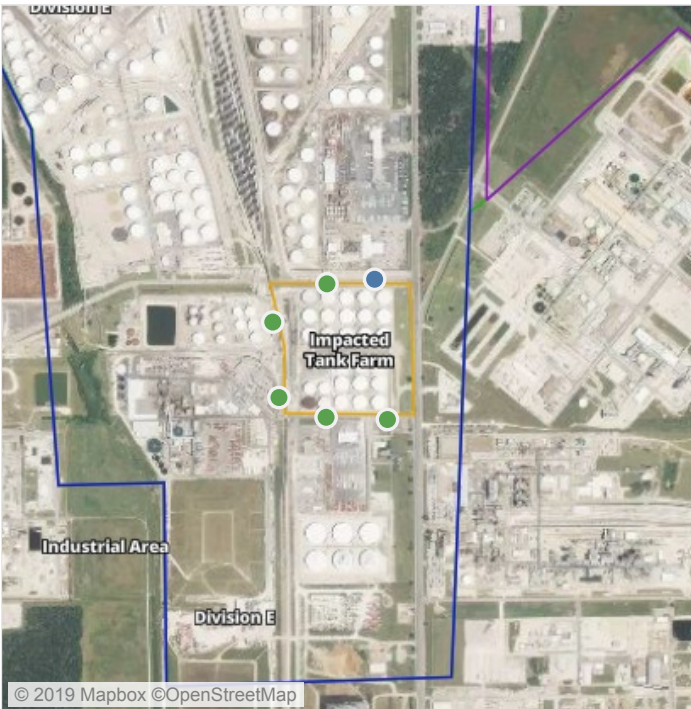
Reading Date
7/8/2019 6:00:00 AM to 7/8/2019 7:00:00 AM

Location Category	Reading Date	Range of Detections
Division E	7/8/2019 06:07:54	0.04000 ppm

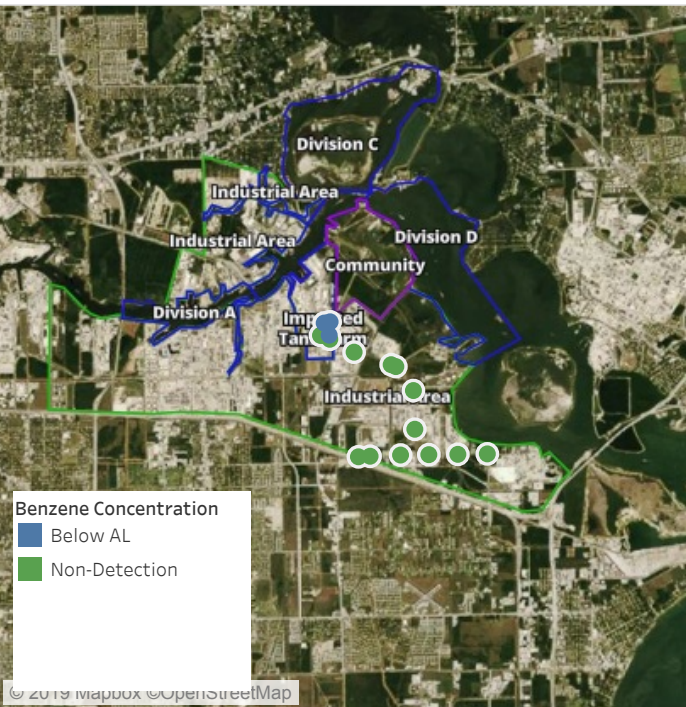
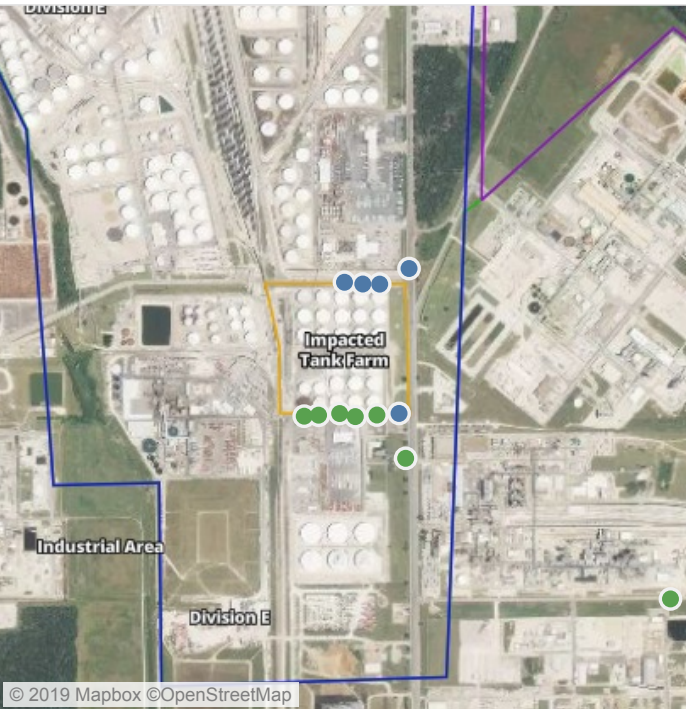
Reading Date
7/8/2019 7:00:00 AM to 7/8/2019 8:00:00 AM

Location Category	Reading Date	Range of Detections
Division E	7/8/2019 07:39:14	0.03000 ppm
	7/8/2019 07:45:28	0.04000 ppm
	7/8/2019 07:26:23	0.05000 ppm
	7/8/2019 07:28:53	0.03000 ppm
	7/8/2019 07:47:42	0.04000 ppm

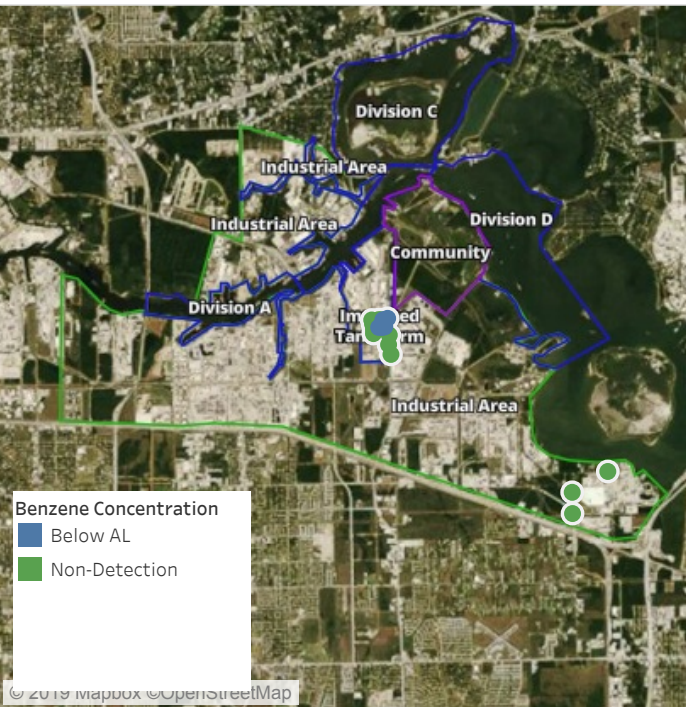
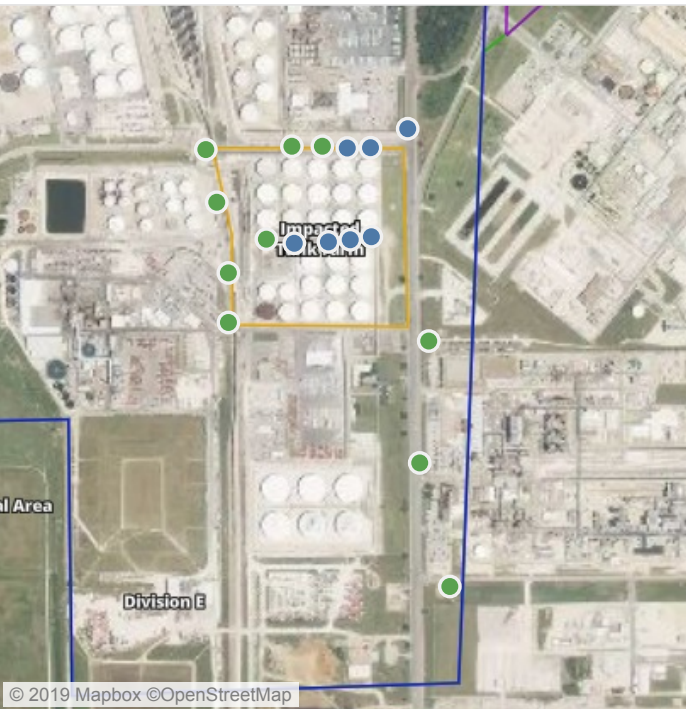
Reading Date
7/8/2019 8:00:00 AM to 7/8/2019 9:00:00 AM

Location Category	Reading Date	Range of Detections
Division E	7/8/2019 08:45:11	0.0400 ppm
	7/8/2019 08:49:51	0.0200 ppm
	7/8/2019 08:47:42	0.0300 ppm
Impacted Tank Farm	7/8/2019 08:22:37	0.0500 ppm
	7/8/2019 08:25:14	0.1200 ppm
	7/8/2019 08:29:39	0.2900 ppm
	7/8/2019 08:34:27	0.1400 ppm

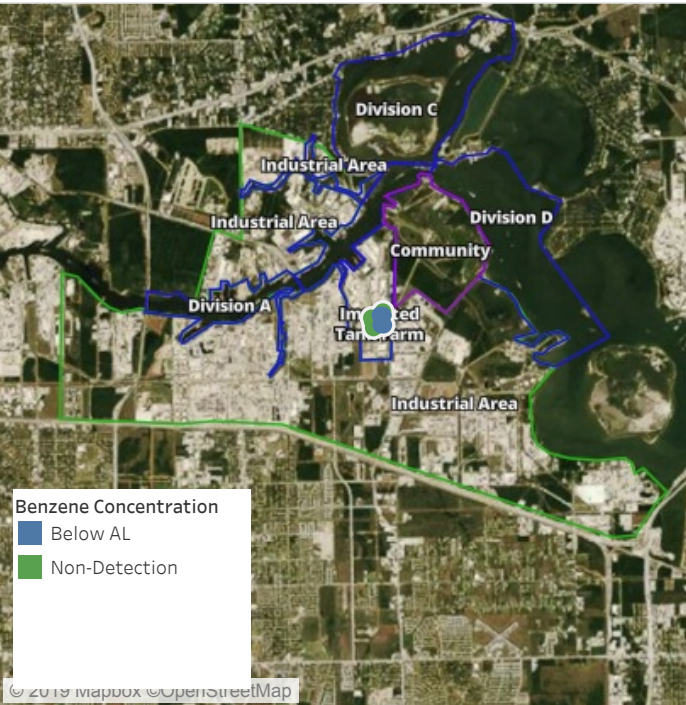
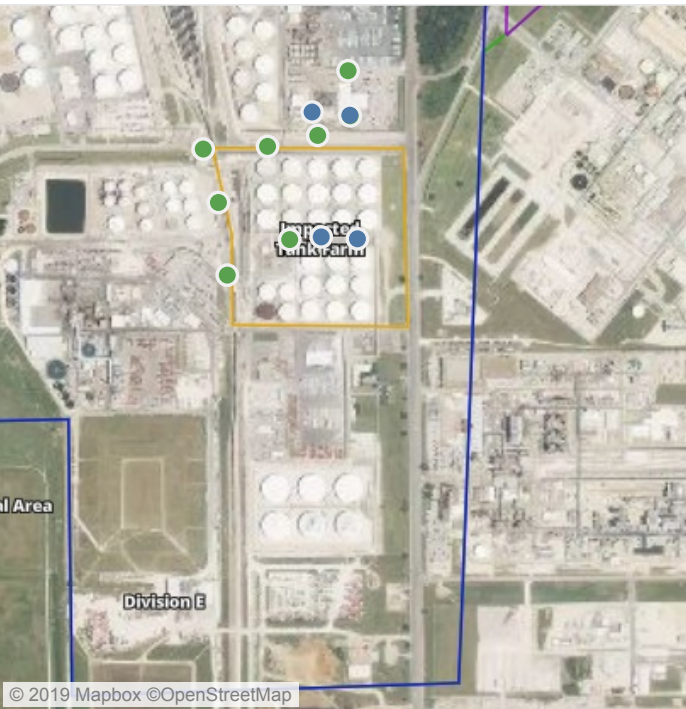
Reading Date
7/8/2019 9:00:00 AM to 7/8/2019 10:00:00 AM

Location Category	Reading Date	Range of Detections
Division E	7/8/2019 09:08:03	0.05000 ppm
	7/8/2019 09:19:26	0.02000 ppm
Impacted Tank Farm	7/8/2019 09:33:32	0.04000 ppm
	7/8/2019 09:35:19	0.04000 ppm

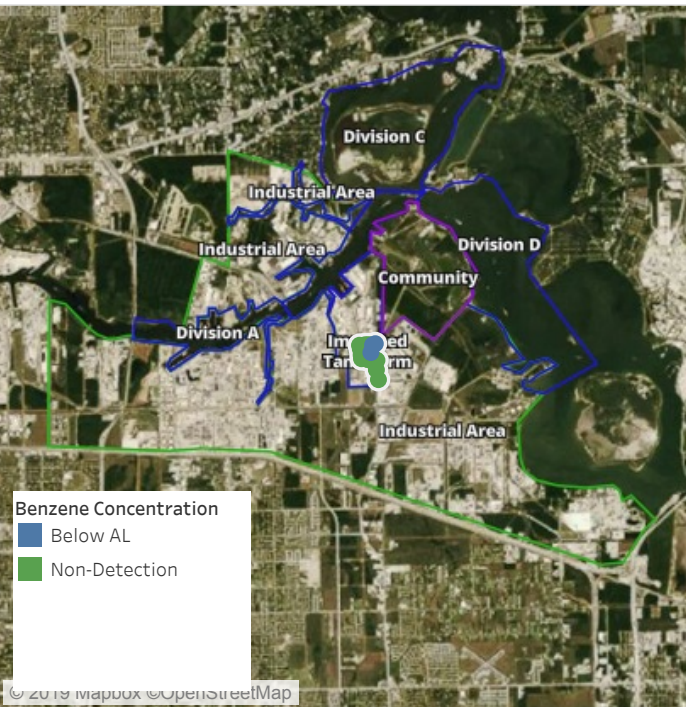
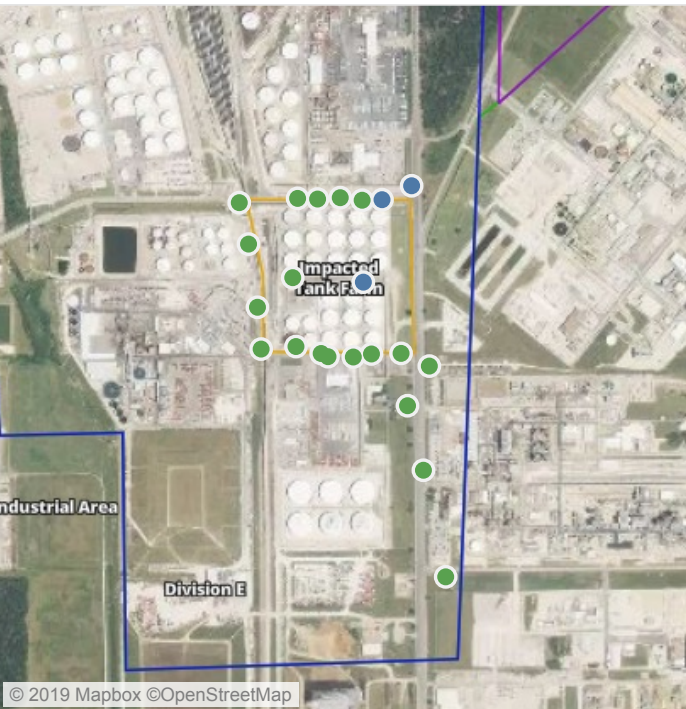
Reading Date
7/8/2019 10:00:00 AM to 7/8/2019 11:00:00 AM

Location Category	Reading Date	Range of Detections
Division E	7/8/2019 10:07:17	0.0200 ppm
	7/8/2019 10:24:31	0.0400 ppm
Impacted Tank Farm	7/8/2019 10:52:27	0.1900 ppm

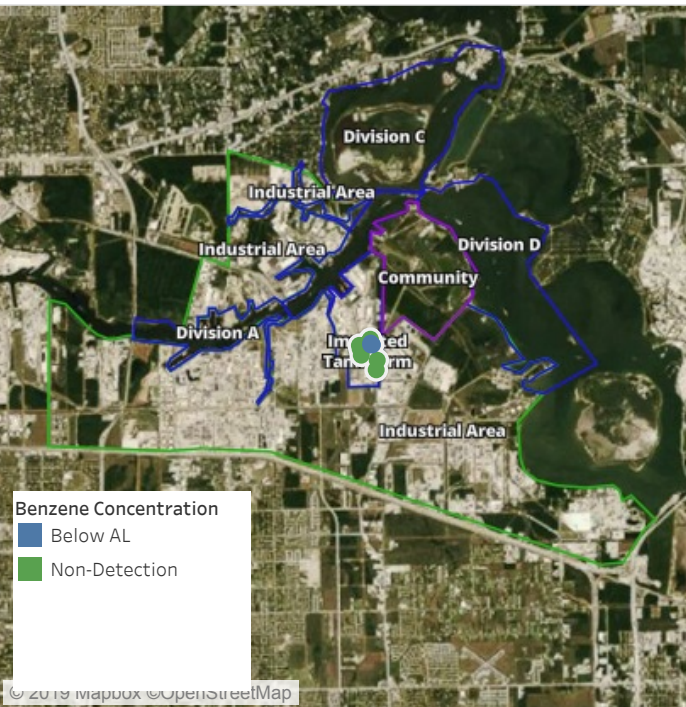
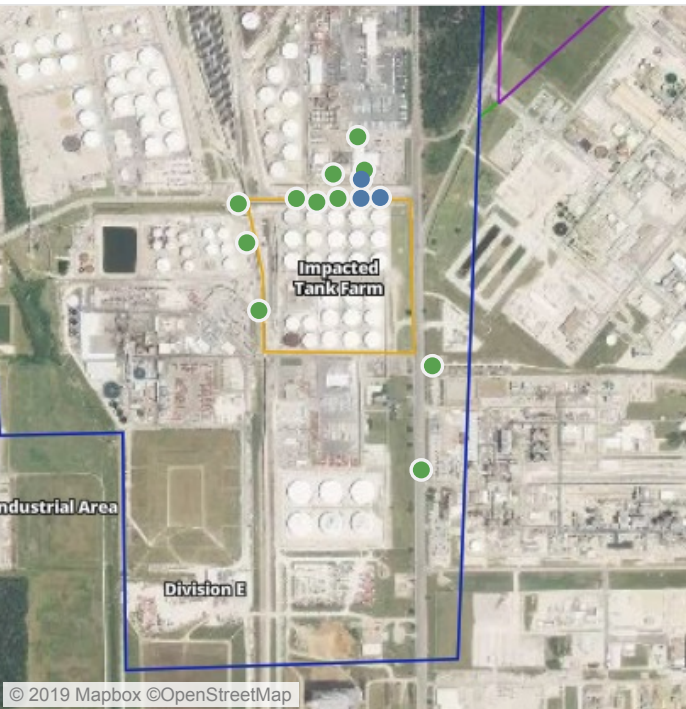
Reading Date
7/8/2019 11:00:00 AM to 7/8/2019 12:00:00 PM

Location Category	Reading Date	Range of Detections
Division E	7/8/2019 11:23:51	0.08000 ppm
	7/8/2019 11:27:46	0.08000 ppm
	7/8/2019 11:31:49	0.04000 ppm

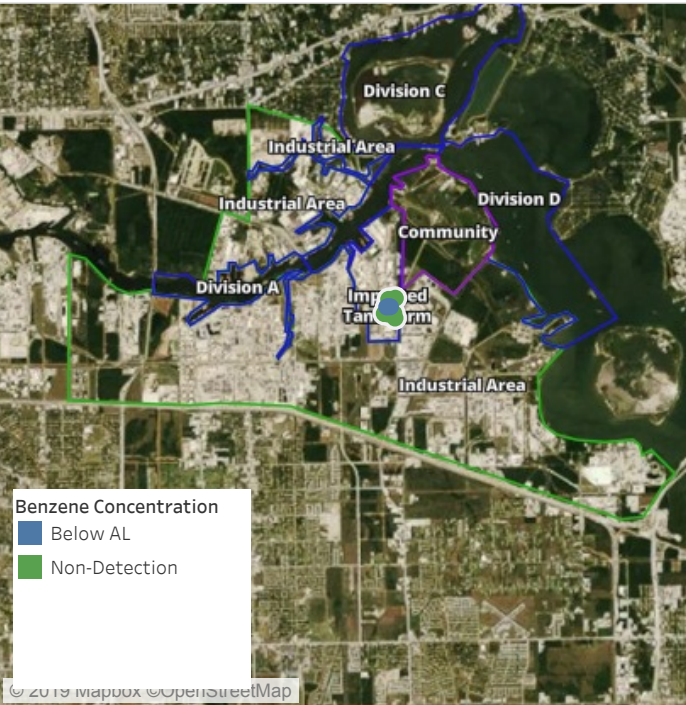
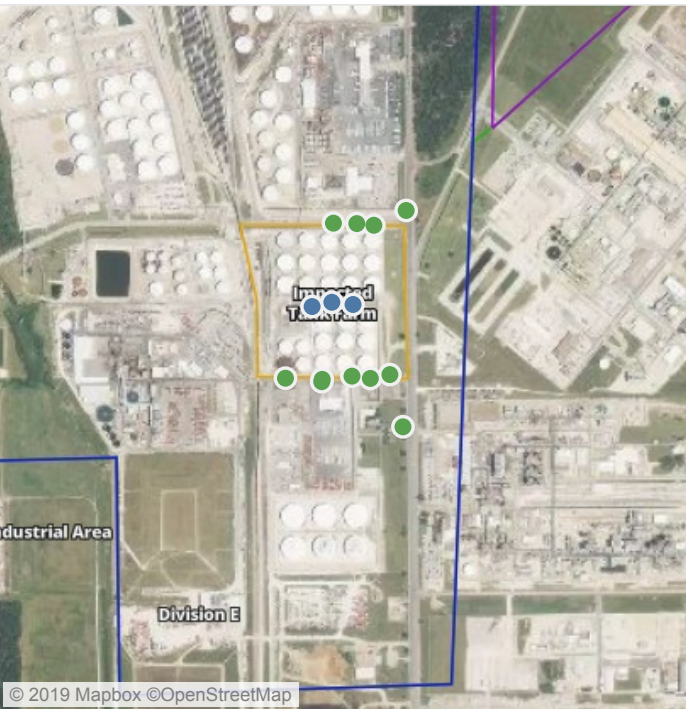
Reading Date
7/8/2019 12:00:00 PM to 7/8/2019 1:00:00 PM

Location Category	Reading Date	Range of Detections
Impacted Tank Farm	7/8/2019 12:04:31	0.02000 ppm
	7/8/2019 12:08:40	0.07000 ppm
	7/8/2019 12:13:56	0.03000 ppm

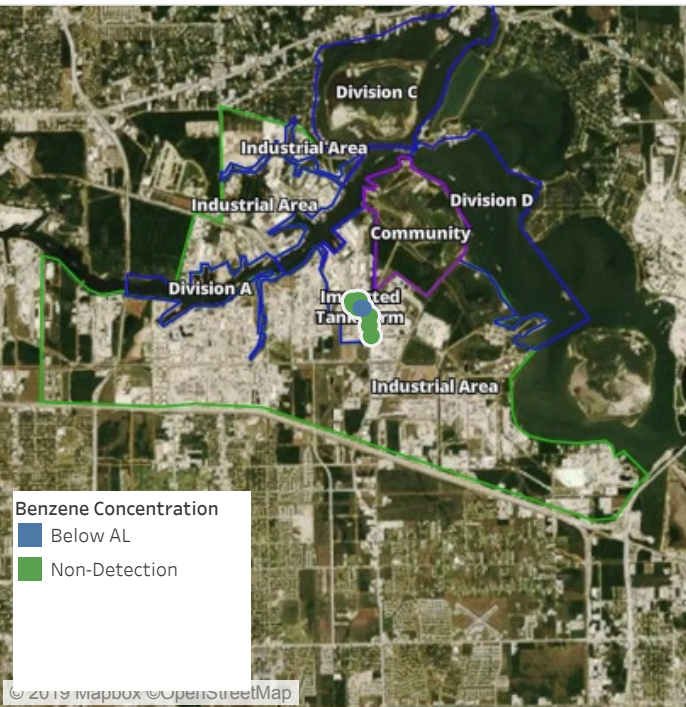
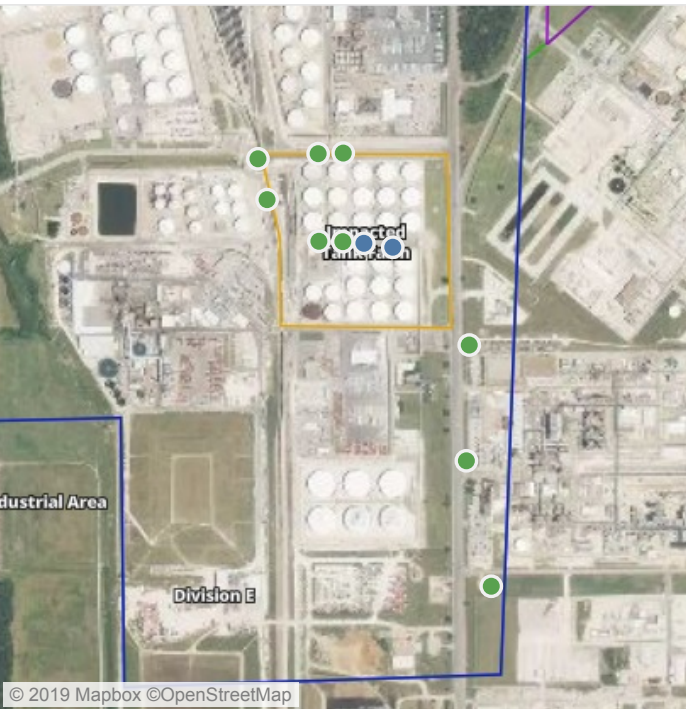
Reading Date
7/8/2019 1:00:00 PM to 7/8/2019 2:00:00 PM

Location Category	Reading Date	Range of Detections
Impacted Tank Farm	7/8/2019 13:37:02	0.05000 ppm
	7/8/2019 13:43:20	0.04000 ppm

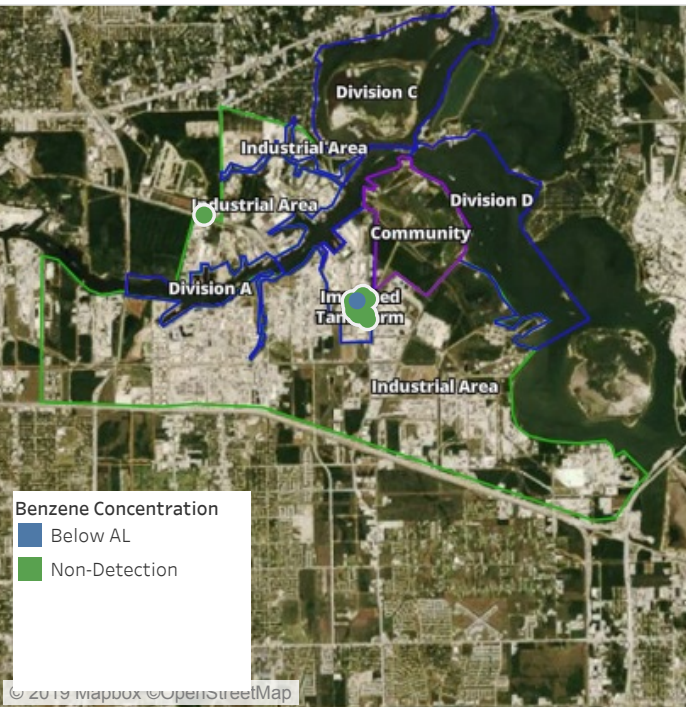
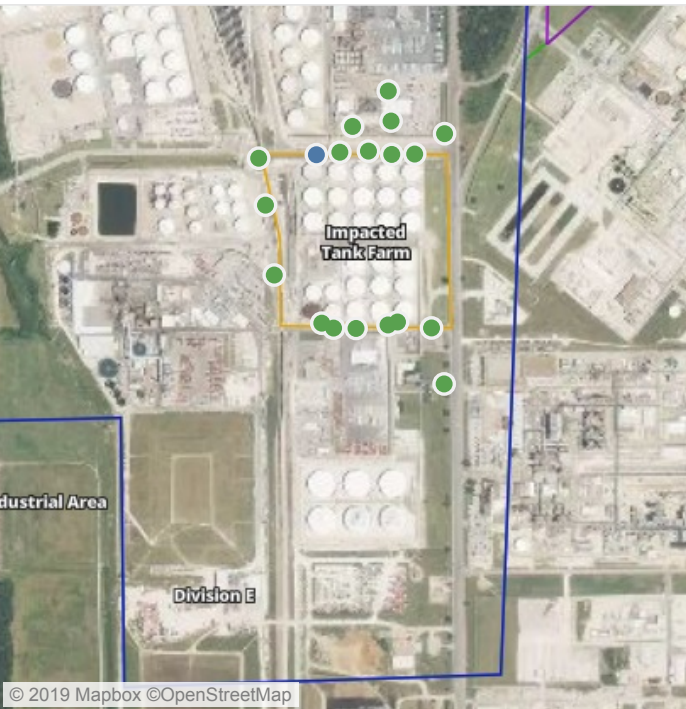
Reading Date
7/8/2019 2:00:00 PM to 7/8/2019 3:00:00 PM

Location Category	Reading Date	Range of Detections
Division E	7/8/2019 14:33:19	0.06000 ppm

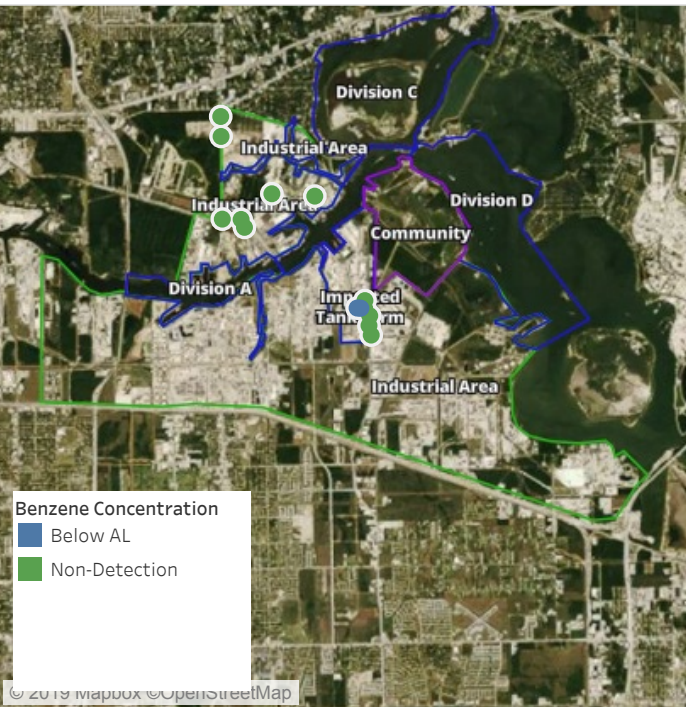
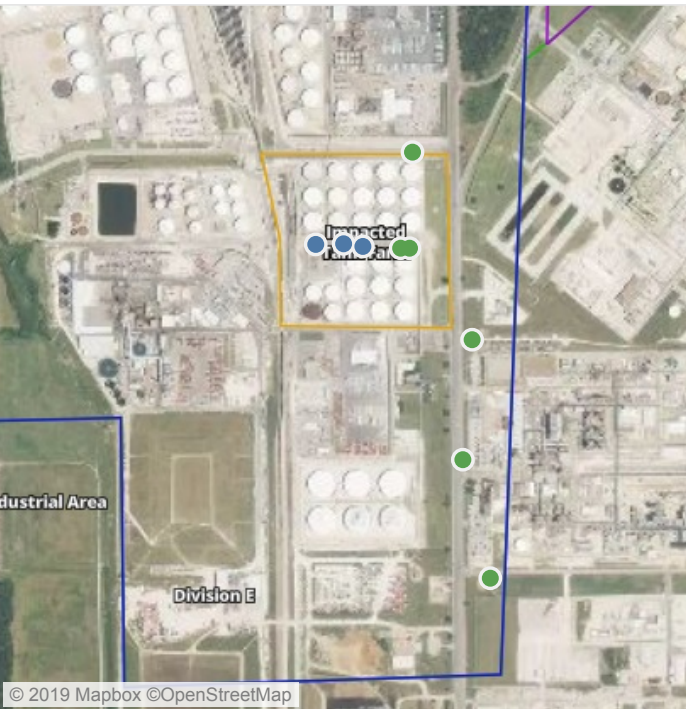
Reading Date
7/8/2019 3:00:00 PM to 7/8/2019 4:00:00 PM

Location Category	Reading Date	Range of Detections
Impacted Tank Farm	7/8/2019 15:18:42	0.0500 ppm
	7/8/2019 15:23:32	0.0900 ppm
	7/8/2019 15:27:41	0.1600 ppm

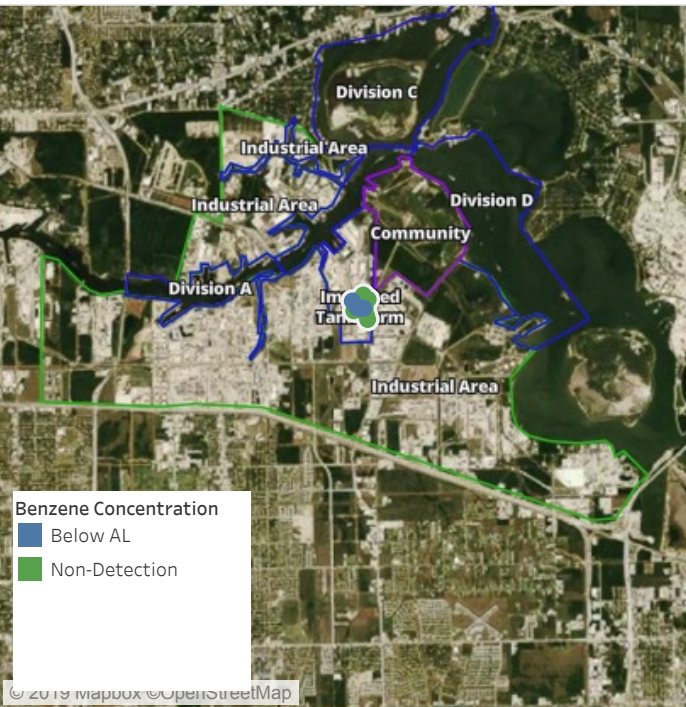
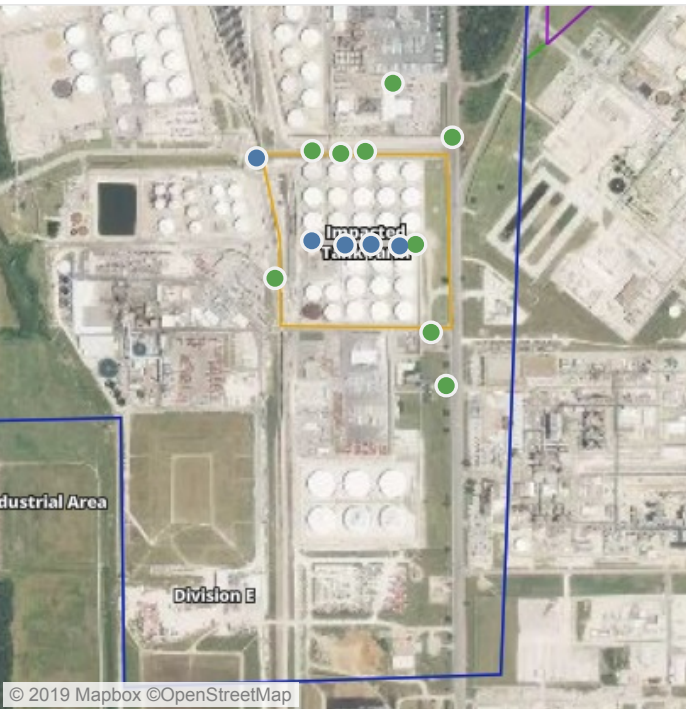
Reading Date
7/8/2019 4:00:00 PM to 7/8/2019 5:00:00 PM

Location Category	Reading Date	Range of Detections
Division E	7/8/2019 16:17:08	0.0200 ppm
Impacted Tank Farm	7/8/2019 16:38:16	0.0600 ppm
	7/8/2019 16:44:33	0.0200 ppm
	7/8/2019 16:33:57	0.0400 ppm
	7/8/2019 16:41:09	0.1300 ppm

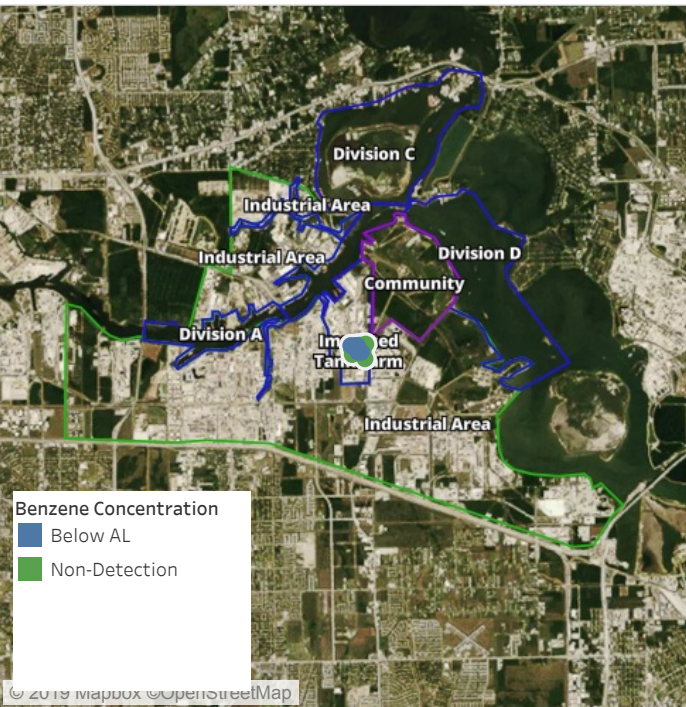
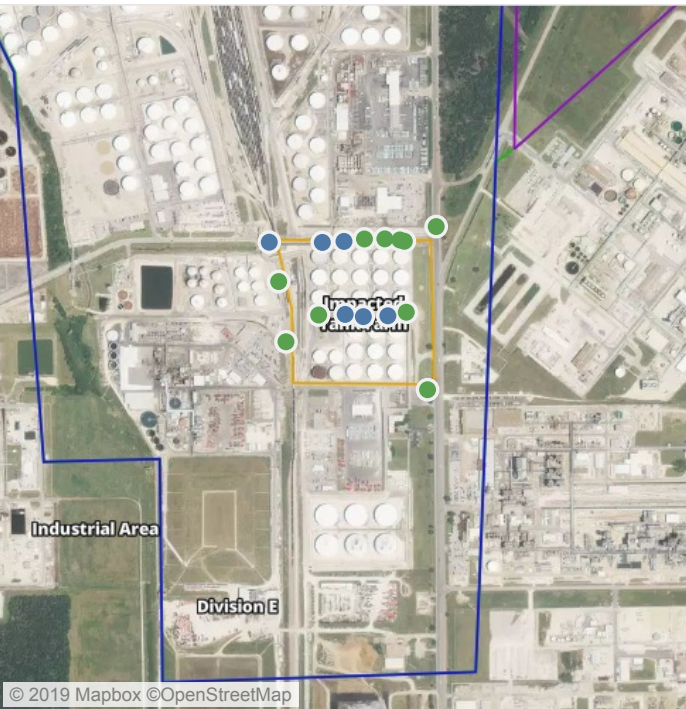
Reading Date
7/8/2019 5:00:00 PM to 7/8/2019 6:00:00 PM

Location Category	Reading Date	Range of Detections
Division E	7/8/2019 17:12:53	0.0300 ppm
	7/8/2019 17:16:27	0.0300 ppm
	7/8/2019 17:23:47	0.0300 ppm
Impacted Tank Farm	7/8/2019 17:42:23	0.0300 ppm
	7/8/2019 17:45:16	0.1300 ppm
	7/8/2019 17:48:34	0.0300 ppm

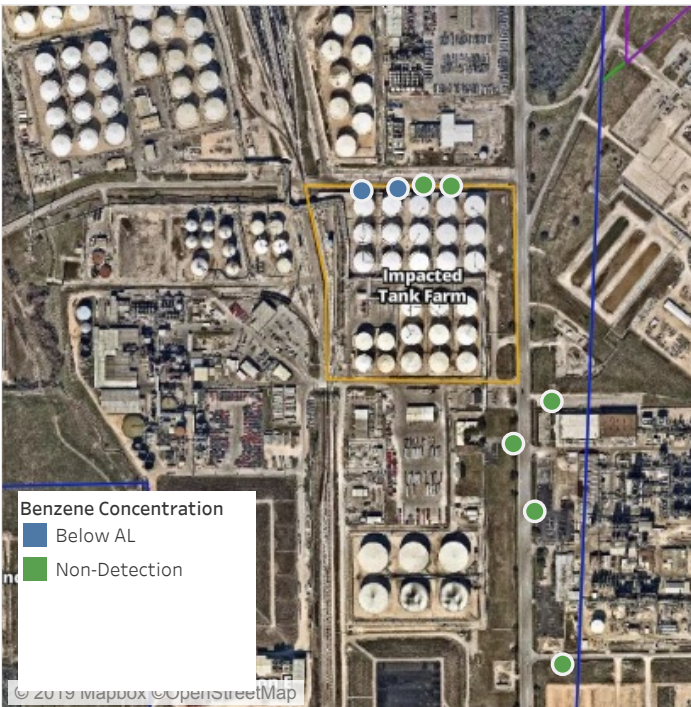
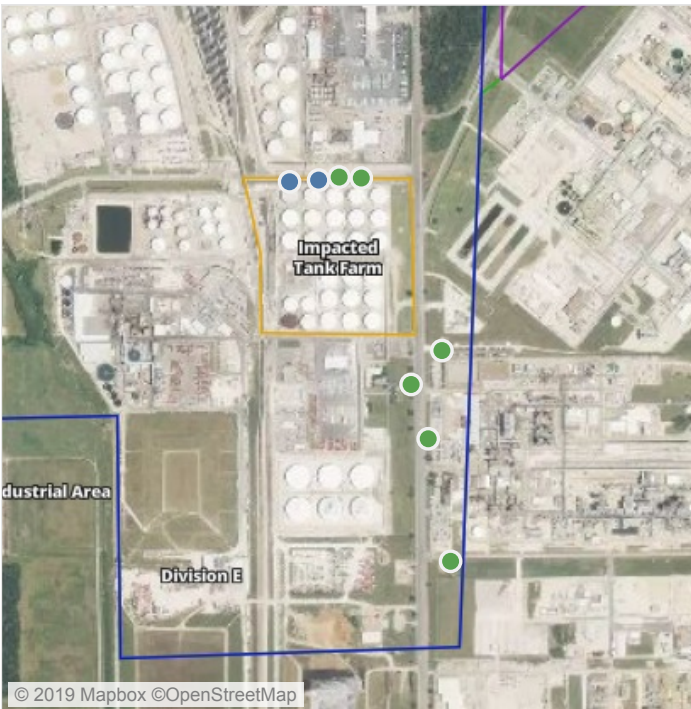
Reading Date
7/8/2019 6:00:00 PM to 7/8/2019 7:00:00 PM

Location Category	Reading Date	Range of Detections
Division E	7/8/2019 18:09:09	0.04000 ppm
	7/8/2019 18:32:32	0.02000 ppm

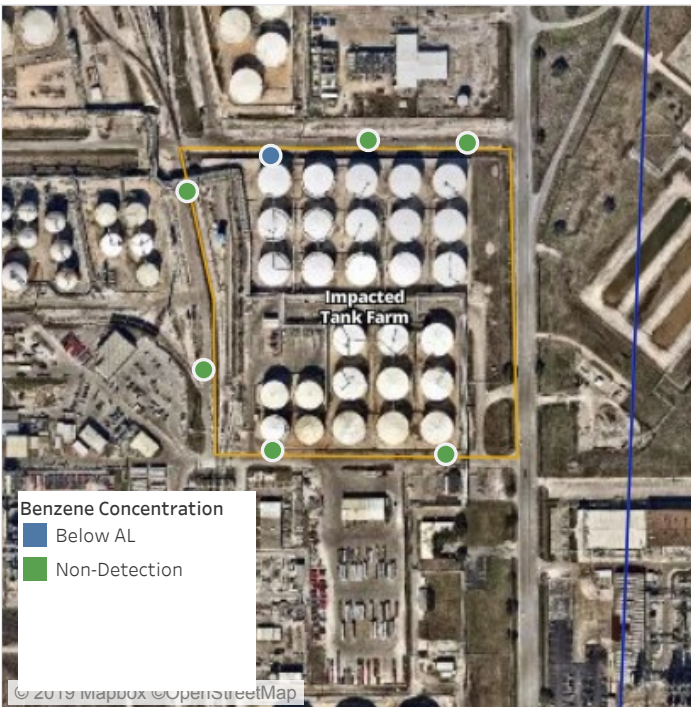
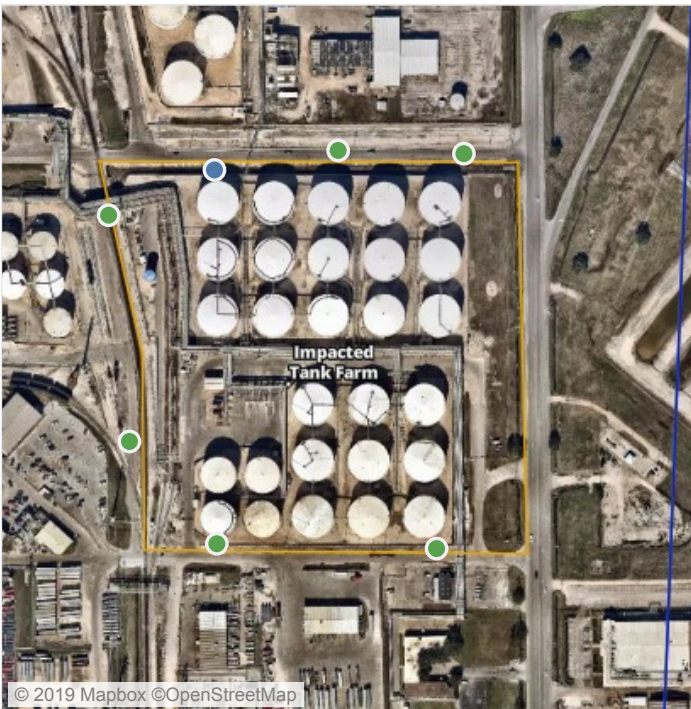
Reading Date
7/8/2019 7:00:00 PM to 7/8/2019 8:00:00 PM

Location Category	Reading Date	Range of Detections
Division E	7/8/2019 19:41:10	0.04000 ppm

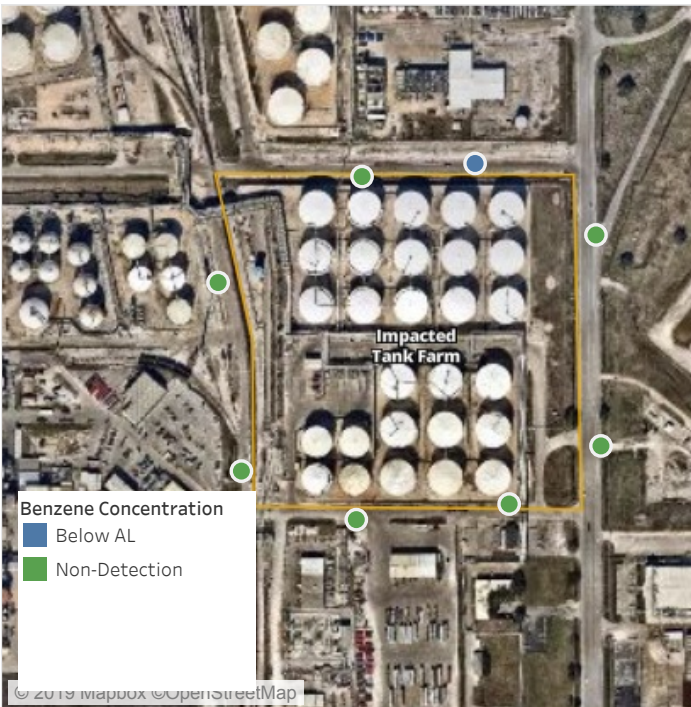
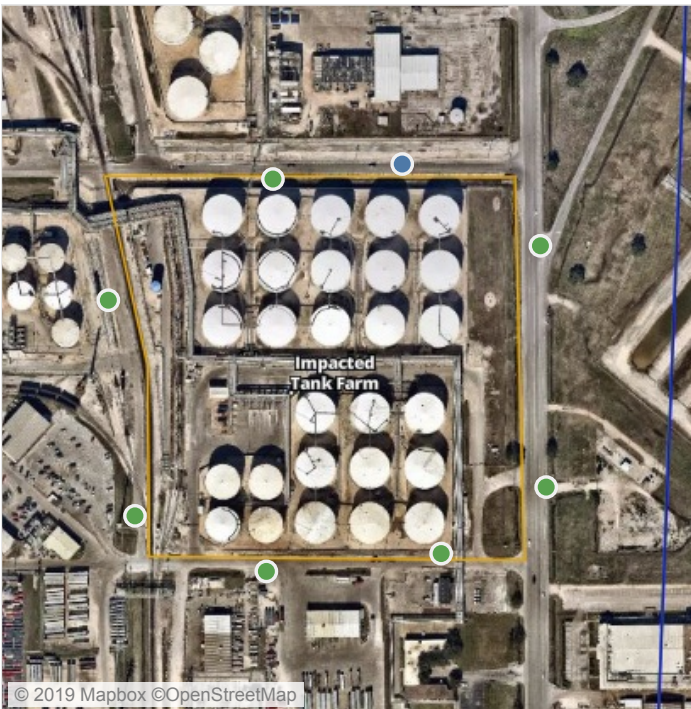
Reading Date
7/8/2019 8:00:00 PM to 7/8/2019 9:00:00 PM

Location Category	Reading Date	Range of Detections
Division E	7/8/2019 20:05:09	0.03000 ppm

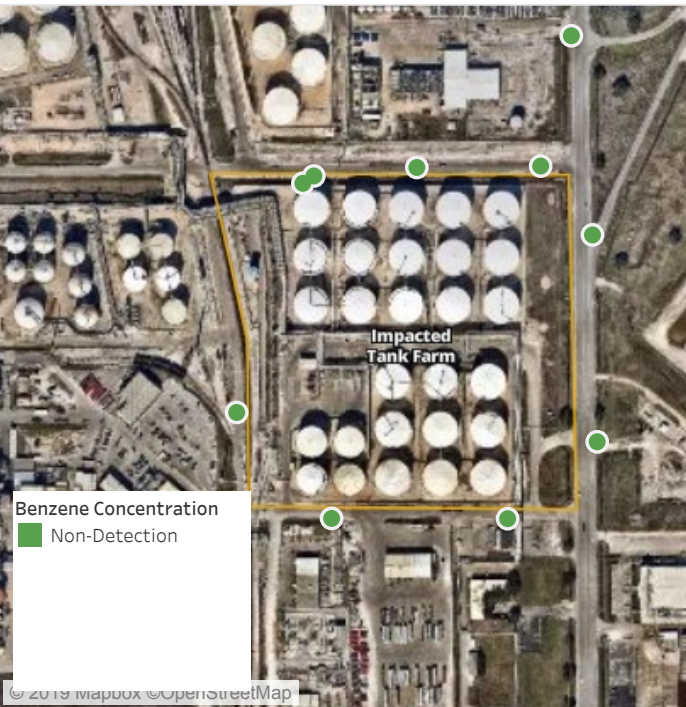
Reading Date
7/8/2019 9:00:00 PM to 7/8/2019 10:00:00 PM

Preliminary Hand- Held Air Monitoring Locations | ITC Deer Park Tank Fire

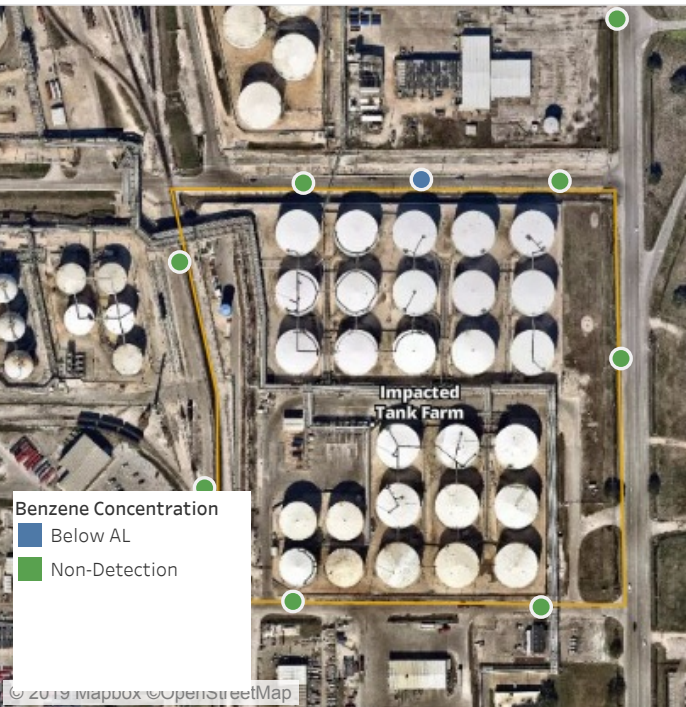
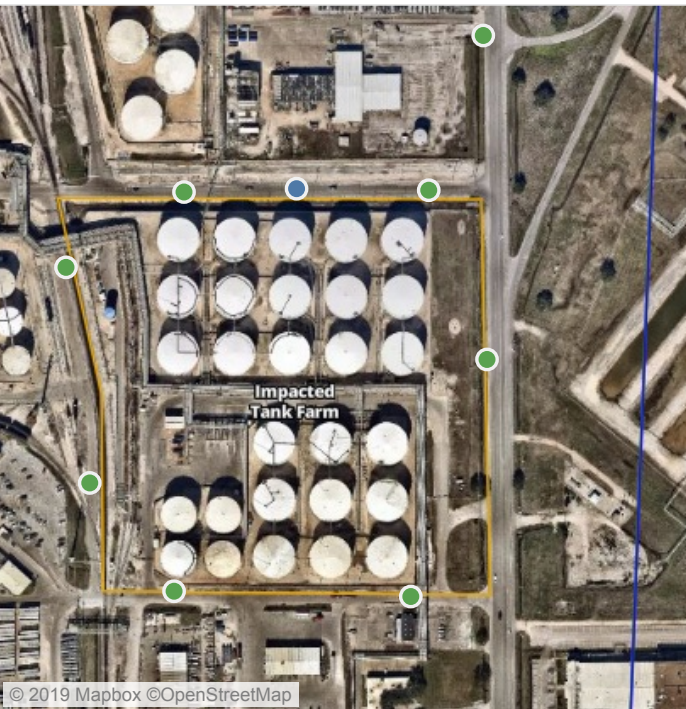
Reading Date
7/8/2019 10:00:00 PM to 7/8/2019 11:00:00 PM

Location Category	Reading Date	Range of Detections
Division E	7/8/2019 22:33:54	0.03000 ppm
