# Preliminary Hand- Held Air Monitoring Locations | ITC Deer Park Tank Fire

7/9/2019 11:00:00 PM to 7/10/2019 12:00:00 AM

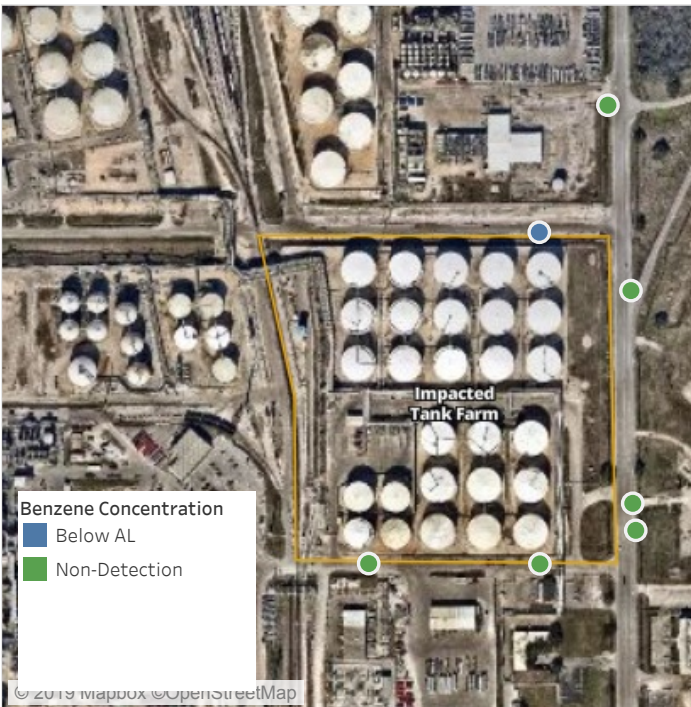
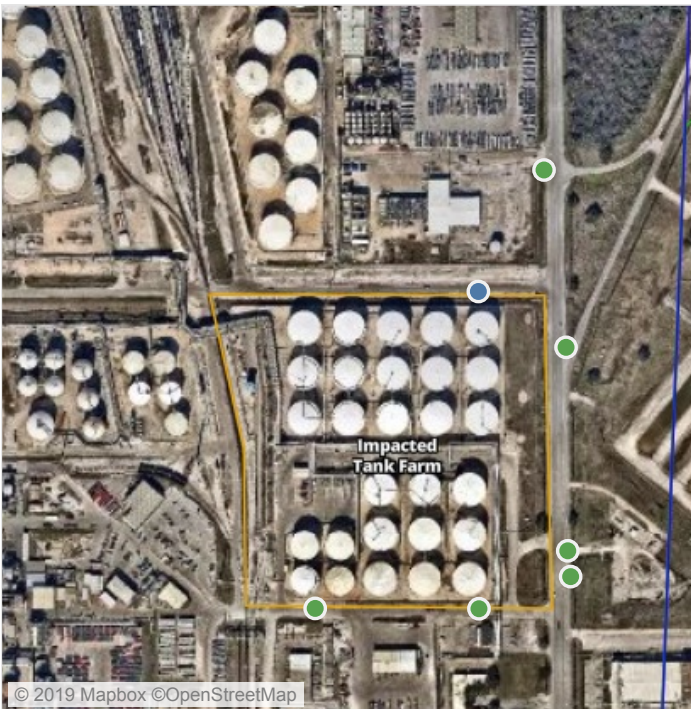
Reading Date  
7/10/2019 5:00:00 AM to 7/10/2019 6:00:00 AM

Location Category	Reading Date	Range of Detections
Division E	7/10/2019 05:51:09	0.07000 ppm

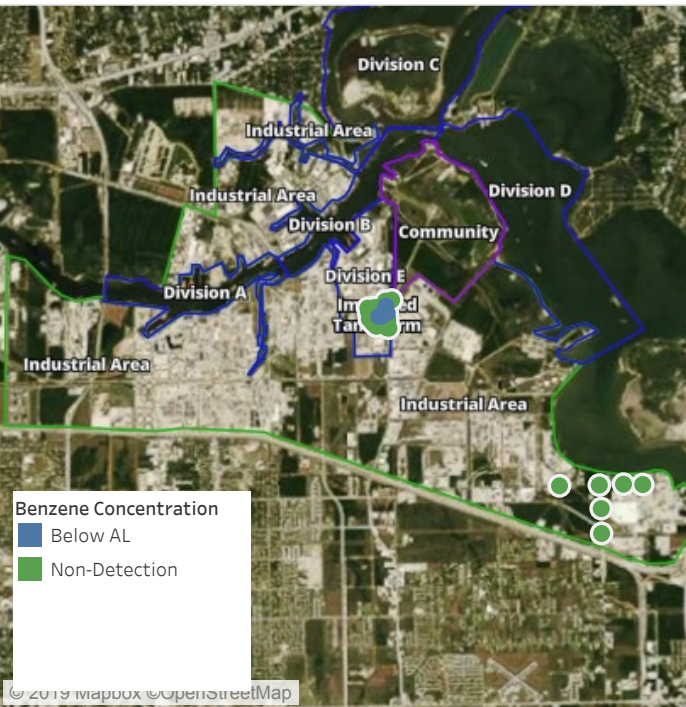
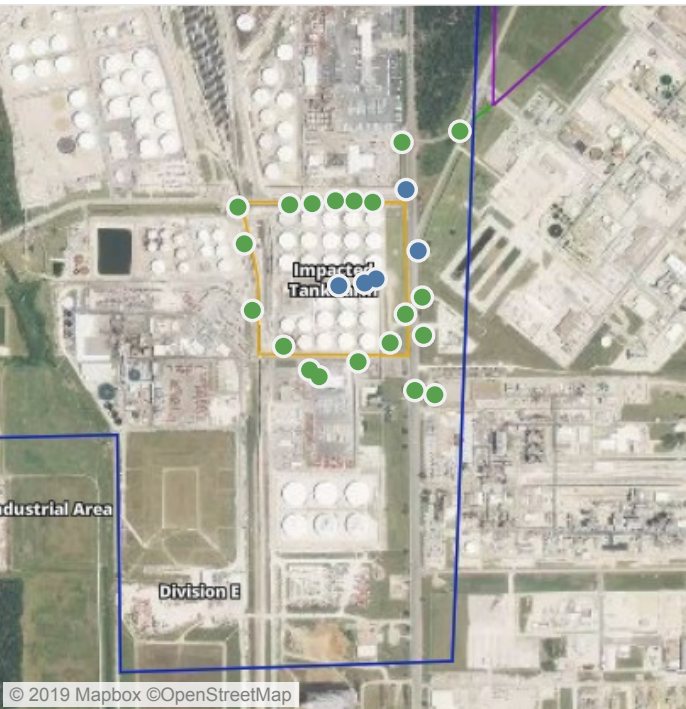
Reading Date  
7/10/2019 8:00:00 AM to 7/10/2019 9:00:00 AM

Location Category	Reading Date	Range of Detections
Division E	7/10/2019 08:49:42	0.05000 ppm
	7/10/2019 08:58:34	0.05000 ppm
Impacted Tank Farm	7/10/2019 08:48:19	0.04000 ppm
	7/10/2019 08:52:57	0.04000 ppm
	7/10/2019 08:55:40	0.04000 ppm

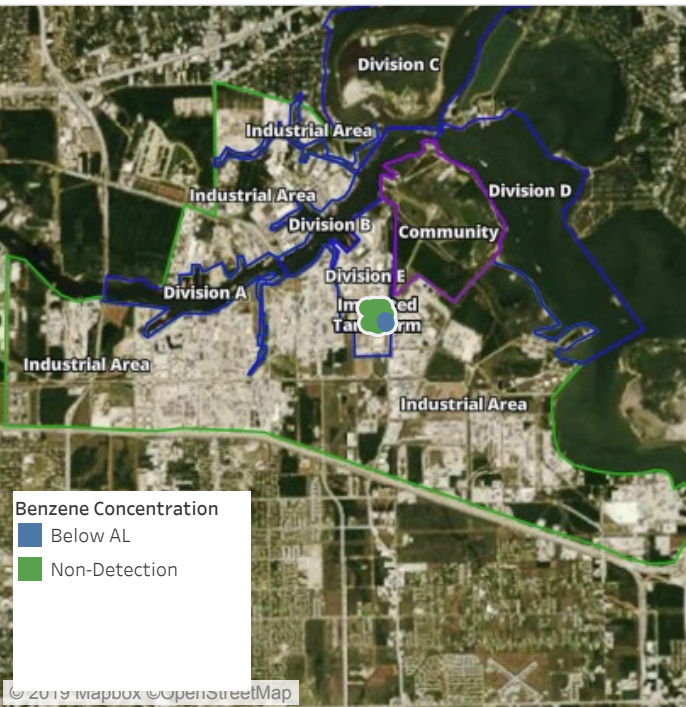
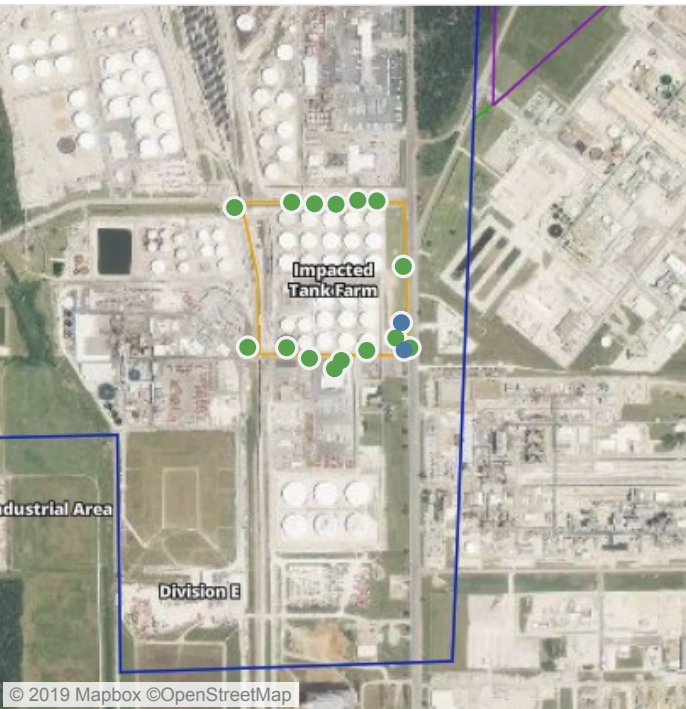
Reading Date  
7/10/2019 9:00:00 AM to 7/10/2019 10:00:00 AM

Location Category	Reading Date	Range of Detections
Division E	7/10/2019 09:06:05	0.0400 ppm
	7/10/2019 09:35:23	0.2100 ppm

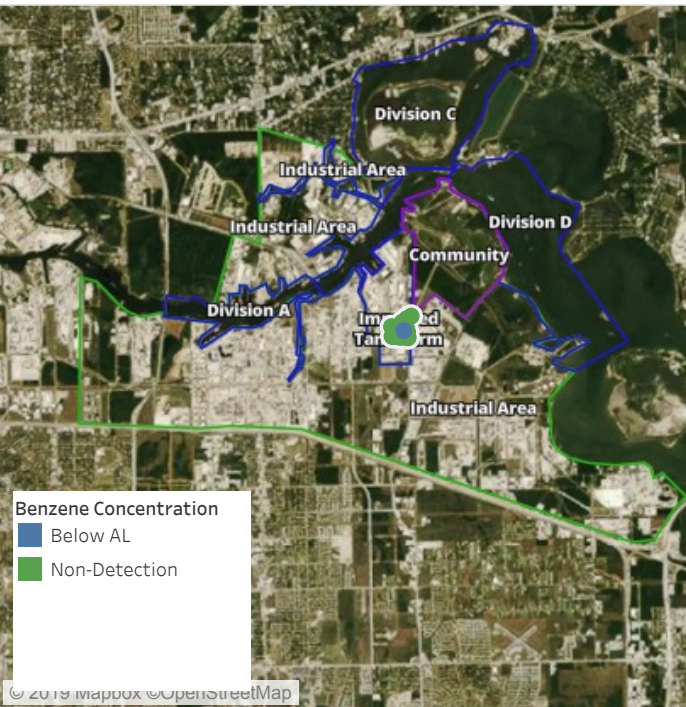
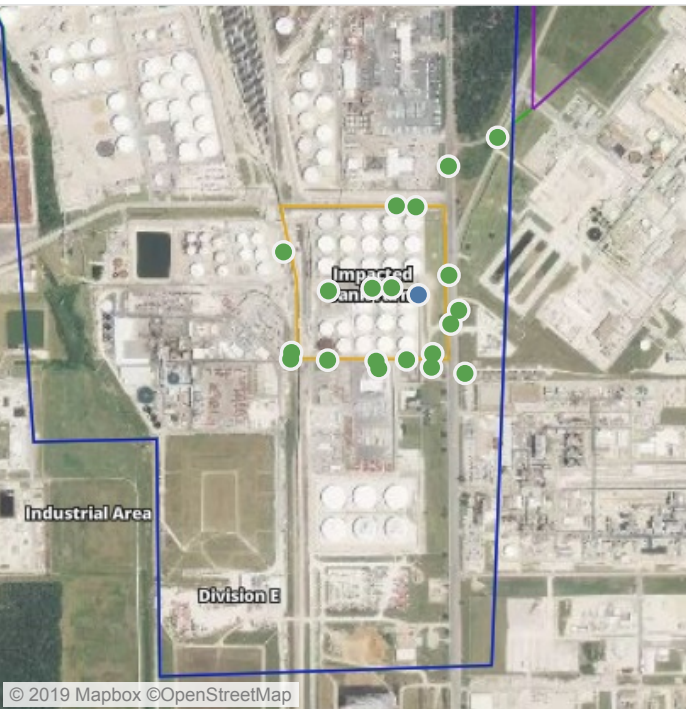
Reading Date  
7/10/2019 10:00:00 AM to 7/10/2019 11:00:00 AM

Location Category	Reading Date	Range of Detections
Impacted Tank Farm	7/10/2019 10:35:15	0.1200 ppm

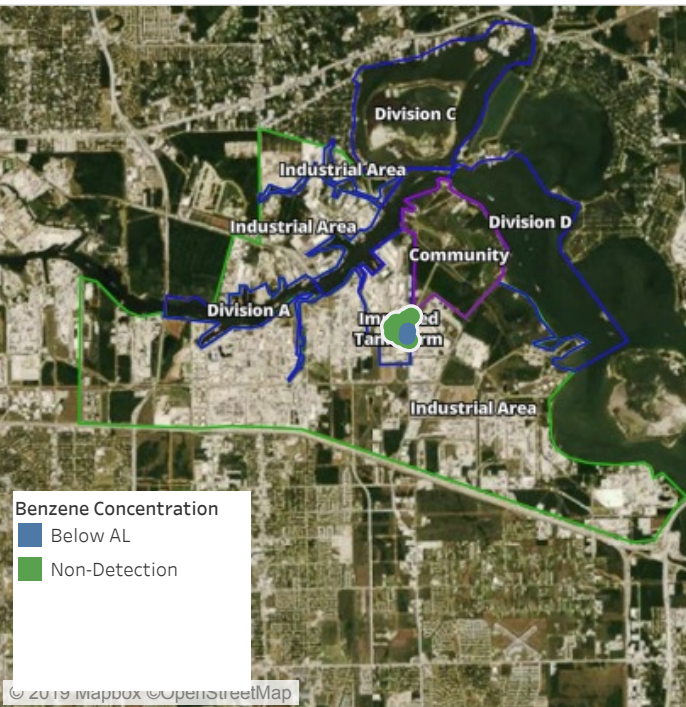
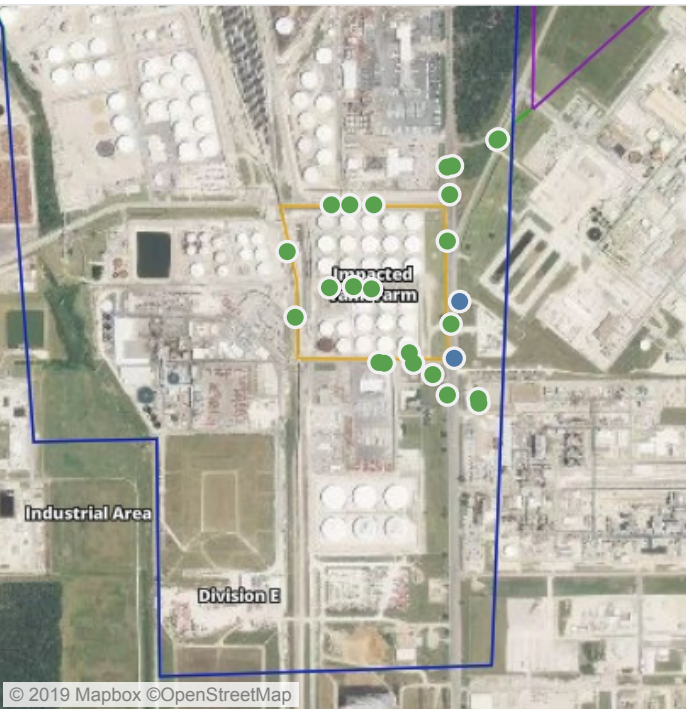
Reading Date  
7/10/2019 11:00:00 AM to 7/10/2019 12:00:00 PM

Location Category	Reading Date	Range of Detections
Division E	7/10/2019 11:17:06	0.04000 ppm
	7/10/2019 11:52:11	0.02000 ppm

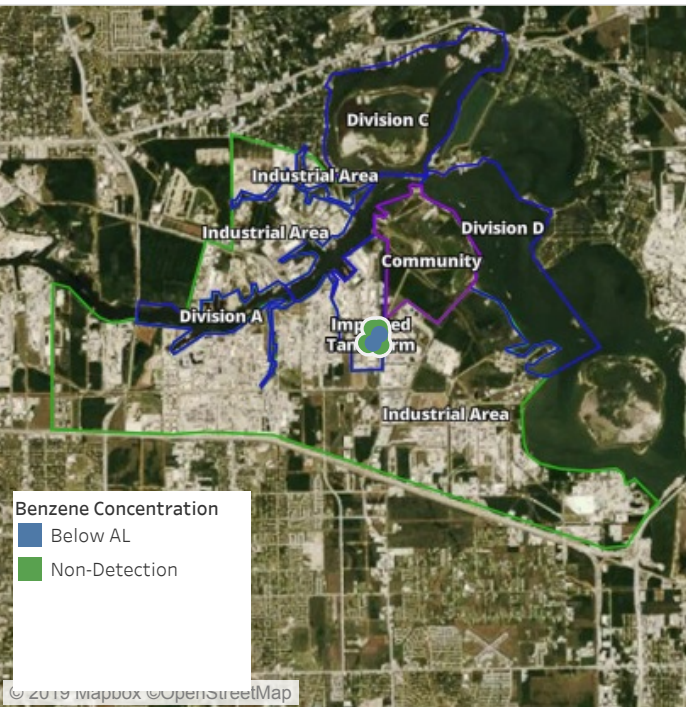
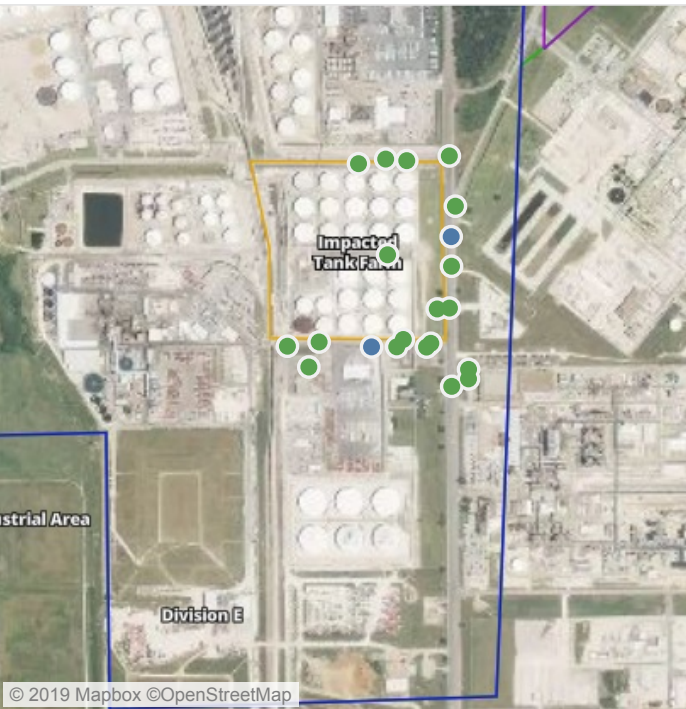
Reading Date  
7/10/2019 12:00:00 PM to 7/10/2019 1:00:00 PM

Location Category	Reading Date	Range of Detections
Division E	7/10/2019 12:07:52	0.02000 ppm
	7/10/2019 12:37:53	0.03000 ppm

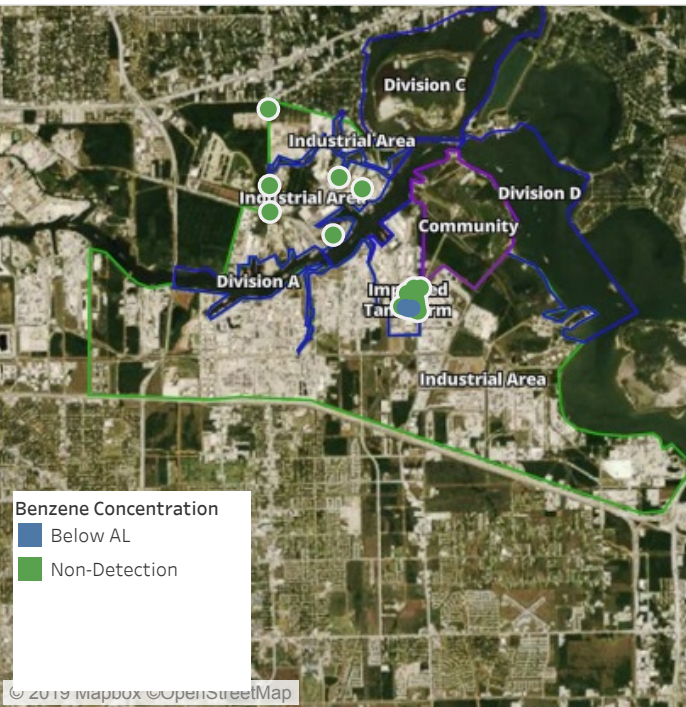
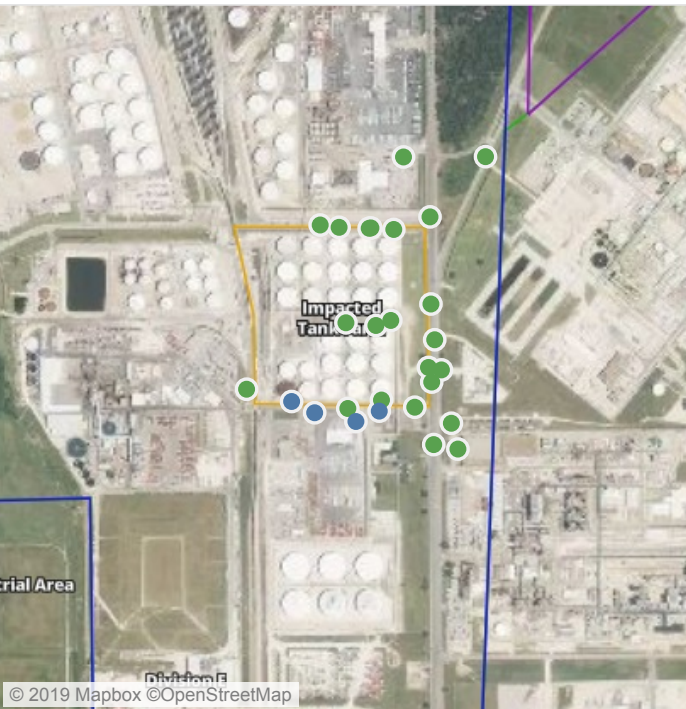
Reading Date  
7/10/2019 2:00:00 PM to 7/10/2019 3:00:00 PM

Location Category	Reading Date	Range of Detections
Division E	7/10/2019 14:17:22	0.12000 ppm
	7/10/2019 14:22:38	0.04000 ppm
	7/10/2019 14:20:33	0.04000 ppm
	7/10/2019 14:15:20	0.08000 ppm

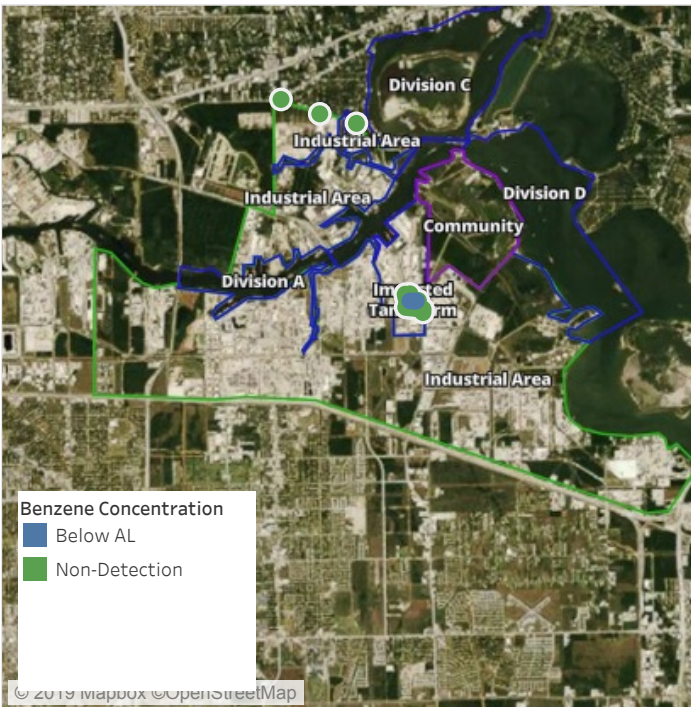
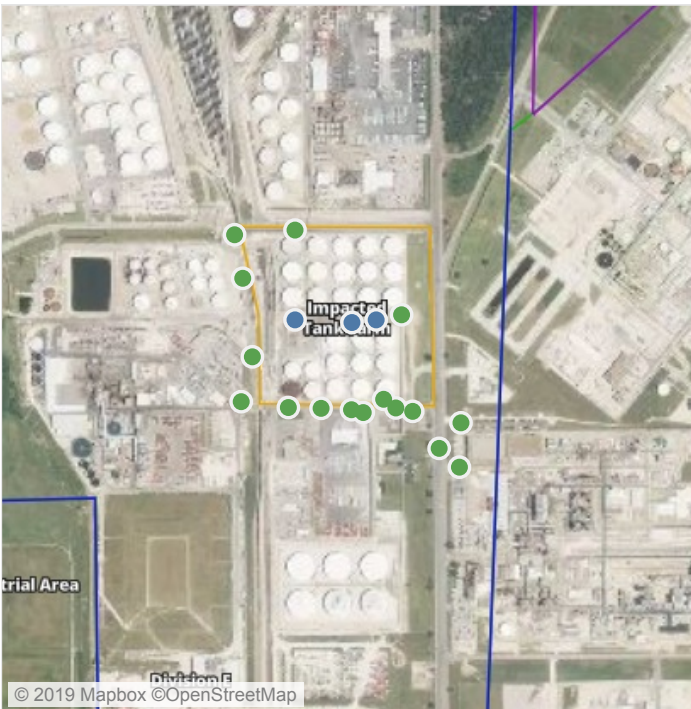
Reading Date  
7/10/2019 3:00:00 PM to 7/10/2019 4:00:00 PM

Location Category	Reading Date	Range of Detections
Impacted Tank Farm	7/10/2019 15:37:48	0.08000 ppm
	7/10/2019 15:42:25	0.09000 ppm
	7/10/2019 15:44:02	0.03000 ppm

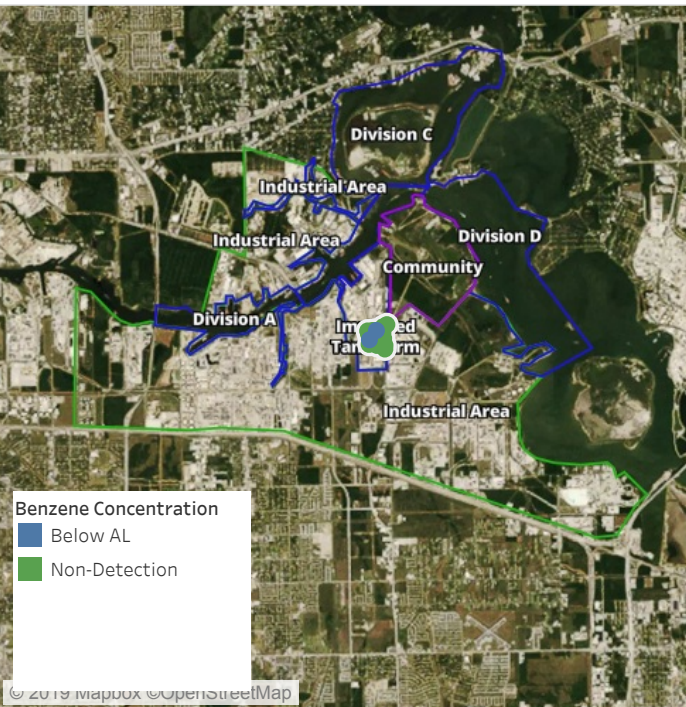
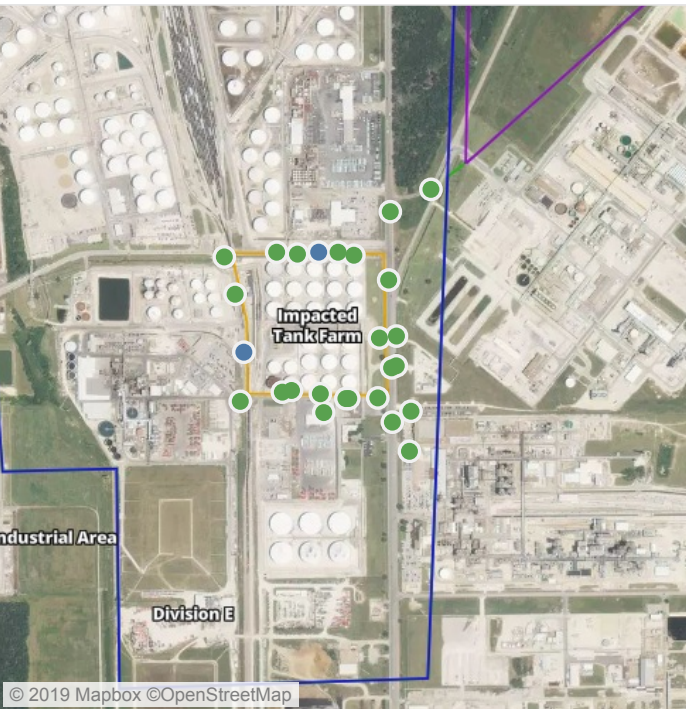
Reading Date  
7/10/2019 4:00:00 PM to 7/10/2019 5:00:00 PM

Location Category	Reading Date	Range of Detections
Division E	7/10/2019 16:21:44	0.03000 ppm
	7/10/2019 16:55:00	0.02000 ppm

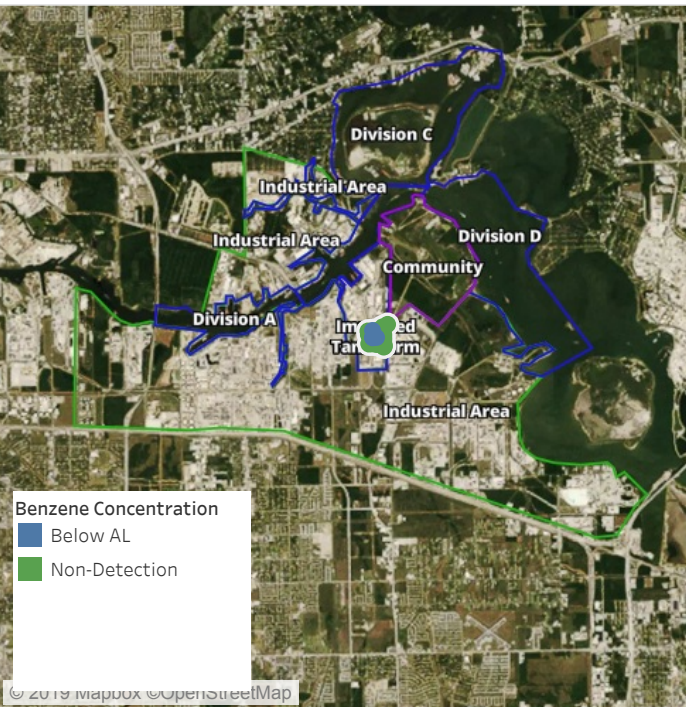
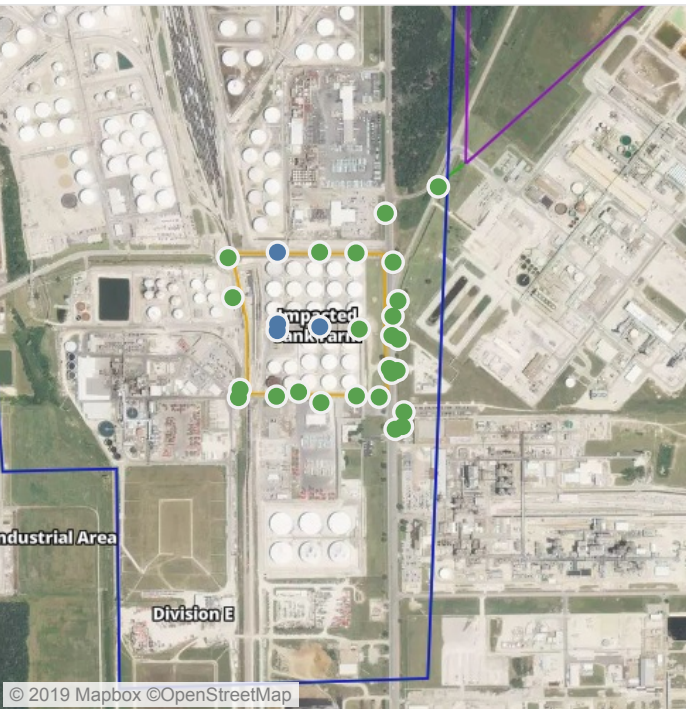
Reading Date  
7/10/2019 5:00:00 PM to 7/10/2019 6:00:00 PM

Location Category	Reading Date	Range of Detections
Division E	7/10/2019 17:32:42	0.0200 ppm
Impacted Tank Farm	7/10/2019 17:07:20	0.1200 ppm
	7/10/2019 17:09:16	0.2600 ppm
	7/10/2019 17:58:40	0.0700 ppm

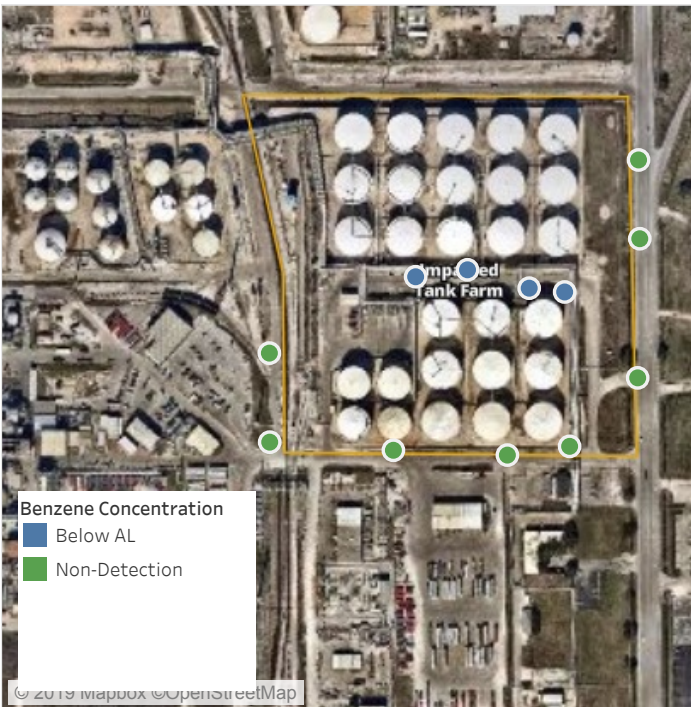
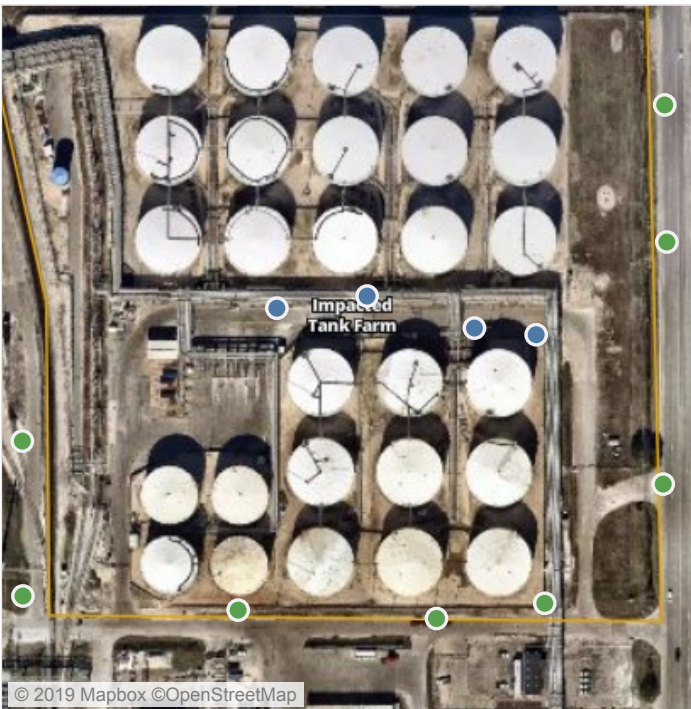
Reading Date  
7/10/2019 6:00:00 PM to 7/10/2019 7:00:00 PM

Location Category	Reading Date	Range of Detections
Impacted Tank Farm	7/10/2019 18:01:23	0.0700 ppm
	7/10/2019 18:05:15	0.0800 ppm
	7/10/2019 18:10:49	0.1800 ppm
	7/10/2019 18:16:03	0.2300 ppm

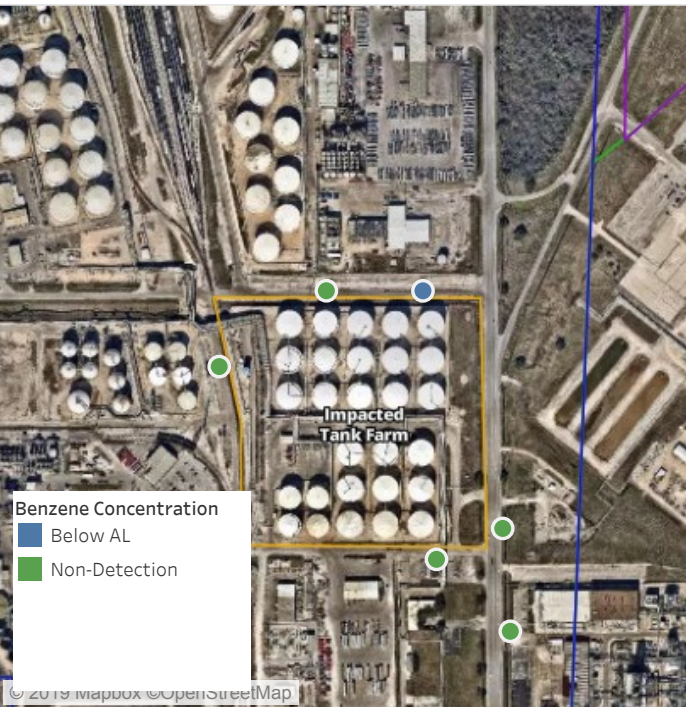
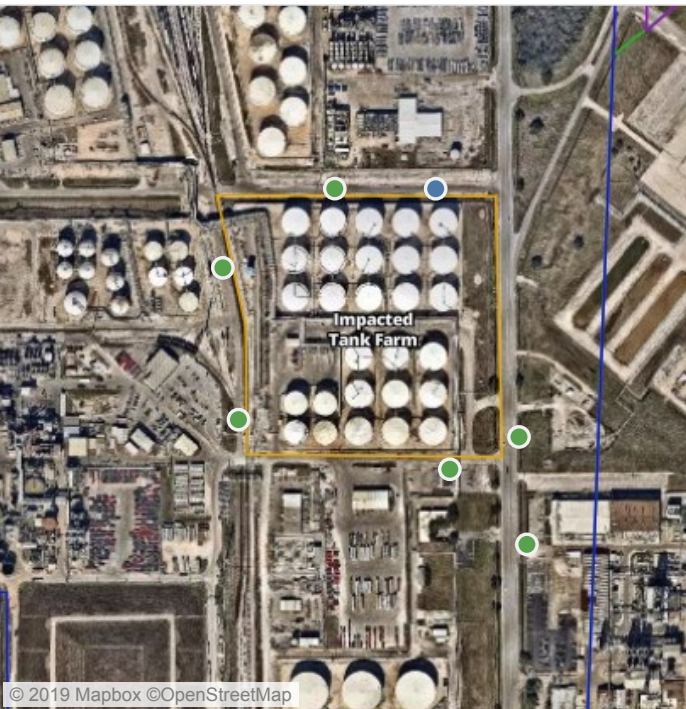
Reading Date  
7/10/2019 10:00:00 PM to 7/10/2019 11:00:00 PM

Location Category	Reading Date	Range of Detections
Division E	7/10/2019 22:06:23	0.05000 ppm
