Preliminary Hand- Held Air Monitoring Locations | ITC Deer Park Tank Fire

Reading Date
7/13/2019 11:00:00 PM to 7/14/2019 12:00:00 AM

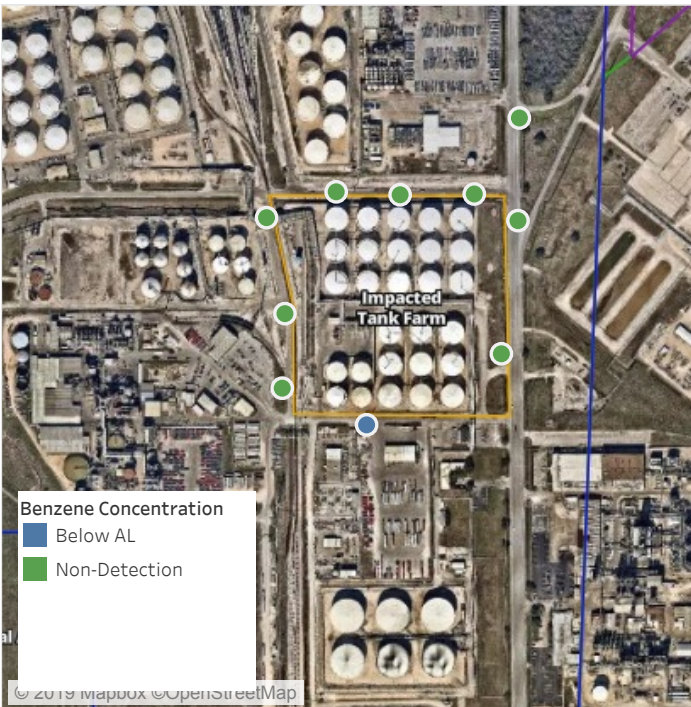
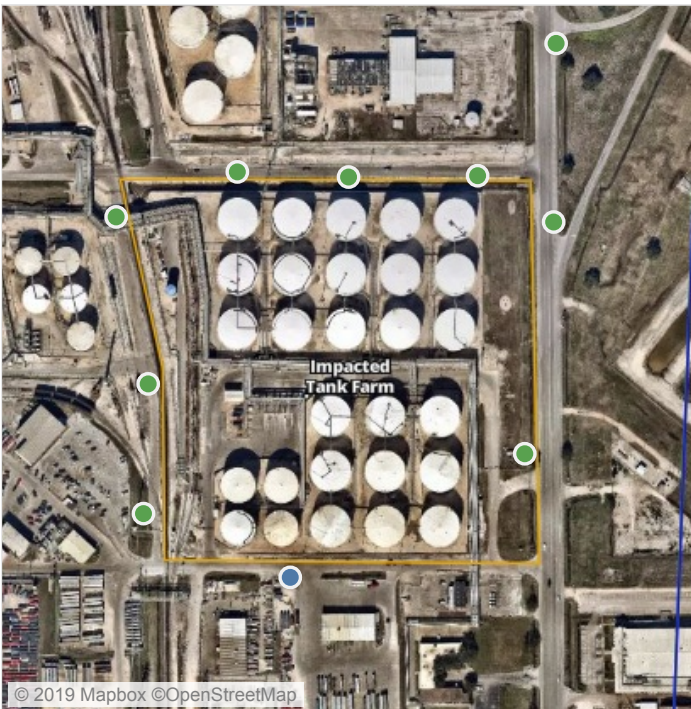
Location Category	Reading Date	Range of Detections
Division E	7/13/2019 23:55:00	0.03000 ppm

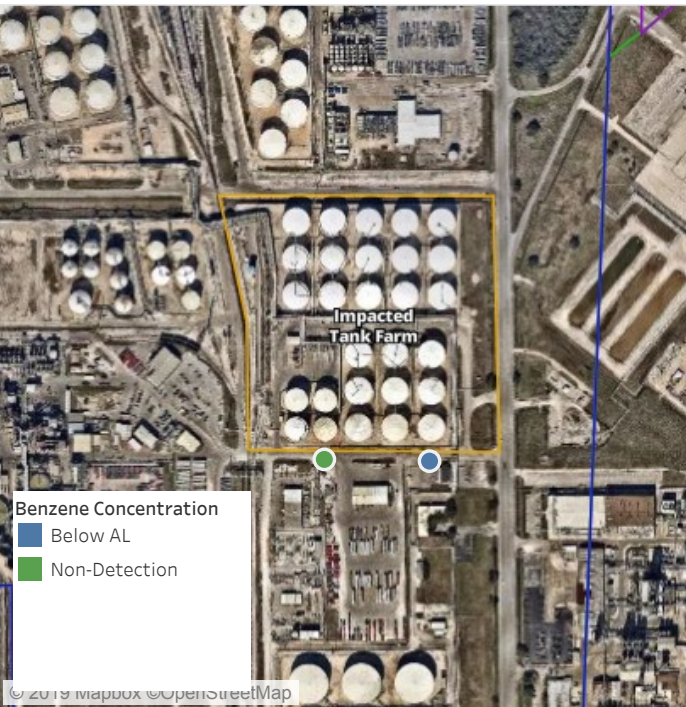
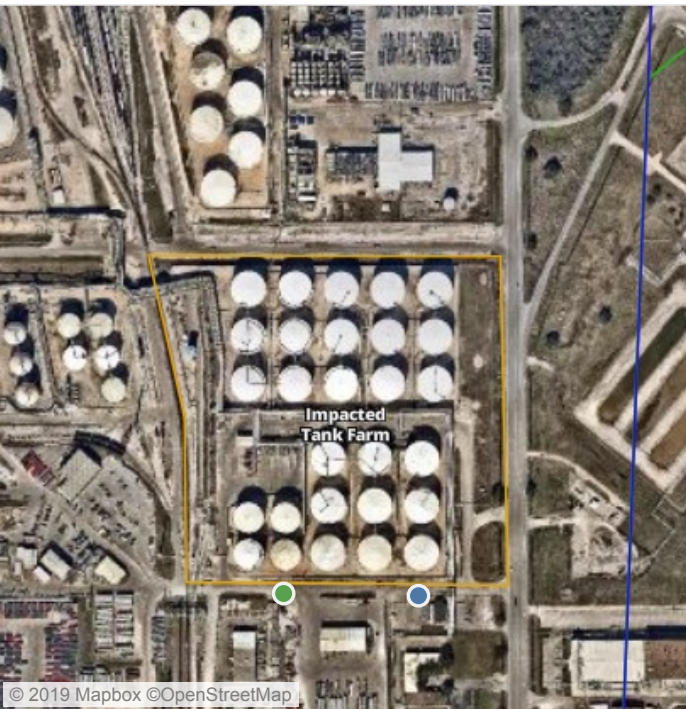
Reading Date
7/14/2019 3:00:00 AM to 7/14/2019 4:00:00 AM

Location Category	Reading Date	Range of Detections
Division E	7/14/2019 03:25:00	0.05000 ppm

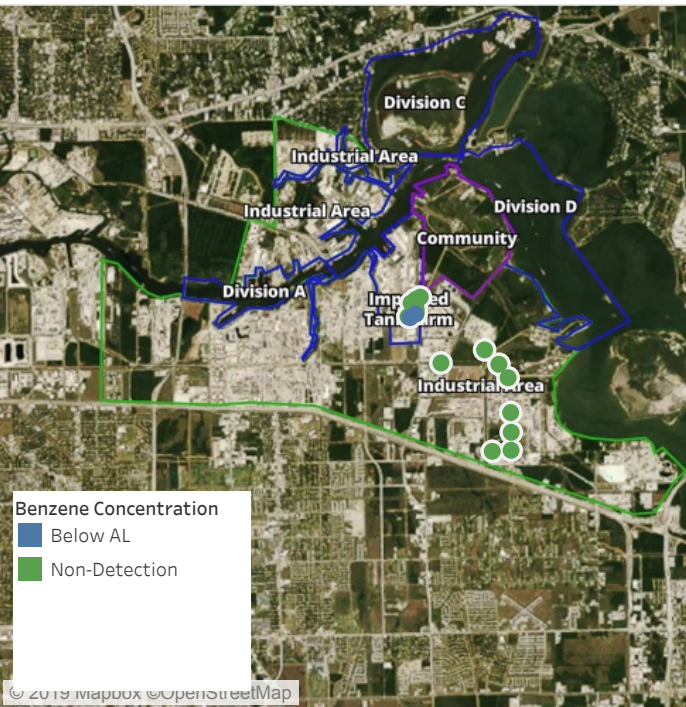
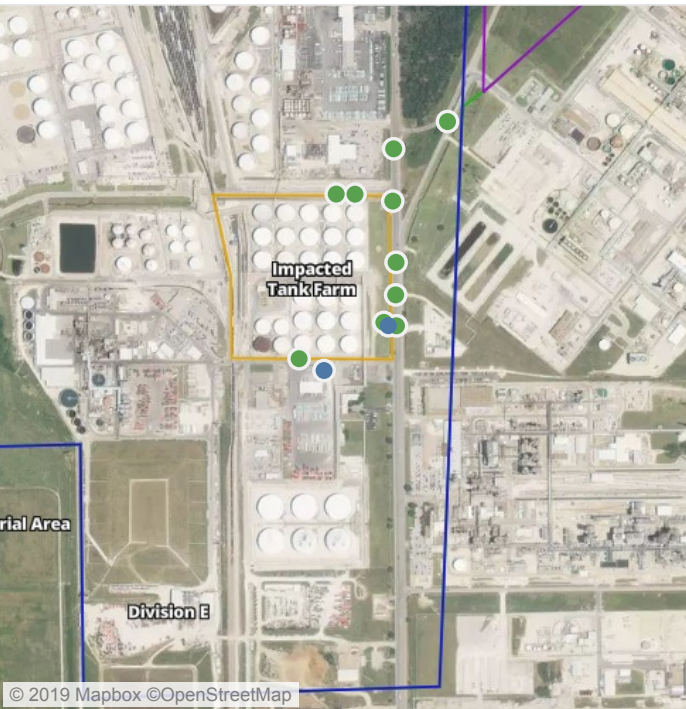
Reading Date
7/14/2019 7:00:00 AM to 7/14/2019 8:00:00 AM

Location Category	Reading Date	Range of Detections
Division E	7/14/2019 07:53:44	0.2300 ppm
	7/14/2019 07:50:07	0.0600 ppm

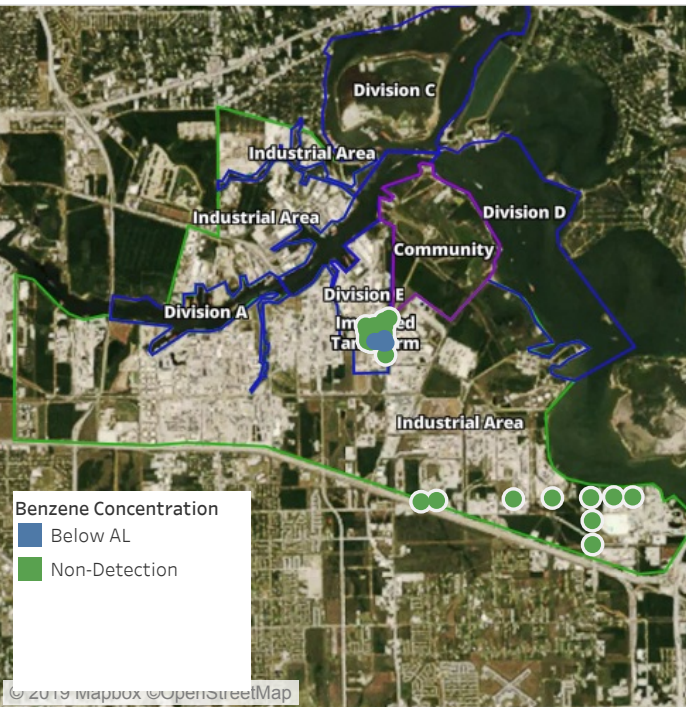
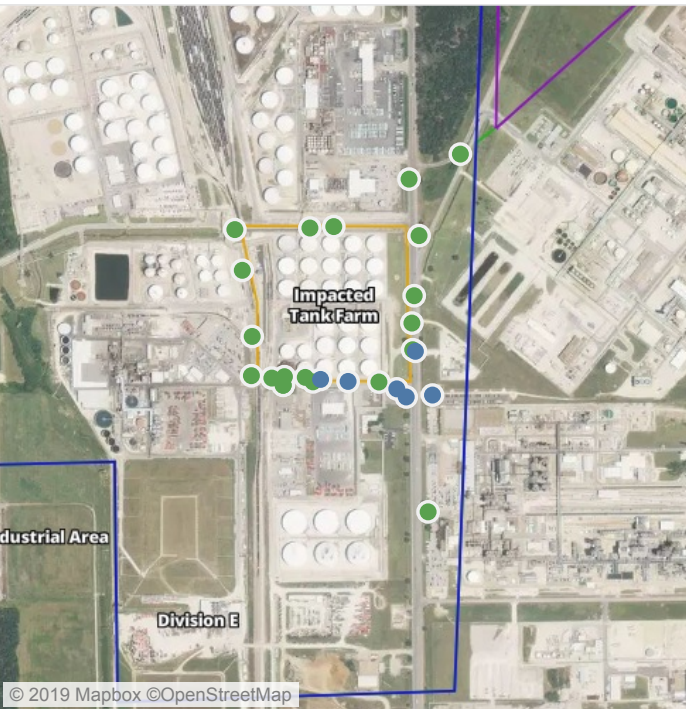
Reading Date
7/14/2019 8:00:00 AM to 7/14/2019 9:00:00 AM

Location Category	Reading Date	Range of Detections
Division E	7/14/2019 08:16:31	0.10000 ppm
	7/14/2019 08:13:05	0.09000 ppm
	7/14/2019 08:25:57	0.07000 ppm
	7/14/2019 08:32:04	0.05000 ppm
	7/14/2019 08:49:34	0.02000 ppm
	7/14/2019 08:52:50	0.03000 ppm

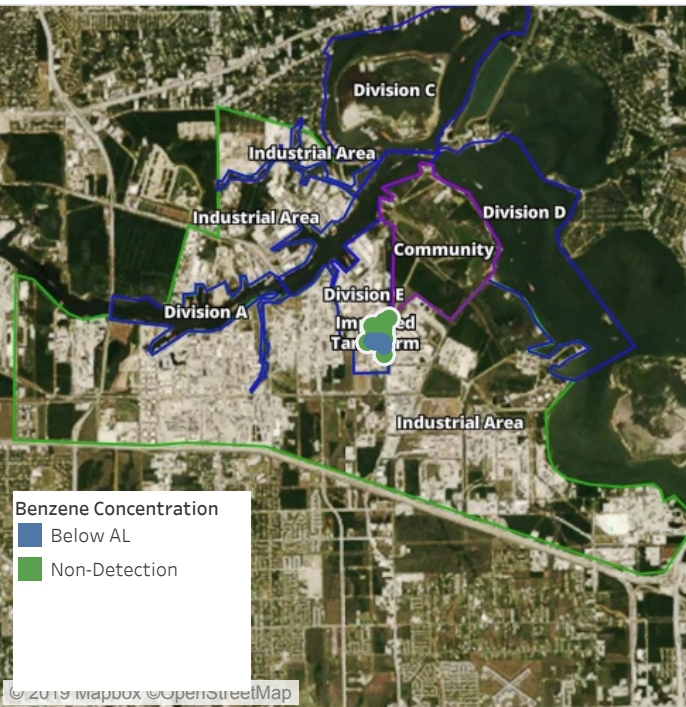
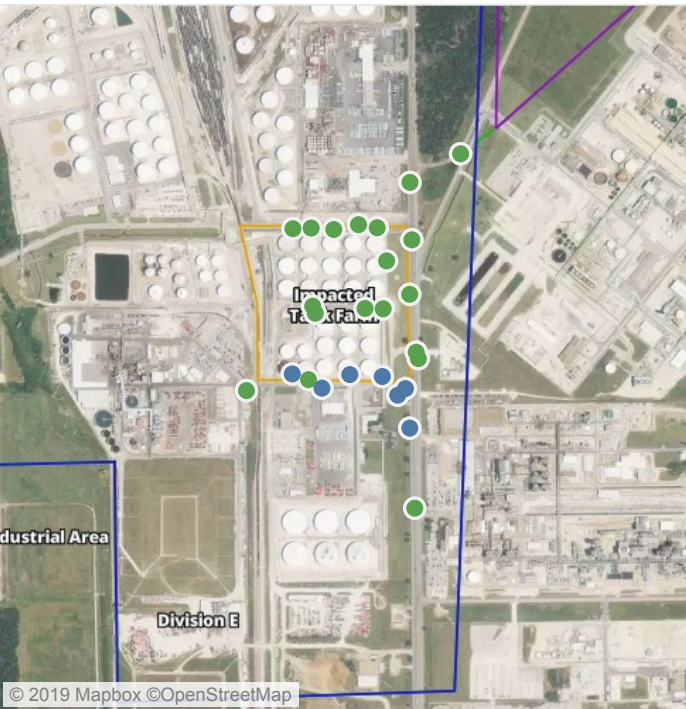
Reading Date
7/14/2019 9:00:00 AM to 7/14/2019 10:00:00 AM

Location Category	Reading Date	Range of Detections
Division E	7/14/2019 09:02:33	0.1200 ppm
	7/14/2019 09:04:50	0.0700 ppm
	7/14/2019 09:39:22	0.1800 ppm
	7/14/2019 09:42:26	0.0300 ppm
	7/14/2019 09:44:49	0.0400 ppm
	7/14/2019 09:57:27	0.2600 ppm
	7/14/2019 09:50:52	0.0200 ppm

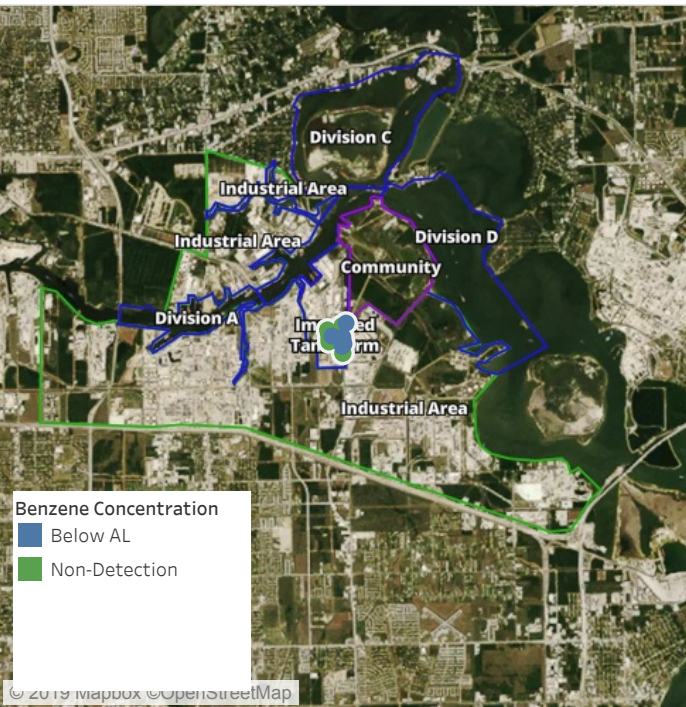
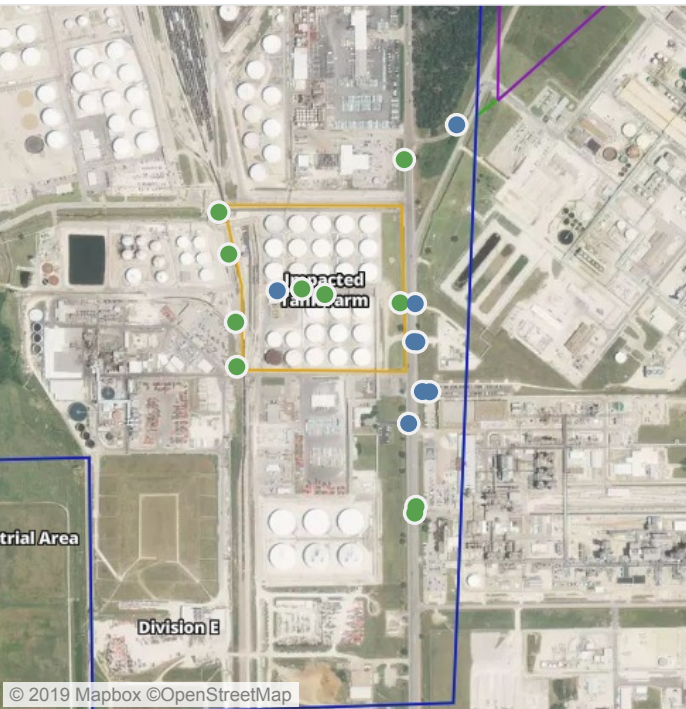
Reading Date
7/14/2019 10:00:00 AM to 7/14/2019 11:00:00 AM

Location Category	Reading Date	Range of Detections
Division E	7/14/2019 10:00:17	0.0200 ppm
	7/14/2019 10:12:10	0.0600 ppm
	7/14/2019 10:08:08	0.0500 ppm
	7/14/2019 10:18:22	0.0200 ppm
	7/14/2019 10:57:02	0.1200 ppm
	7/14/2019 10:53:12	0.0500 ppm
	7/14/2019 10:59:21	0.0700 ppm
Impacted Tank Farm	7/14/2019 10:43:04	0.0200 ppm

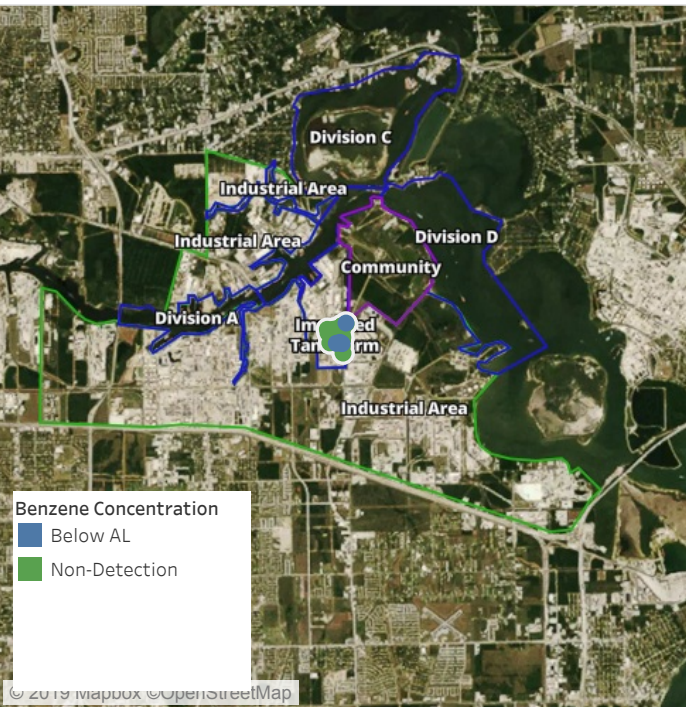
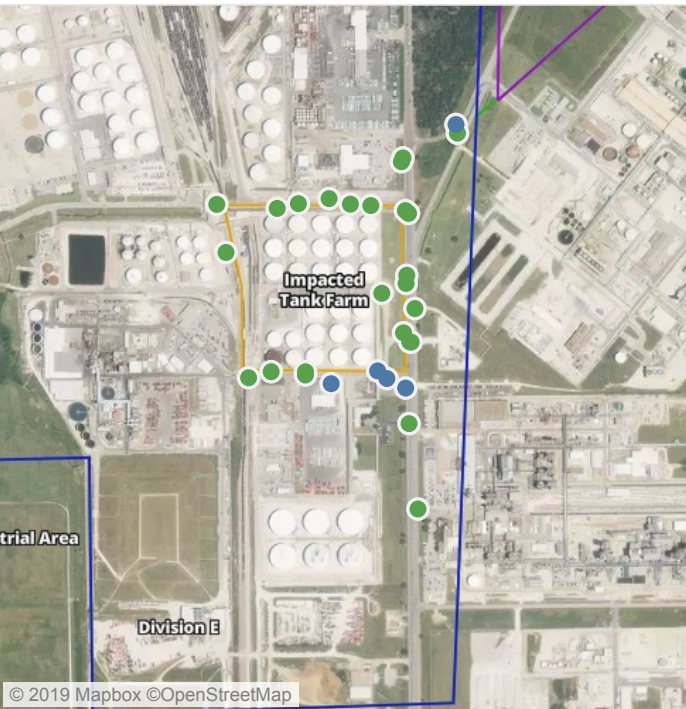
Reading Date
7/14/2019 11:00:00 AM to 7/14/2019 12:00:00 PM

Location Category	Reading Date	Range of Detections
Division E	7/14/2019 11:03:01	0.0200 ppm
	7/14/2019 11:19:24	0.0300 ppm
	7/14/2019 11:21:55	0.0500 ppm
	7/14/2019 11:33:31	0.1300 ppm
	7/14/2019 11:40:59	0.0200 ppm

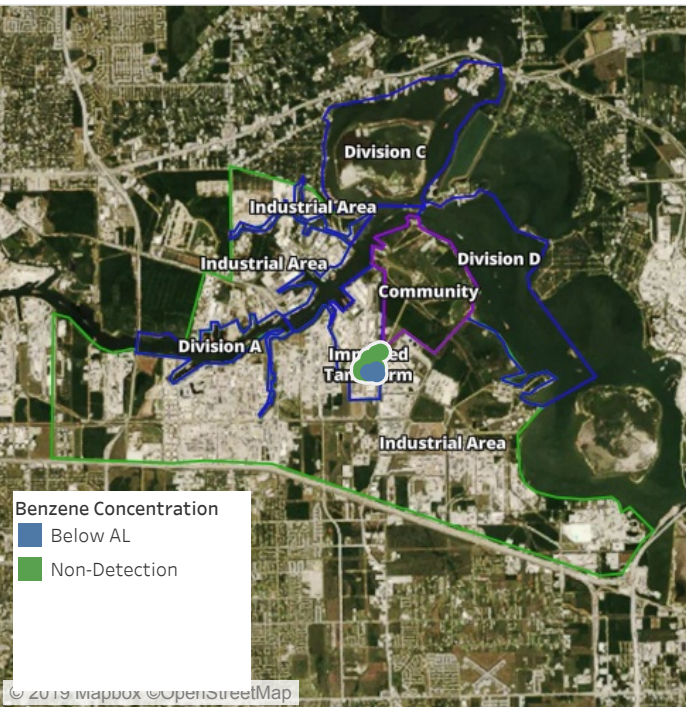
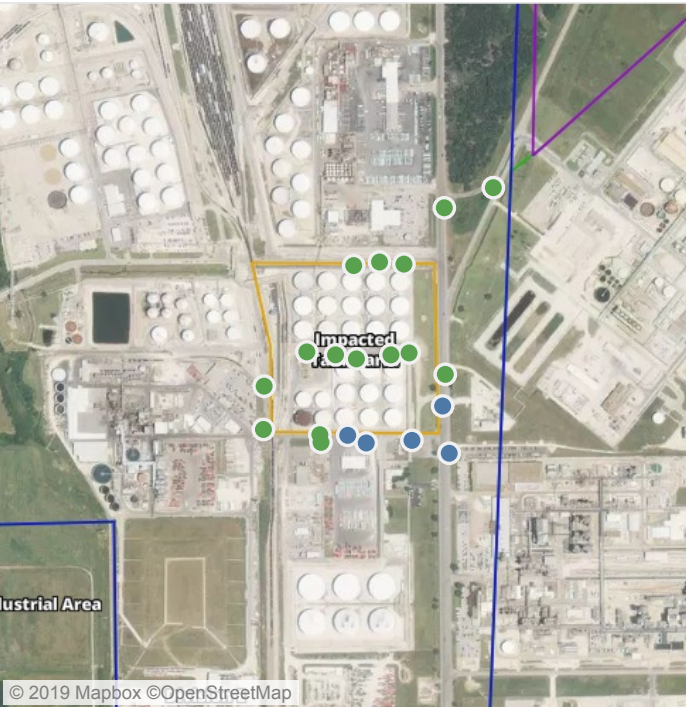
Reading Date
7/14/2019 12:00:00 PM to 7/14/2019 1:00:00 PM

Location Category	Reading Date	Range of Detections
Division E	7/14/2019 12:01:19	0.1700 ppm
	7/14/2019 12:03:59	0.0300 ppm
	7/14/2019 12:05:52	0.0200 ppm
	7/14/2019 12:22:45	0.0200 ppm
	7/14/2019 12:49:08	0.0400 ppm

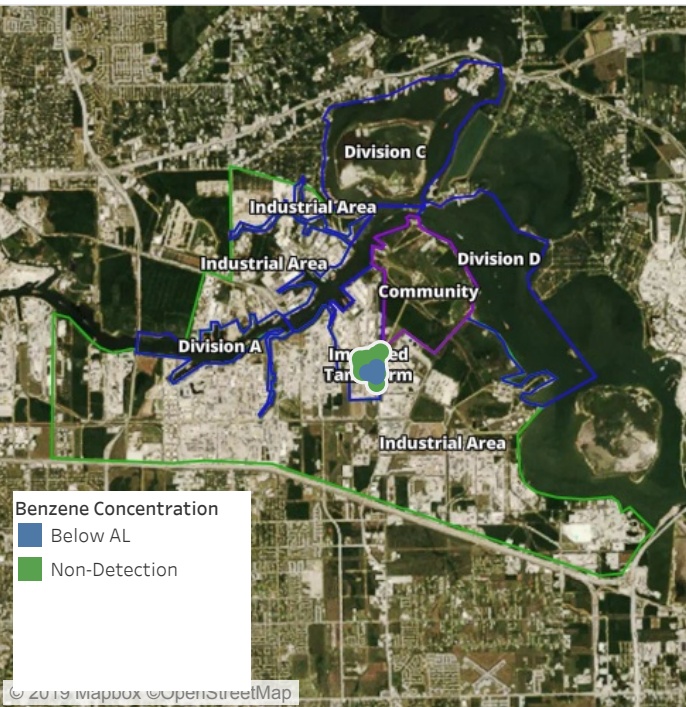
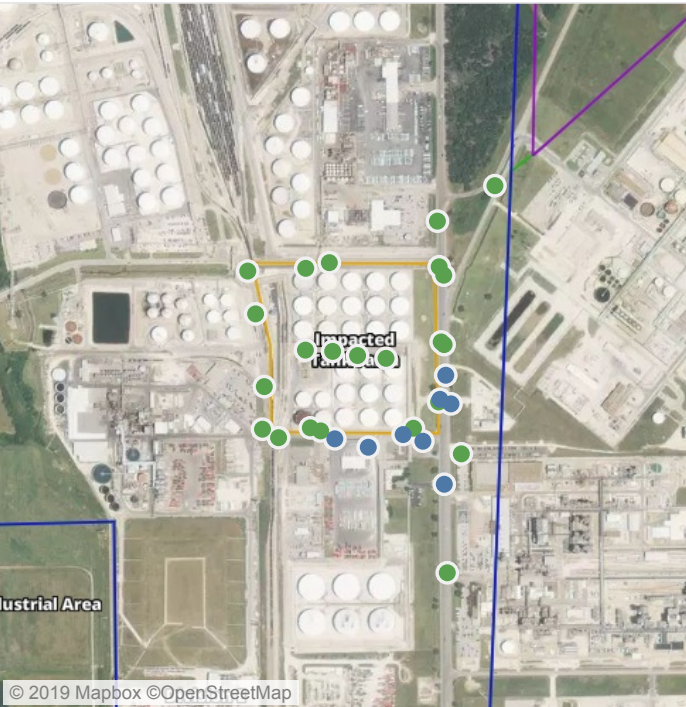
Reading Date
7/14/2019 1:00:00 PM to 7/14/2019 2:00:00 PM

Location Category	Reading Date	Range of Detections
Division E	7/14/2019 13:04:58	0.0600 ppm
	7/14/2019 13:10:28	0.0300 ppm
	7/14/2019 13:14:29	0.0500 ppm
	7/14/2019 13:26:35	0.1100 ppm
	7/14/2019 13:29:14	0.0200 ppm
	7/14/2019 13:39:20	0.0900 ppm
	7/14/2019 13:41:52	0.0800 ppm
	7/14/2019 13:58:46	0.1400 ppm

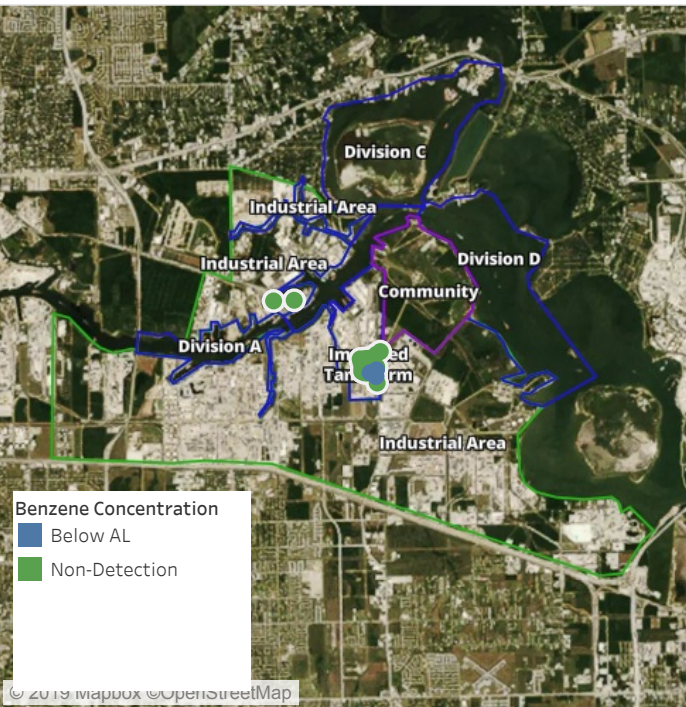
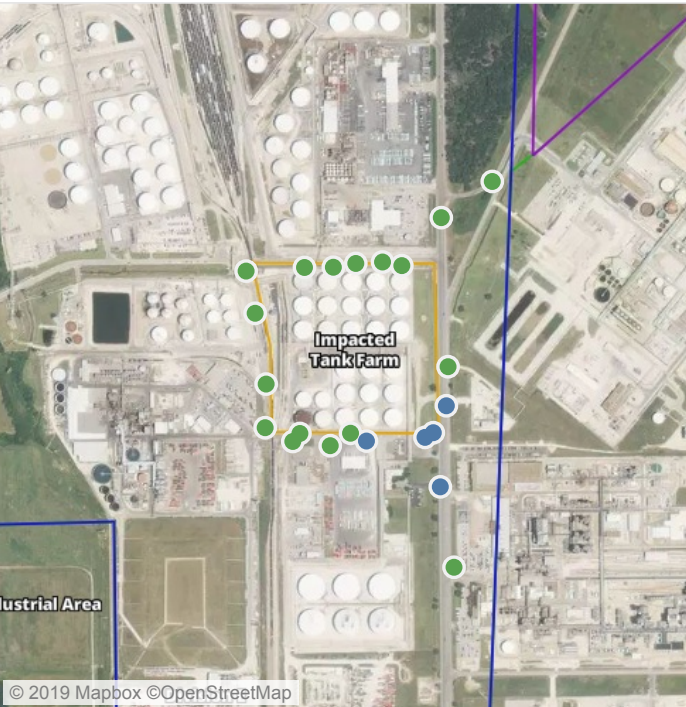
Reading Date
7/14/2019 2:00:00 PM to 7/14/2019 3:00:00 PM

Location Category	Reading Date	Range of Detections
Division E	7/14/2019 14:01:31	0.07000 ppm
	7/14/2019 14:14:53	0.03000 ppm
	7/14/2019 14:17:41	0.05000 ppm
	7/14/2019 14:47:40	0.04000 ppm
	7/14/2019 14:44:39	0.02000 ppm

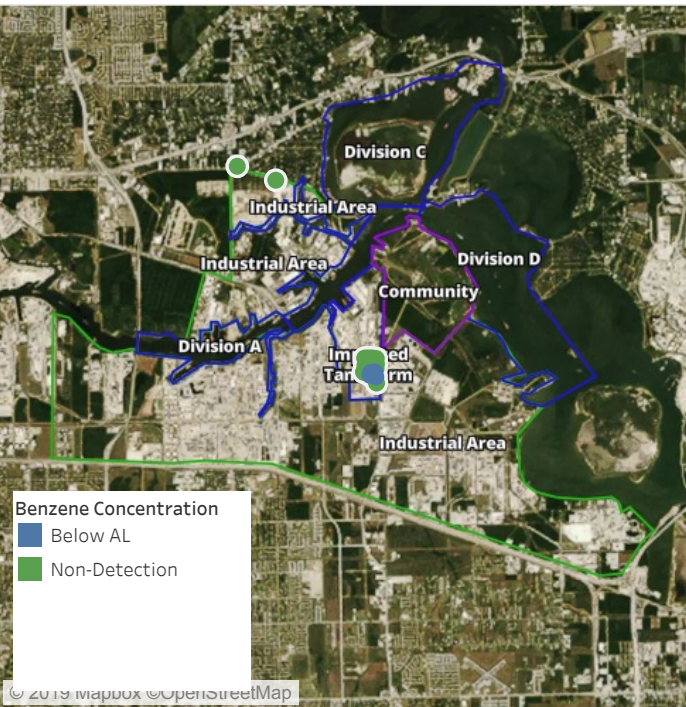
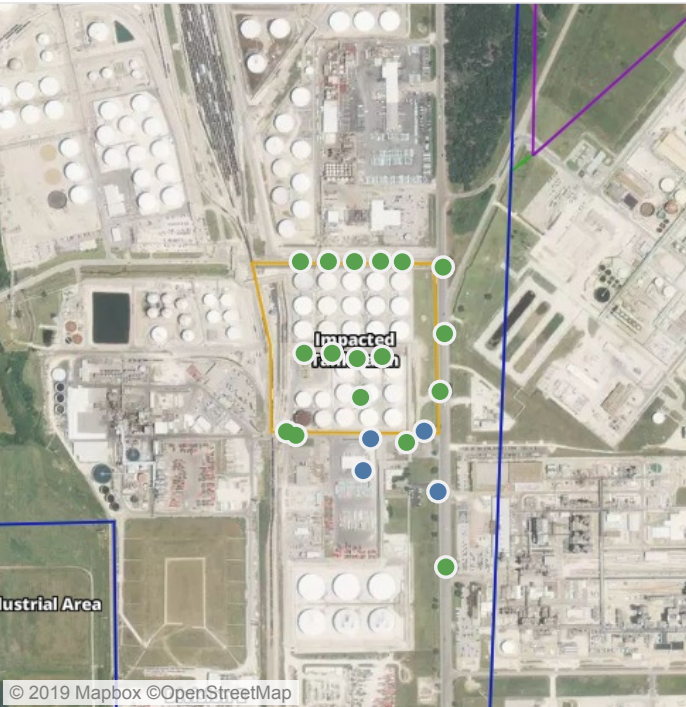
Reading Date
7/14/2019 3:00:00 PM to 7/14/2019 4:00:00 PM

Location Category	Reading Date	Range of Detections
Division E	7/14/2019 15:15:06	0.03000 ppm
	7/14/2019 15:09:37	0.11000 ppm
	7/14/2019 15:23:04	0.05000 ppm
	7/14/2019 15:47:20	0.02000 ppm

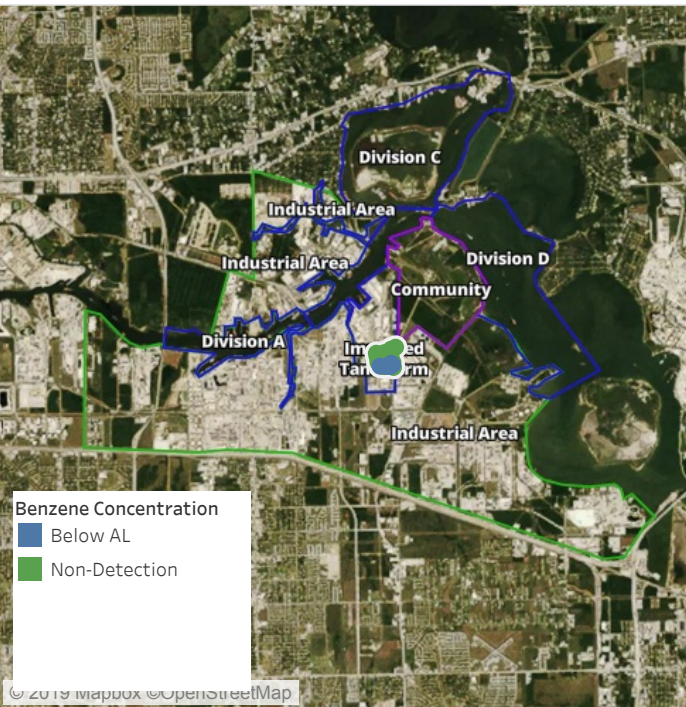
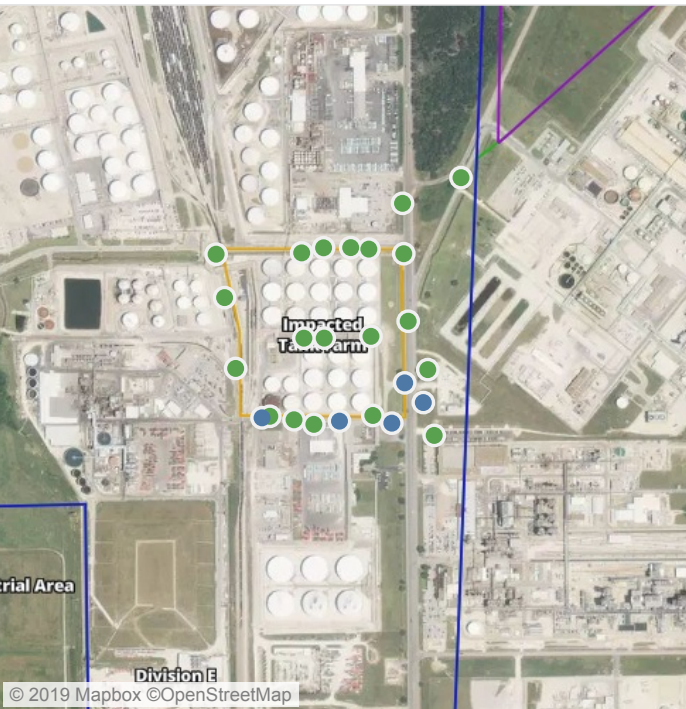
Reading Date
7/14/2019 4:00:00 PM to 7/14/2019 5:00:00 PM

Location Category	Reading Date	Range of Detections
Division E	7/14/2019 16:06:02	0.1000 ppm
	7/14/2019 16:20:15	0.0200 ppm
	7/14/2019 16:38:22	0.1200 ppm
	7/14/2019 16:49:40	0.0300 ppm
	7/14/2019 16:52:57	0.1600 ppm

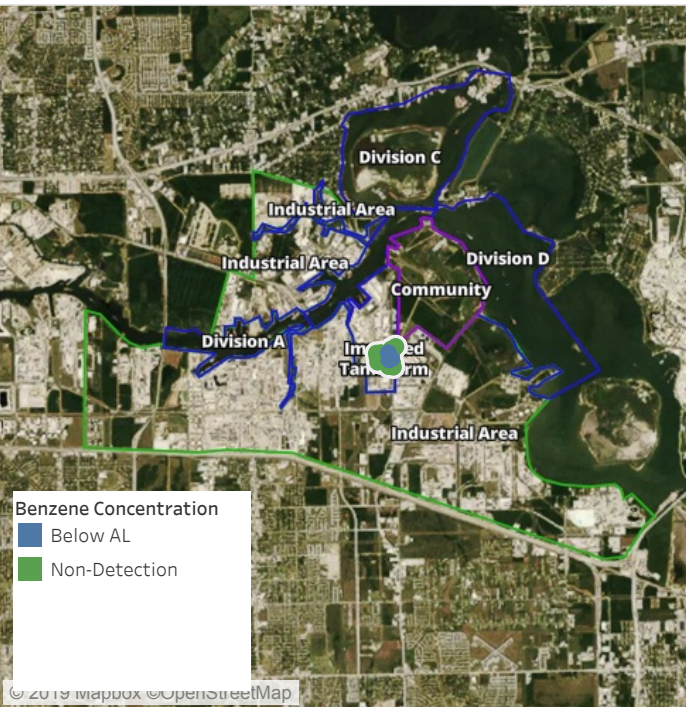
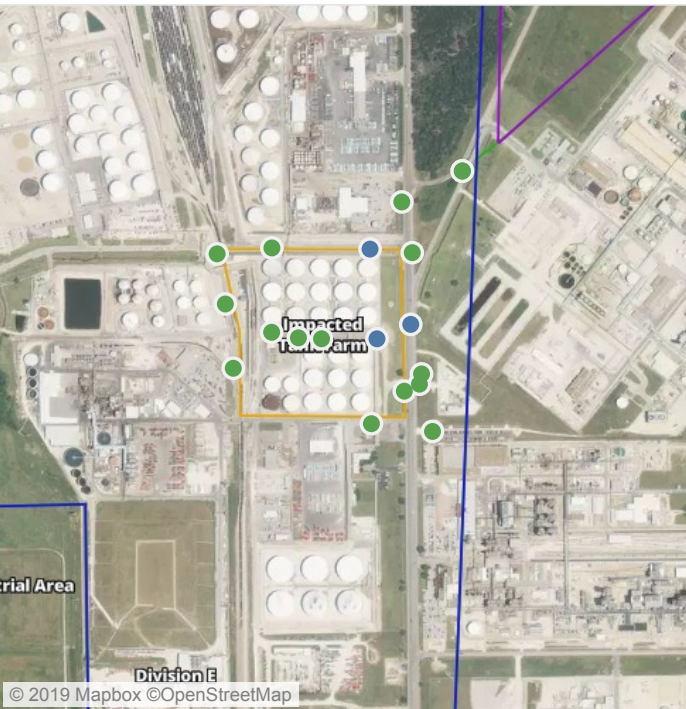
Reading Date
7/14/2019 5:00:00 PM to 7/14/2019 6:00:00 PM

Location Category	Reading Date	Range of Detections
Division E	7/14/2019 17:42:35	0.06000 ppm
	7/14/2019 17:55:54	0.04000 ppm
Impacted Tank Farm	7/14/2019 17:35:15	0.08000 ppm

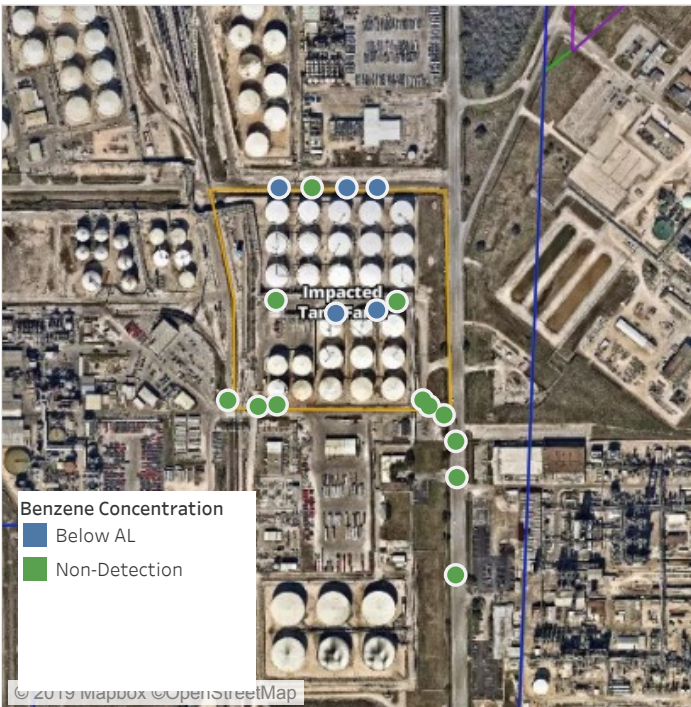
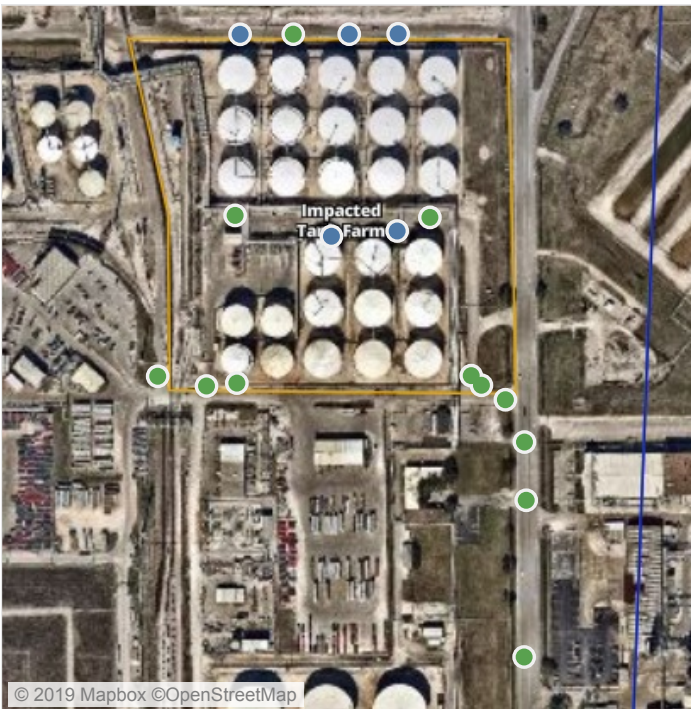
Reading Date
7/14/2019 6:00:00 PM to 7/14/2019 7:00:00 PM

Location Category	Reading Date	Range of Detections
Division E	7/14/2019 18:00:51	0.02000 ppm
	7/14/2019 18:05:58	0.02000 ppm
	7/14/2019 18:14:03	0.06000 ppm
Impacted Tank Farm	7/14/2019 18:25:26	0.07000 ppm
	7/14/2019 18:30:01	0.03000 ppm
