Preliminary Hand- Held Air Monitoring Locations | ITC Deer Park Tank Fire

Reading Date
7/21/2019 7:00:00 AM to 7/21/2019 8:00:00 AM

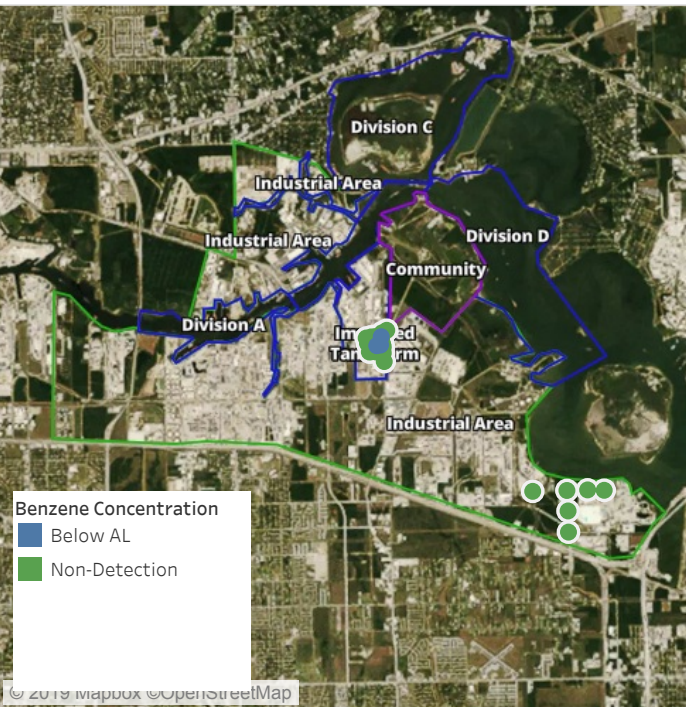
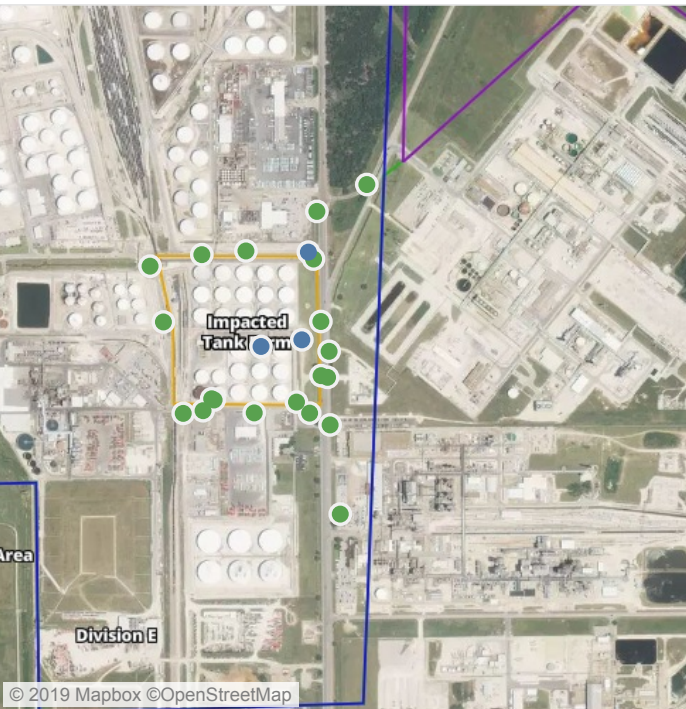
Recent Benzene Detections

Location Category	Reading Date	Range of Detections
Division E	7/21/2019 08:26:44	0.04000 ppm
Impacted Tank Farm	7/21/2019 08:07:44	0.04000 ppm
	7/21/2019 08:15:19	0.05000 ppm

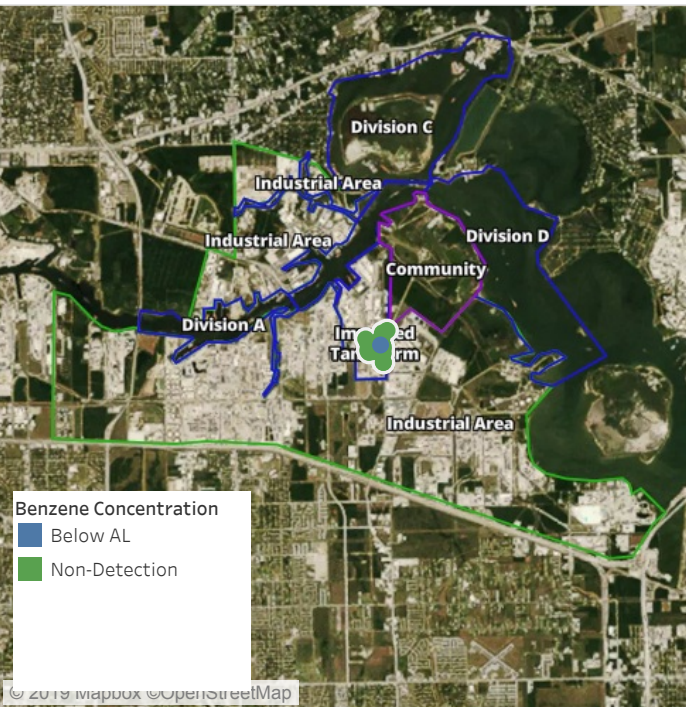
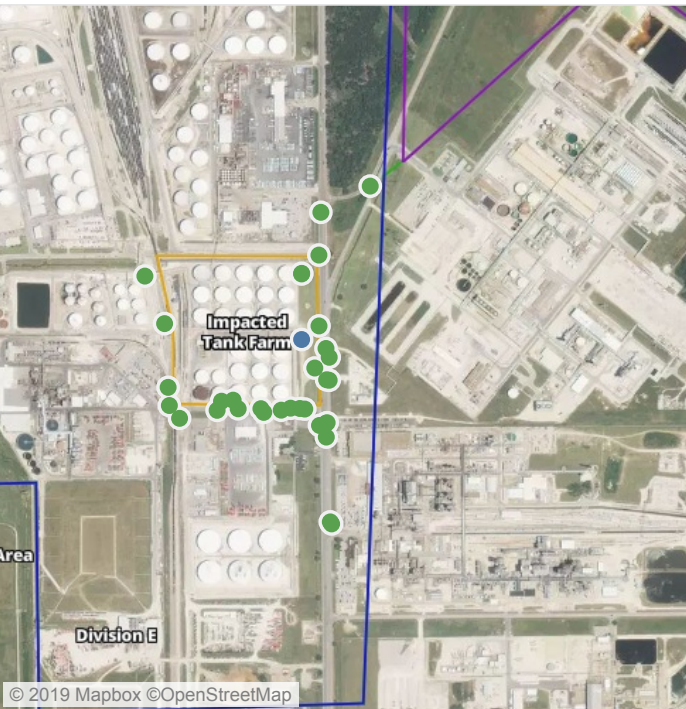
Recent Benzene Detections

Location Category	Reading Date	Range of Detections
Division E	7/21/2019 09:20:58	0.1300 ppm

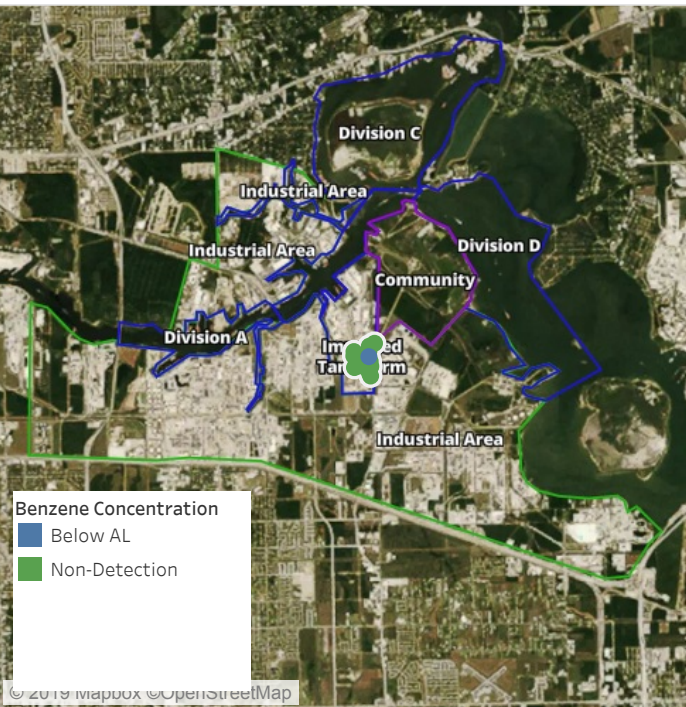
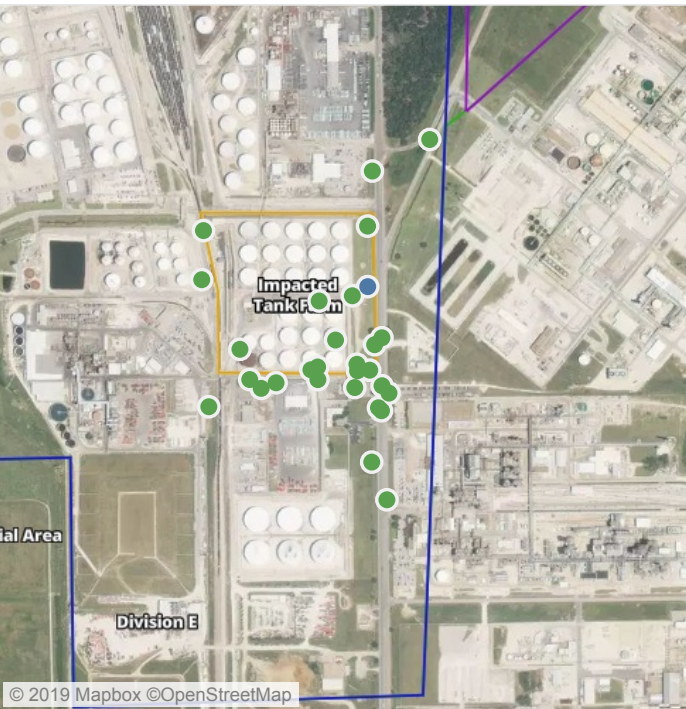
Recent Benzene Detections

Location Category	Reading Date	Range of Detections
Division E	7/21/2019 11:20:06	0.04000 ppm

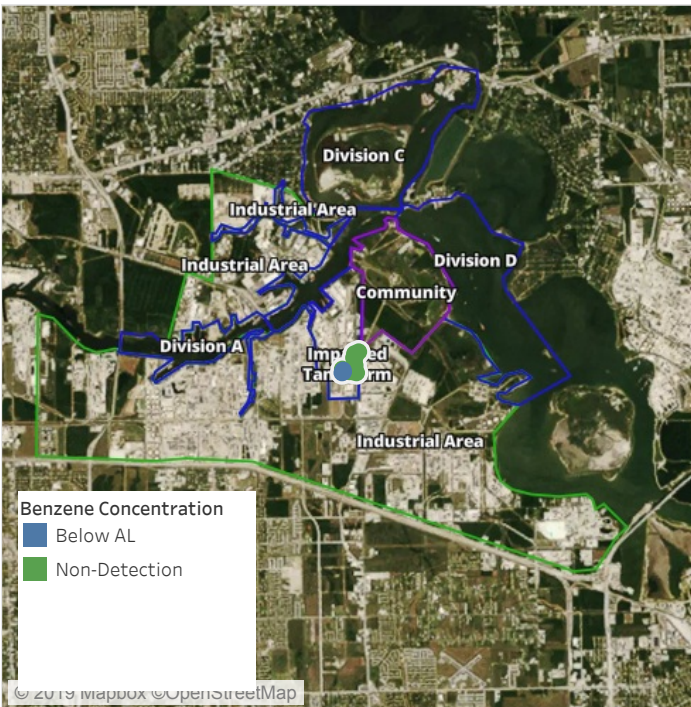
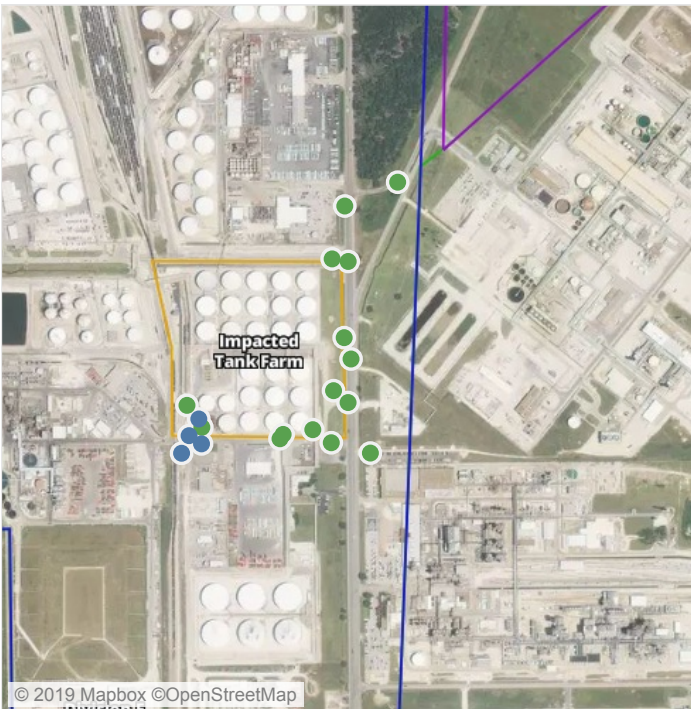
Recent Benzene Detections

Location Category	Reading Date	Range of Detections
Division E	7/21/2019 12:34:53	0.1600 ppm
	7/21/2019 12:39:17	0.0600 ppm
	7/21/2019 12:57:12	0.1600 ppm
	7/21/2019 12:48:15	0.2300 ppm

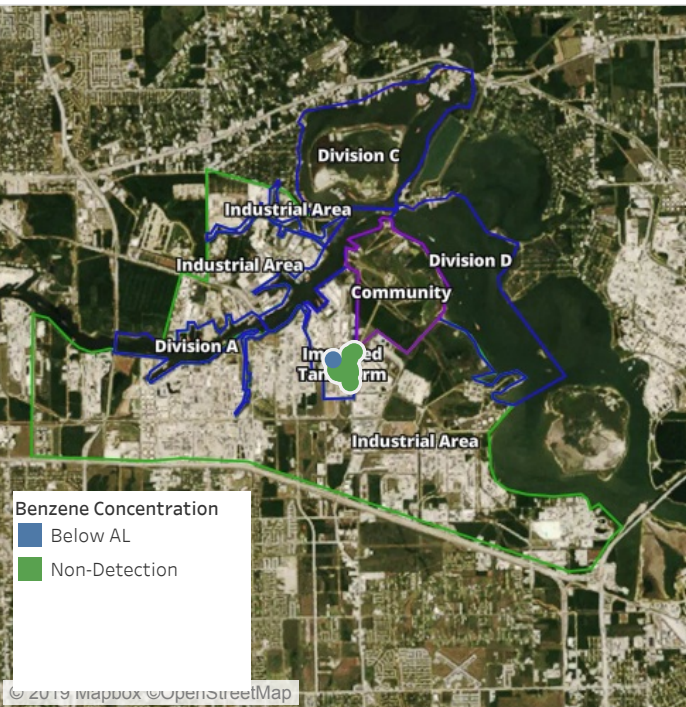
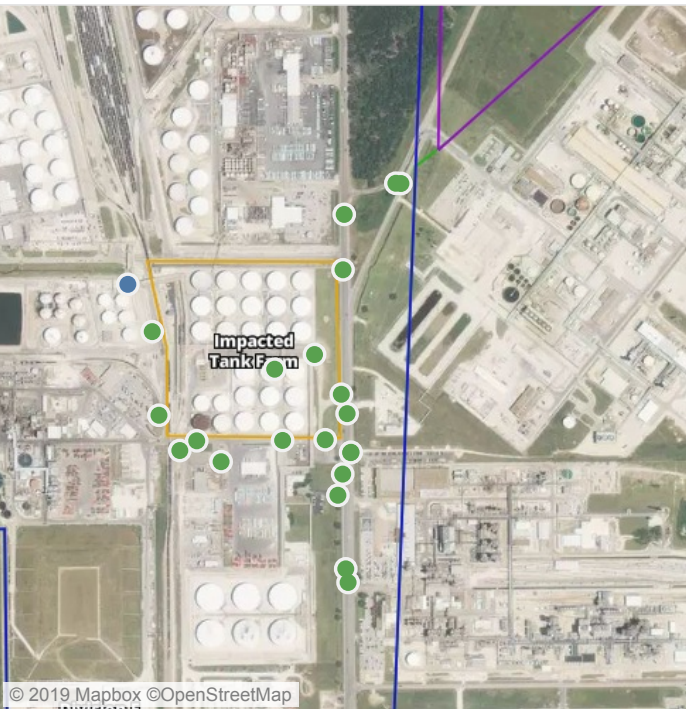
Recent Benzene Detections

Location Category	Reading Date	Range of Detections
Division E	7/21/2019 13:59:07	0.02000 ppm

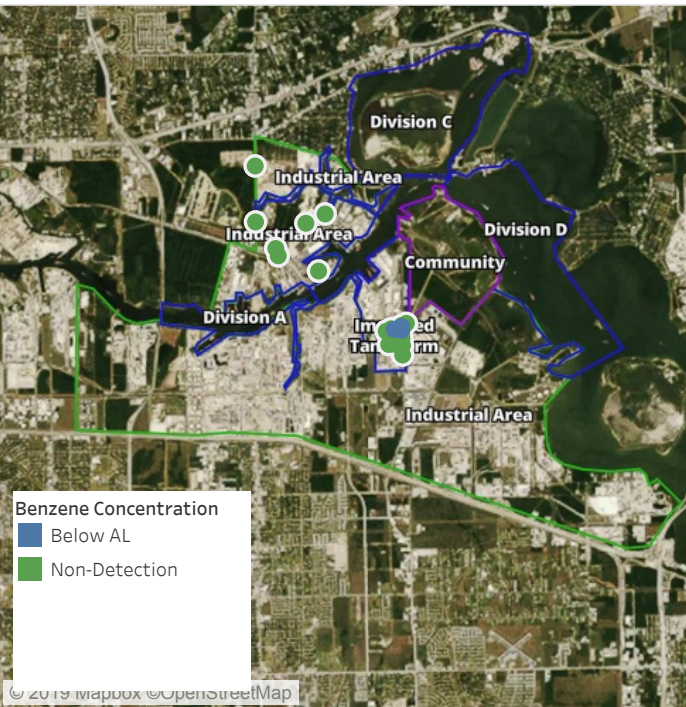
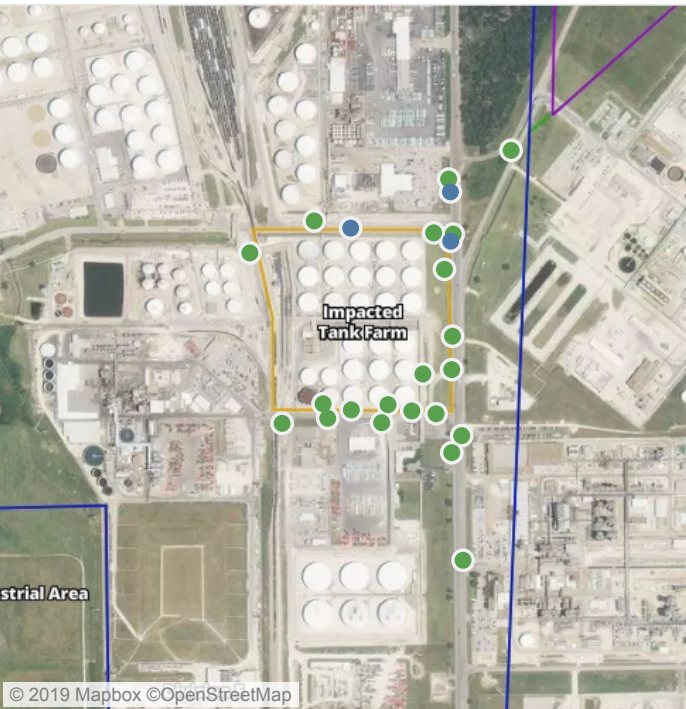
Recent Benzene Detections

Location Category	Reading Date	Range of Detections
Division E	7/21/2019 14:09:00	0.08000 ppm
	7/21/2019 14:04:15	0.05000 ppm
	7/21/2019 14:20:38	0.03000 ppm

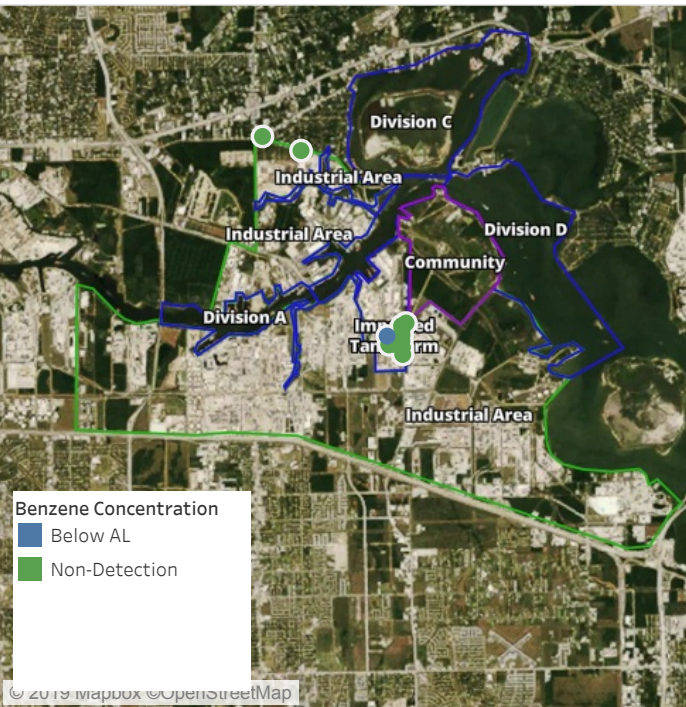
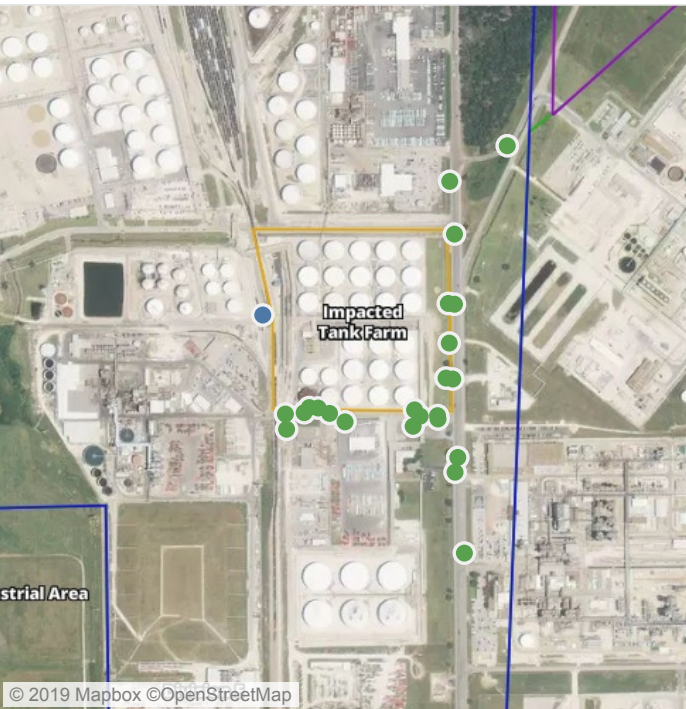
Recent Benzene Detections

Location Category	Reading Date	Range of Detections
Division E	7/21/2019 15:23:26	0.02000 ppm

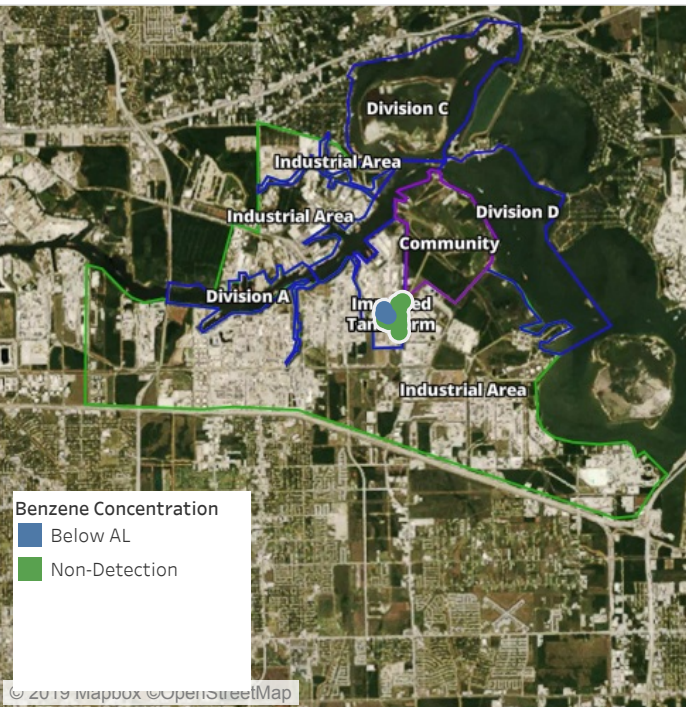
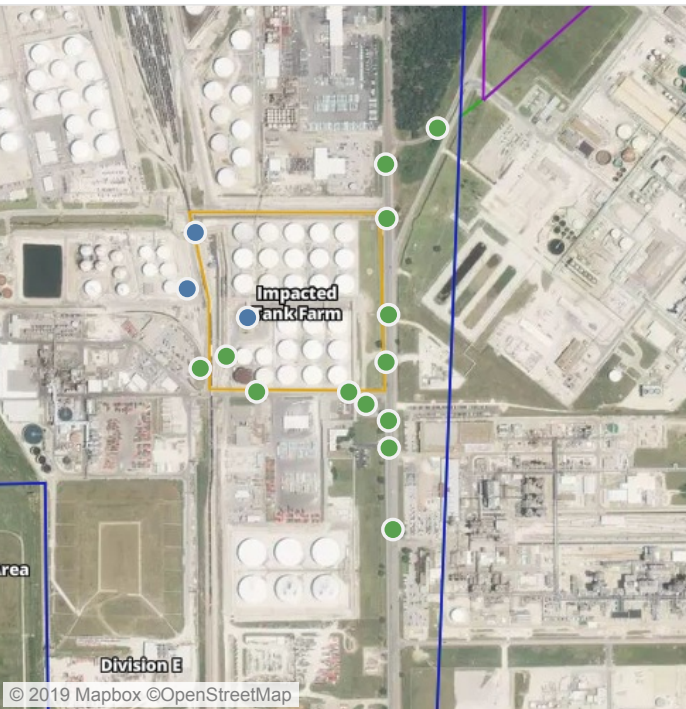
Recent Benzene Detections

Location Category	Reading Date	Range of Detections
Division E	7/21/2019 17:09:21	0.0400 ppm
	7/21/2019 17:15:34	0.0300 ppm
Impacted Tank Farm	7/21/2019 17:52:13	0.1400 ppm
