# Preliminary Hand- Held Air Monitoring Locations | ITC Deer Park Tank Fire

Reading Date  
7/24/2019 7:00:00 AM to 7/24/2019 8:00:00 AM

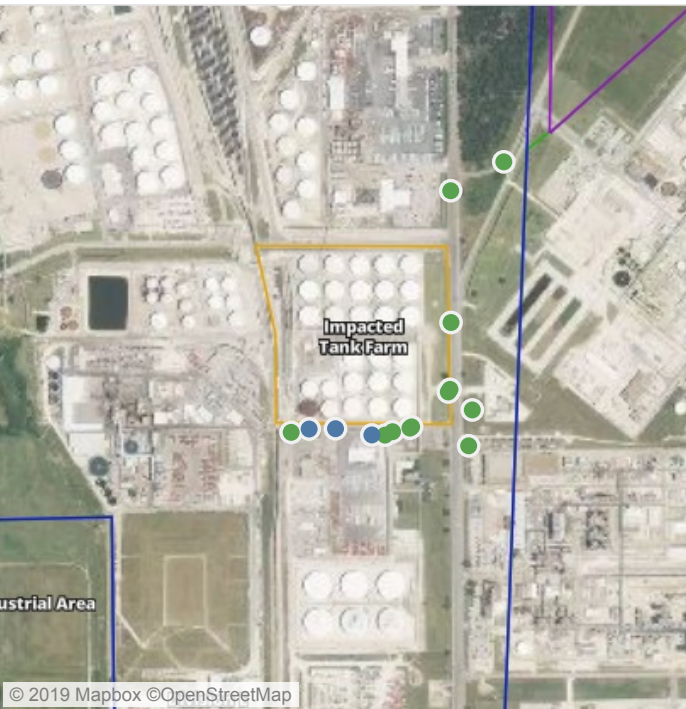
## Recent Benzene Detections

Location Category	Reading Date	Range of Detections
Division E	7/24/2019 13:51:10	0.15000 ppm
	7/24/2019 13:55:32	0.09000 ppm
	7/24/2019 13:53:33	0.08000 ppm

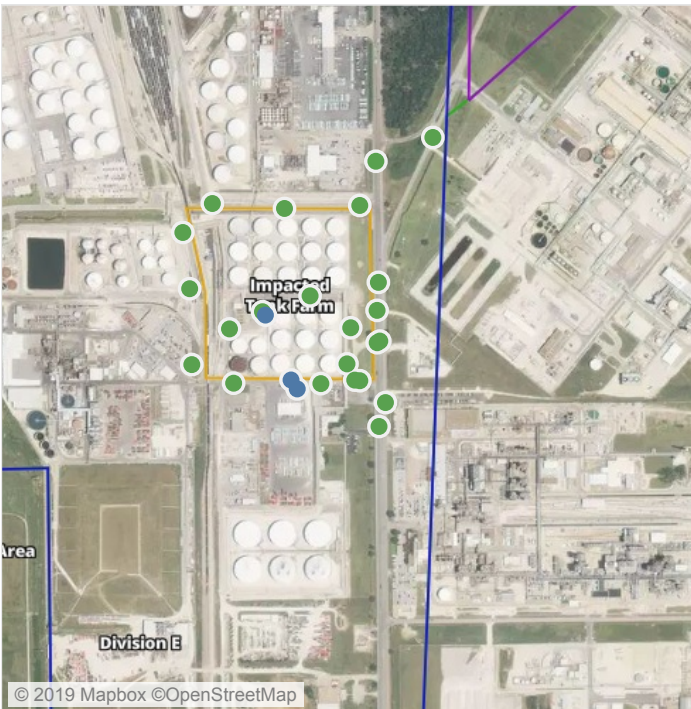
## Recent Benzene Detections

Location Category	Reading Date	Range of Detections
Division E	7/24/2019 17:24:21	0.08000 ppm
	7/24/2019 17:30:37	0.09000 ppm
Impacted Tank Farm	7/24/2019 17:44:55	0.04000 ppm
