# Preliminary Hand- Held Air Monitoring Locations | ITC Deer Park Tank Fire

Reading Date  
7/26/2019 7:00:00 AM to 7/26/2019 8:00:00 AM

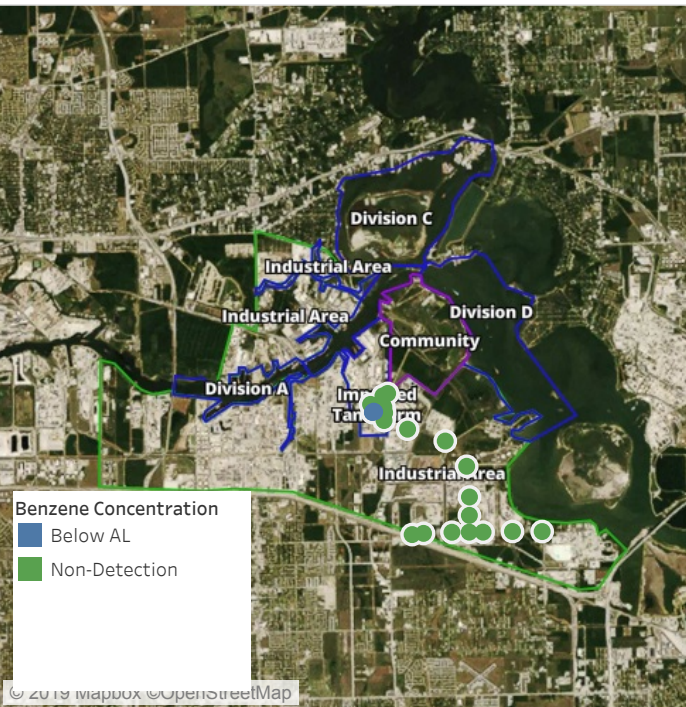
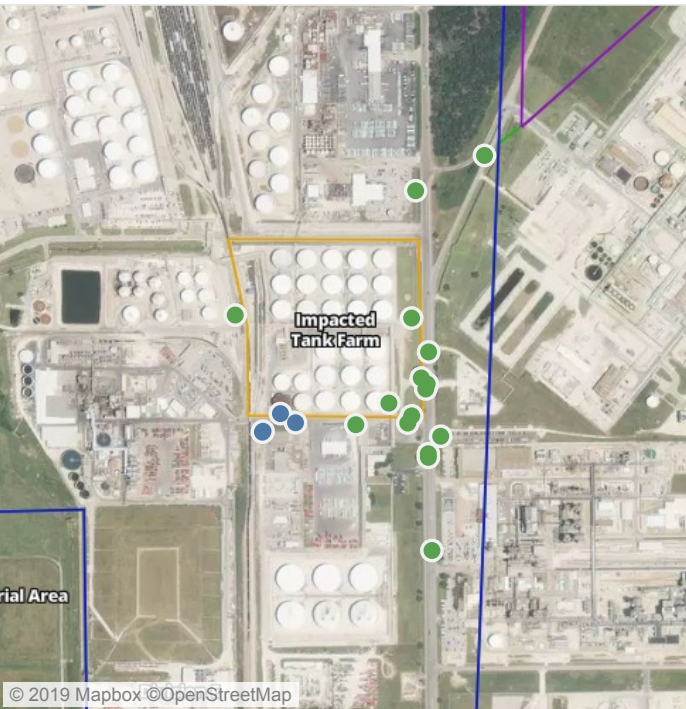
## Recent Benzene Detections

Location Category	Reading Date	Range of Detections
Division E	7/26/2019 07:42:28	0.0200 ppm
	7/26/2019 07:48:20	0.0300 ppm
	7/26/2019 07:42:12	0.1400 ppm
	7/26/2019 07:45:25	0.2300 ppm

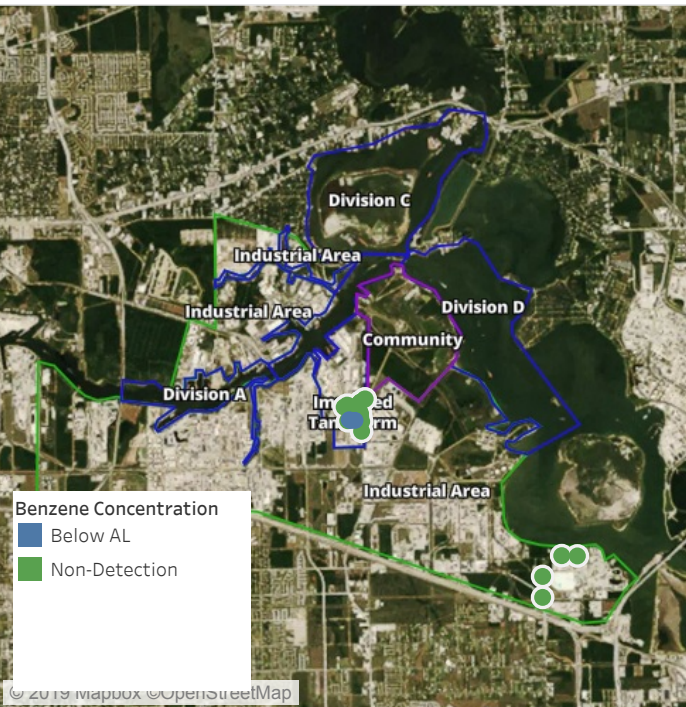
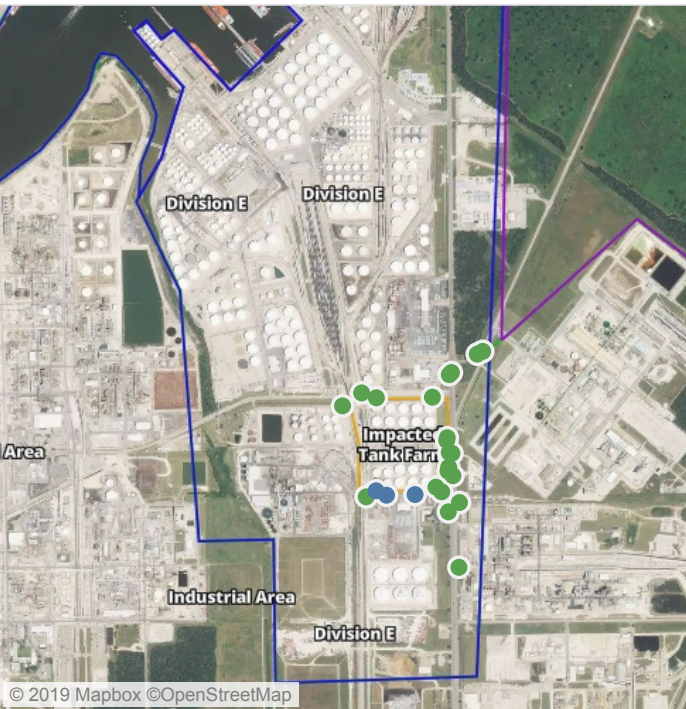
Reading Date  
7/26/2019 8:00:00 AM to 7/26/2019 9:00:00 AM

## Recent Benzene Detections

Location Category	Reading Date	Range of Detections
Division E	7/26/2019 08:15:40	0.0500 ppm
	7/26/2019 08:18:46	0.1700 ppm
	7/26/2019 08:22:29	0.0900 ppm

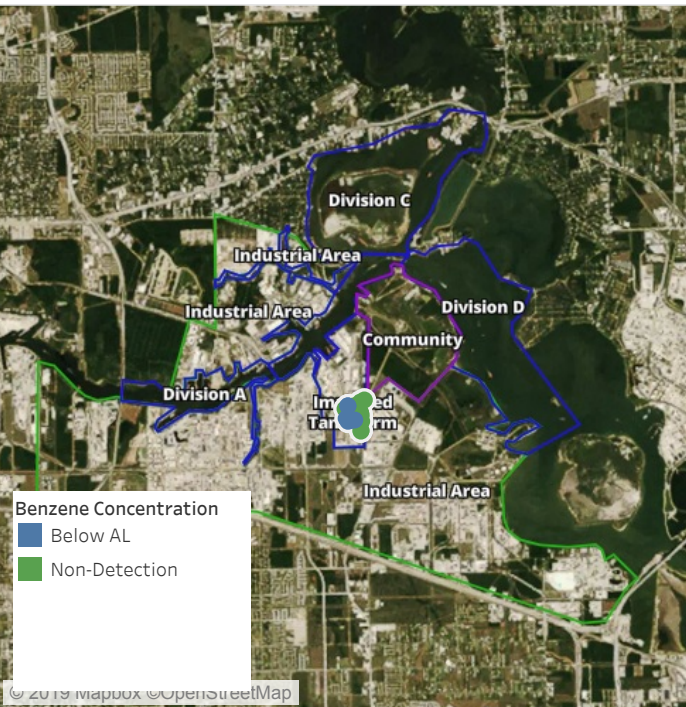
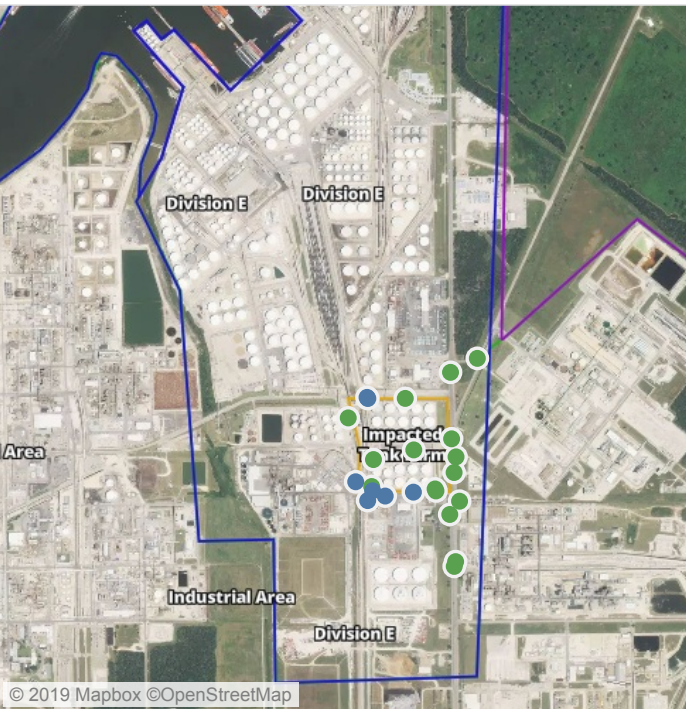
Reading Date  
7/26/2019 9:00:00 AM to 7/26/2019 10:00:00 AM

## Recent Benzene Detections

Location Category	Reading Date	Range of Detections
Division E	7/26/2019 09:04:53	0.0300 ppm
	7/26/2019 09:02:05	0.0200 ppm
	7/26/2019 09:04:07	0.1500 ppm
	7/26/2019 09:09:20	0.0200 ppm
	7/26/2019 09:09:16	0.0300 ppm
	7/26/2019 09:06:54	0.1200 ppm
	7/26/2019 09:22:37	0.0200 ppm

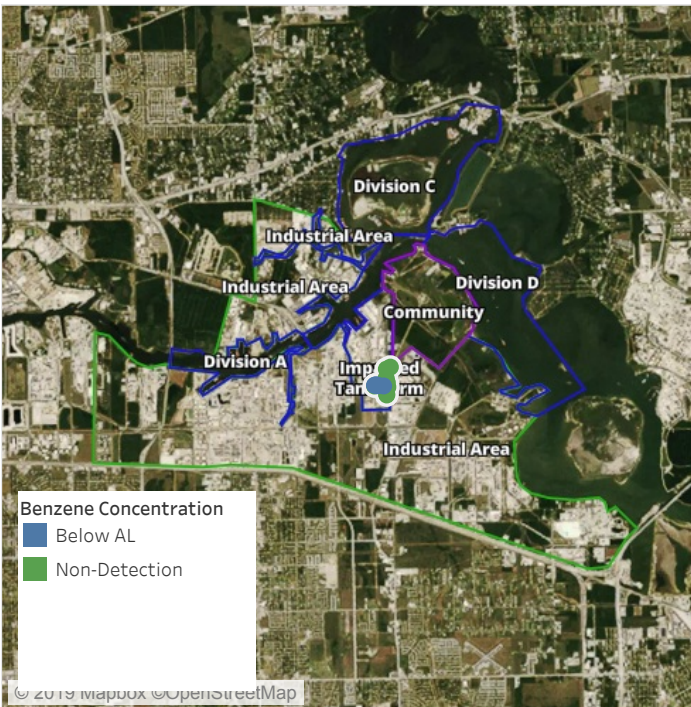
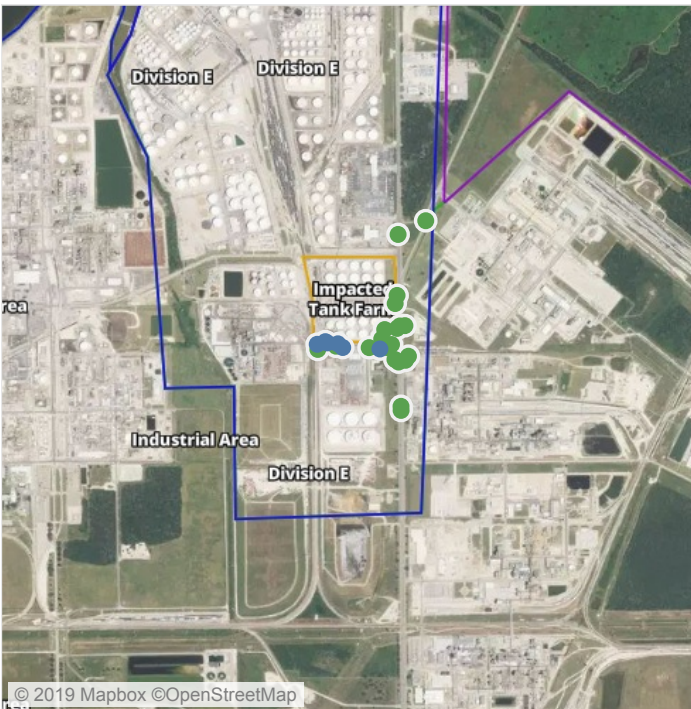
Reading Date  
7/26/2019 10:00:00 AM to 7/26/2019 11:00:00 AM

## Recent Benzene Detections

Location Category	Reading Date	Range of Detections
Division E	7/26/2019 10:01:14	0.02000 ppm
	7/26/2019 10:07:11	0.04000 ppm
	7/26/2019 10:04:21	0.02000 ppm
	7/26/2019 10:07:31	0.04000 ppm
	7/26/2019 10:11:44	0.09000 ppm
	7/26/2019 10:36:53	0.02000 ppm

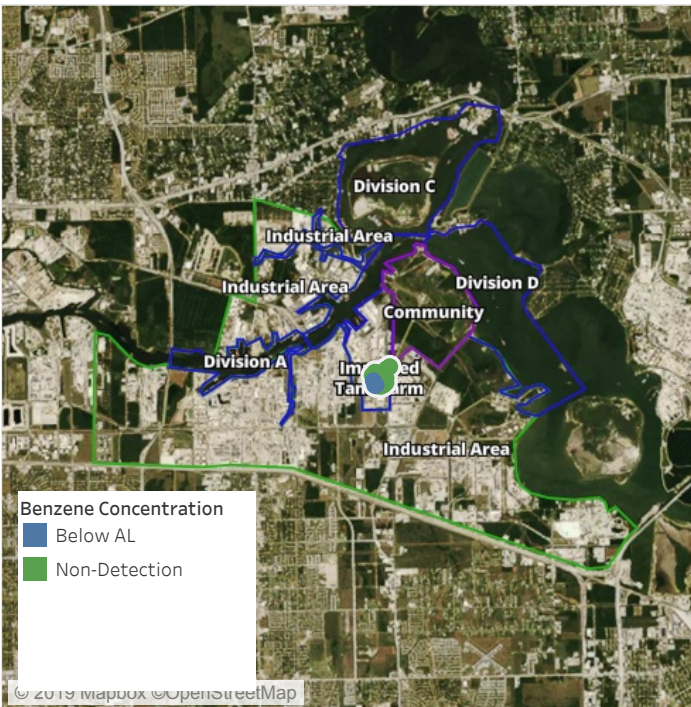
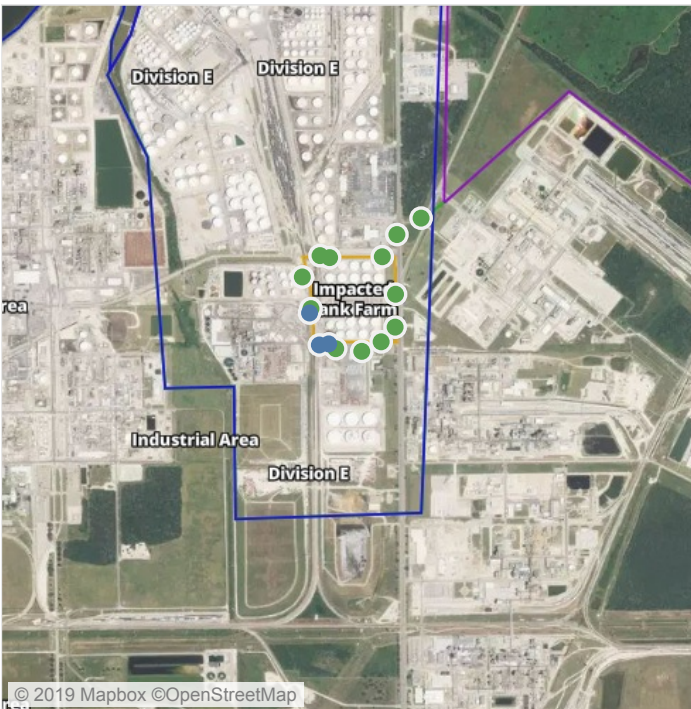
Reading Date  
7/26/2019 11:00:00 AM to 7/26/2019 12:00:00 PM

## Recent Benzene Detections

Location Category	Reading Date	Range of Detections
Division E	7/26/2019 11:00:29	0.04000 ppm
	7/26/2019 11:43:21	0.02000 ppm
	7/26/2019 11:40:35	0.08000 ppm

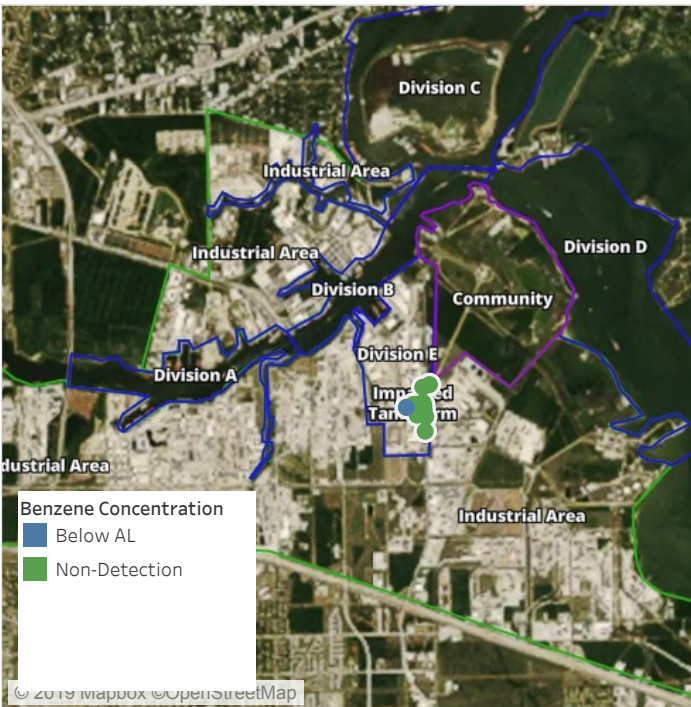
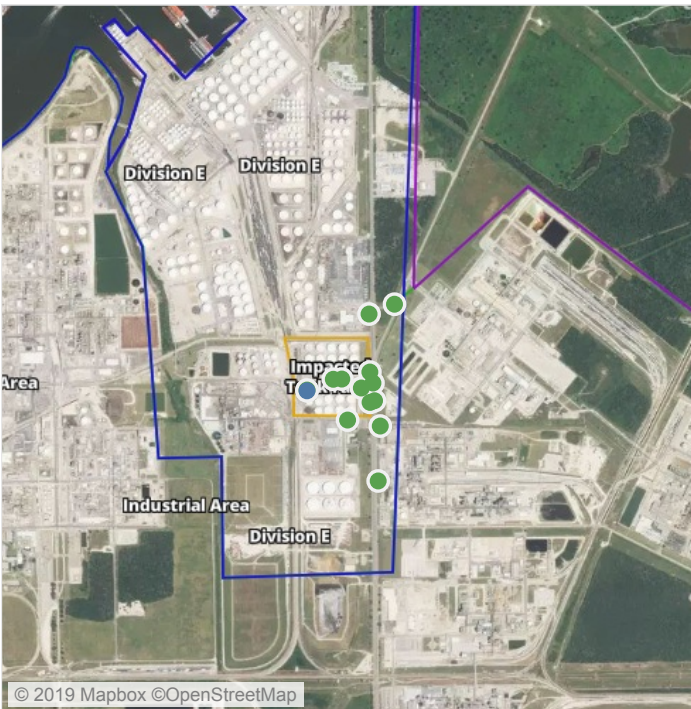
Reading Date  
7/26/2019 12:00:00 PM to 7/26/2019 1:00:00 PM

## Recent Benzene Detections

Location Category	Reading Date	Range of Detections
Impacted Tank Farm	7/26/2019 12:21:12	0.05000 ppm

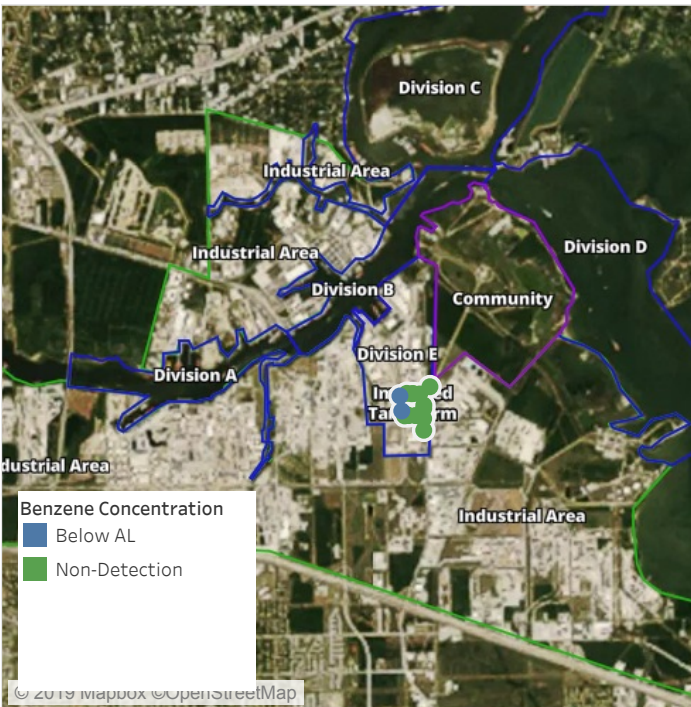
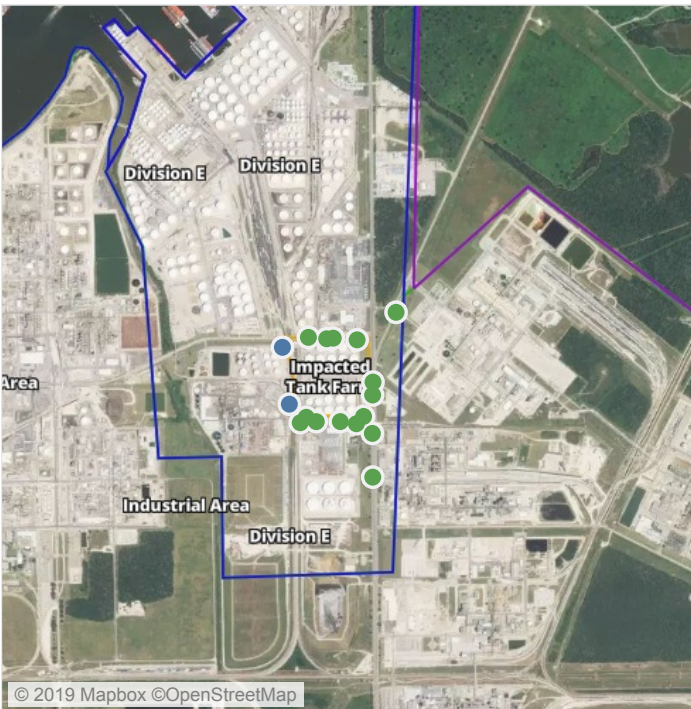
Reading Date  
7/26/2019 1:00:00 PM to 7/26/2019 2:00:00 PM

## Recent Benzene Detections

Location Category	Reading Date	Range of Detections
Division E	7/26/2019 13:00:37	0.03000 ppm
	7/26/2019 13:06:32	0.04000 ppm

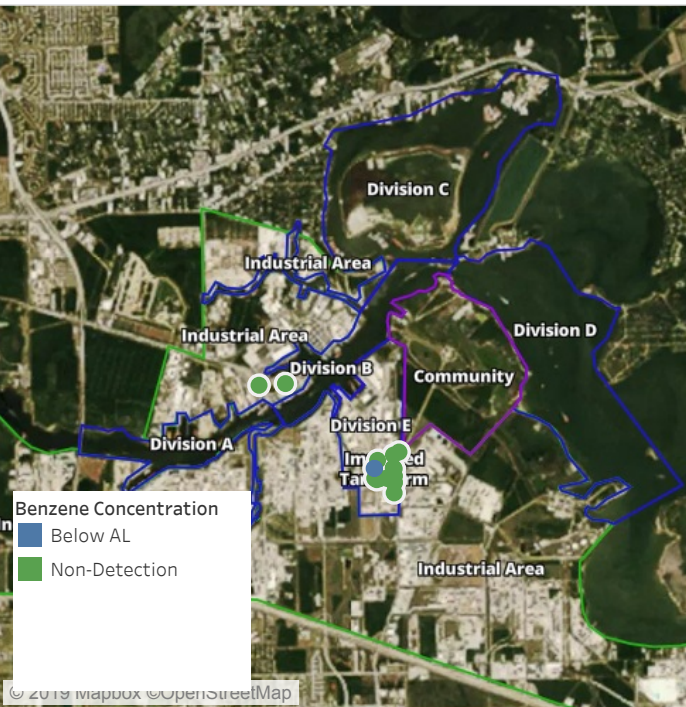
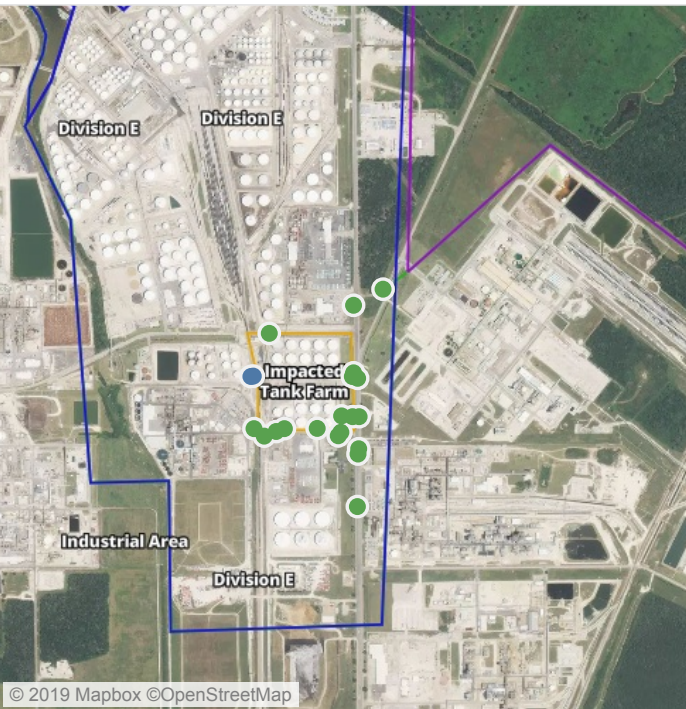
Reading Date  
7/26/2019 2:00:00 PM to 7/26/2019 3:00:00 PM

## Recent Benzene Detections

Location Category	Reading Date	Range of Detections
Division E	7/26/2019 14:37:55	0.06000 ppm
	7/26/2019 14:42:55	0.04000 ppm

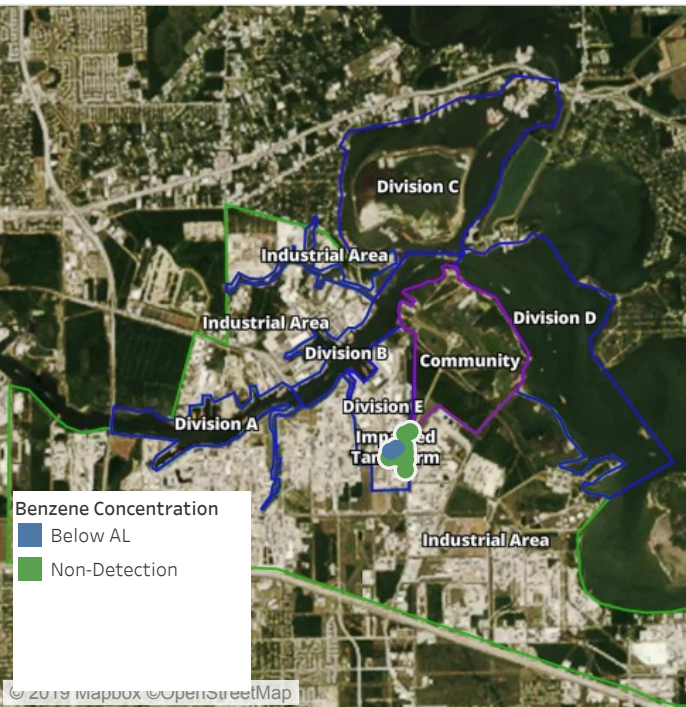
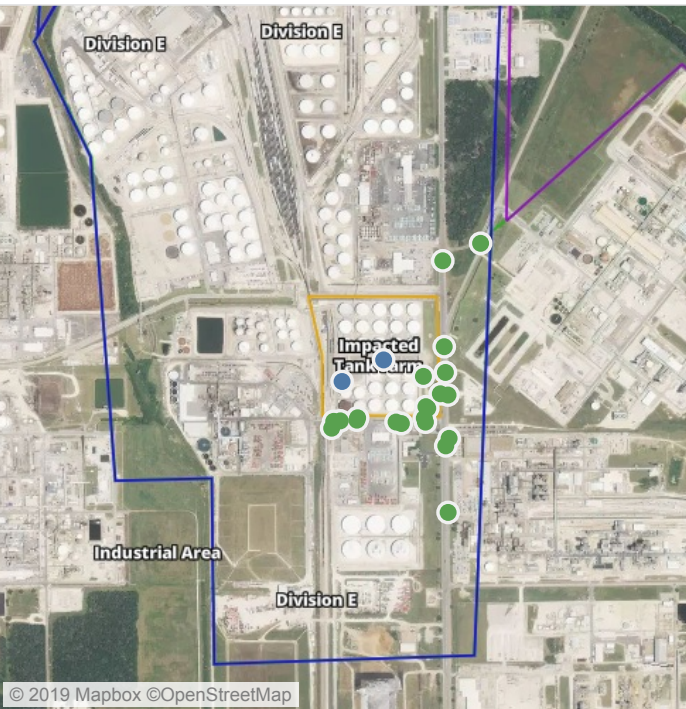
Reading Date  
7/26/2019 3:00:00 PM to 7/26/2019 4:00:00 PM

## Recent Benzene Detections

Location Category	Reading Date	Range of Detections
Impacted Tank Farm	7/26/2019 15:31:50	0.04000 ppm
	7/26/2019 15:39:33	0.08000 ppm

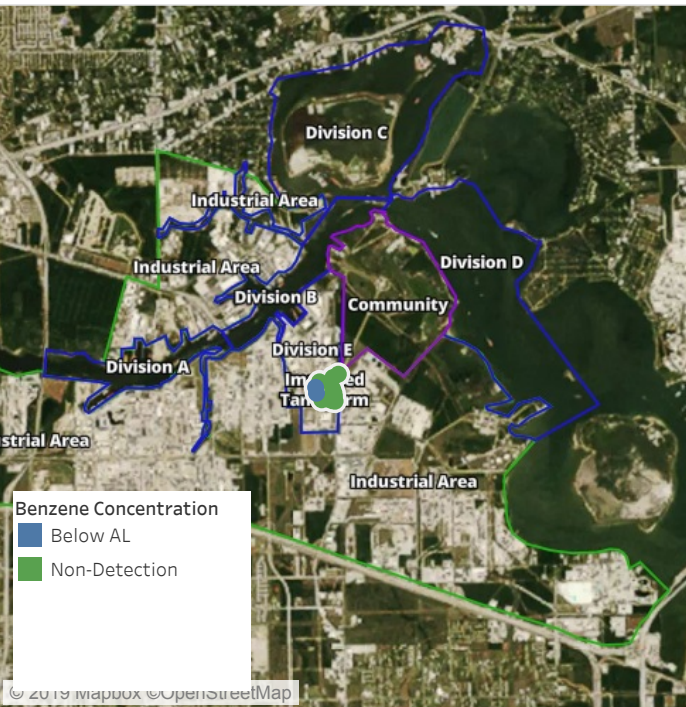
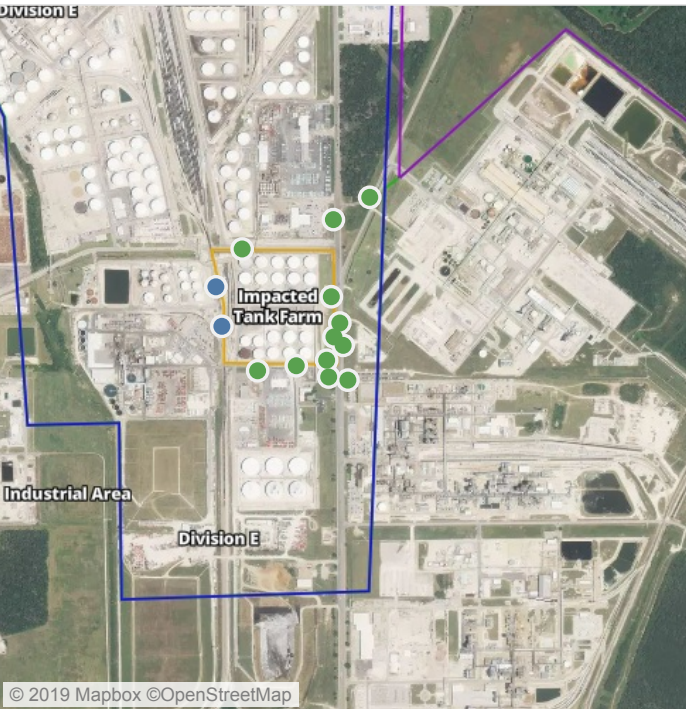
Reading Date  
7/26/2019 4:00:00 PM to 7/26/2019 5:00:00 PM

## Recent Benzene Detections

Location Category	Reading Date	Range of Detections
Division E	7/26/2019 16:22:52	0.05000 ppm
	7/26/2019 16:34:46	0.03000 ppm
