# Preliminary Hand- Held Air Monitoring Locations | ITC Deer Park Tank Fire

Reading Date  
7/28/2019 7:00:00 AM to 7/28/2019 8:00:00 AM

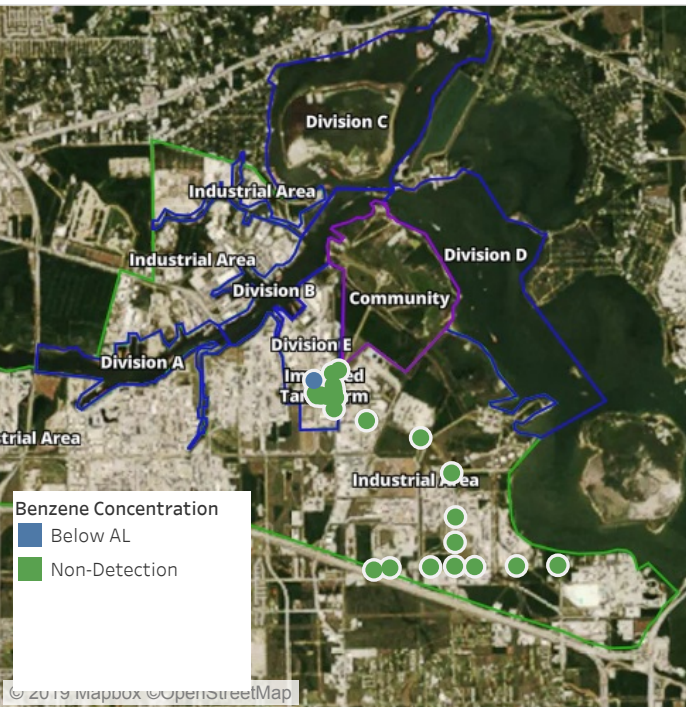
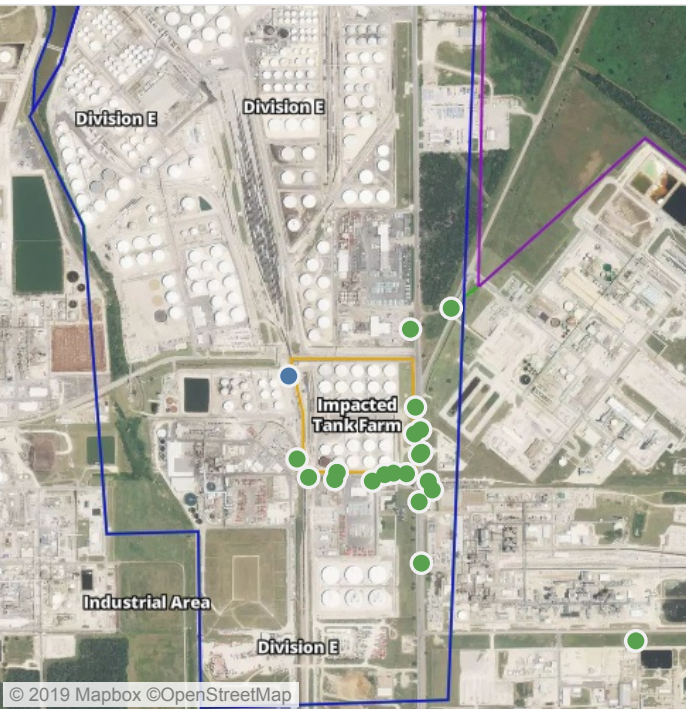
Location Category	Reading Date	Range of Detections
Division E	7/28/2019 07:53:49	0.06000 ppm

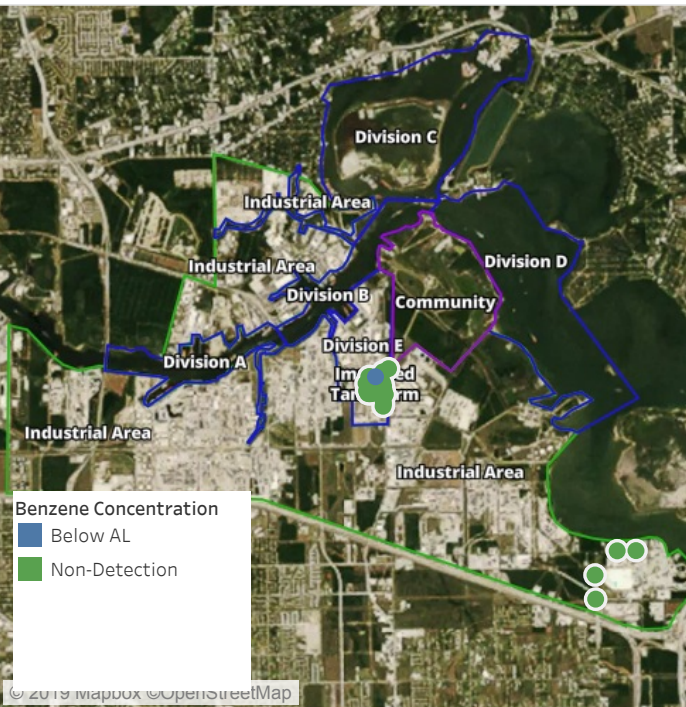
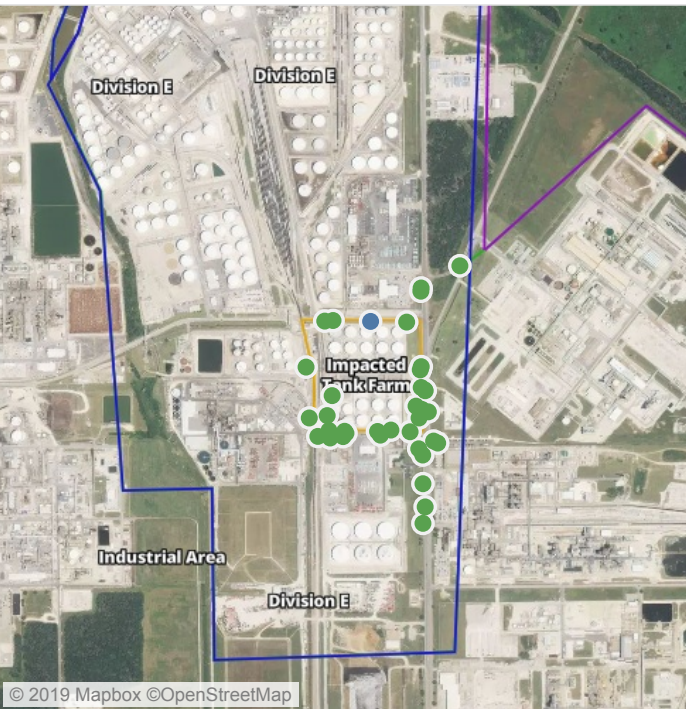
Reading Date  
7/28/2019 8:00:00 AM to 7/28/2019 9:00:00 AM

# Preliminary Hand- Held Air Monitoring Locations | ITC Deer Park Tank Fire

Location Category	Reading Date	Range of Detections
Division E	7/28/2019 08:11:28	0.04000 ppm

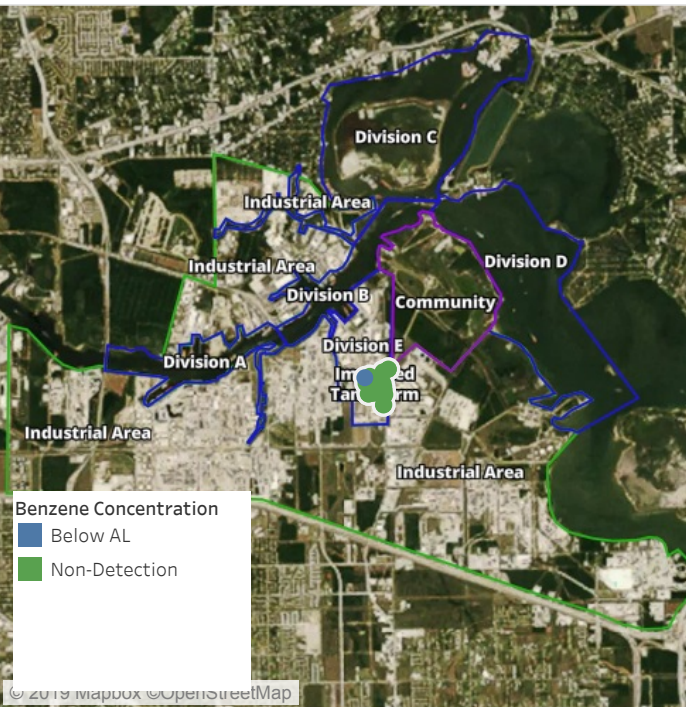
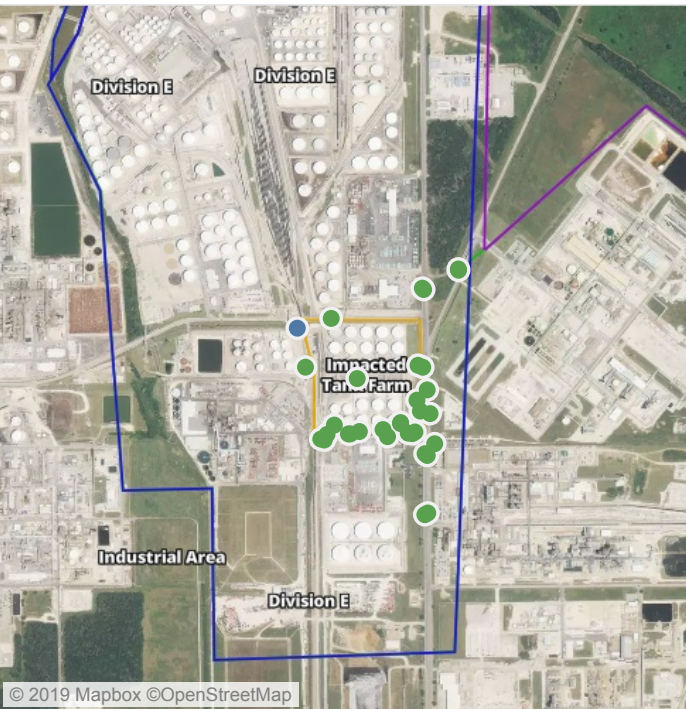
Reading Date  
7/28/2019 9:00:00 AM to 7/28/2019 10:00:00 AM

# Preliminary Hand- Held Air Monitoring Locations | ITC Deer Park Tank Fire

Location Category	Reading Date	Range of Detections
Division E	7/28/2019 09:43:29	0.02000 ppm

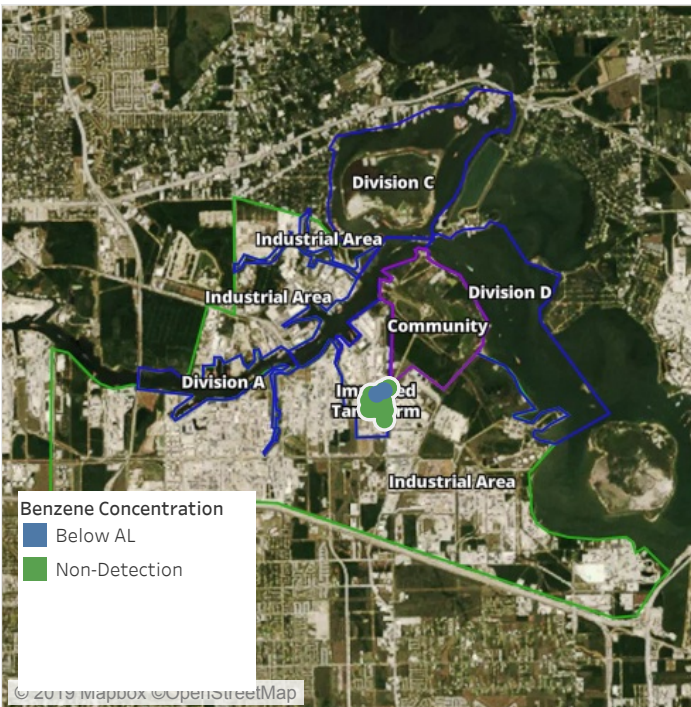
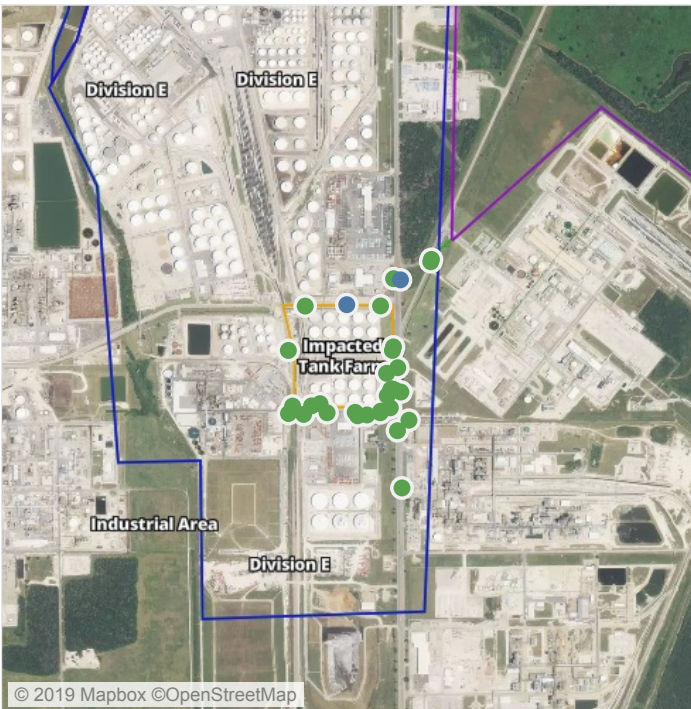
Reading Date  
7/28/2019 10:00:00 AM to 7/28/2019 11:00:00 AM

# Preliminary Hand- Held Air Monitoring Locations | ITC Deer Park Tank Fire

Location Category	Reading Date	Range of Detections
Division E	7/28/2019 10:09:25	0.02000 ppm
	7/28/2019 10:36:40	0.02000 ppm

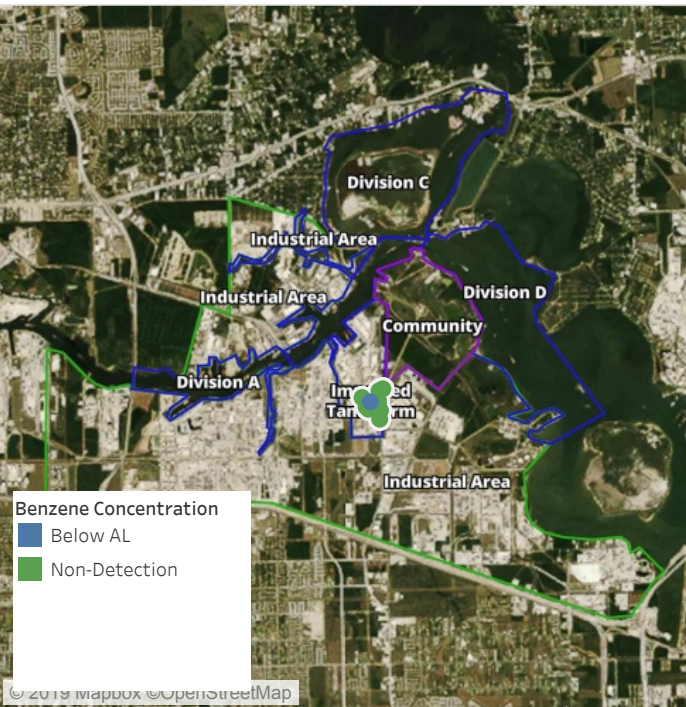
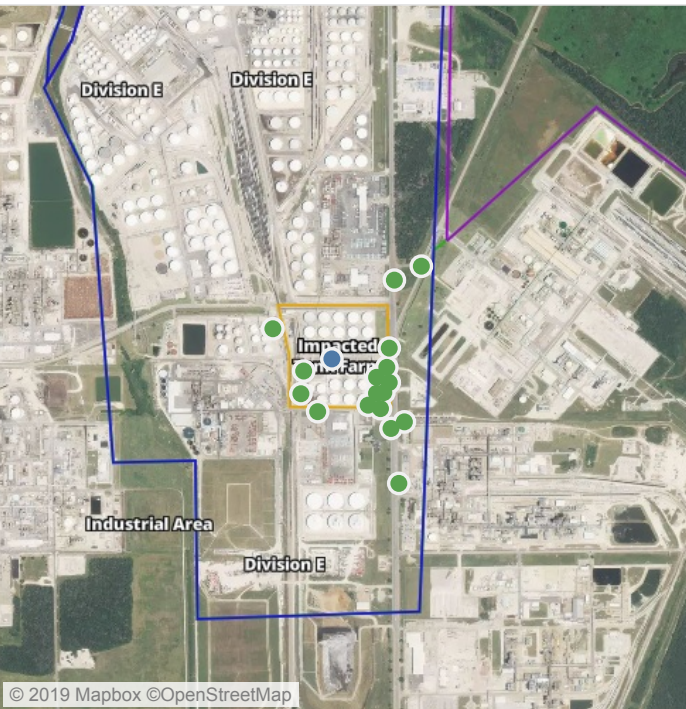
Reading Date  
7/28/2019 11:00:00 AM to 7/28/2019 12:00:00 PM

# Preliminary Hand- Held Air Monitoring Locations | ITC Deer Park Tank Fire

Location Category	Reading Date	Range of Detections
Impacted Tank Farm	7/28/2019 11:15:13	0.03000 ppm

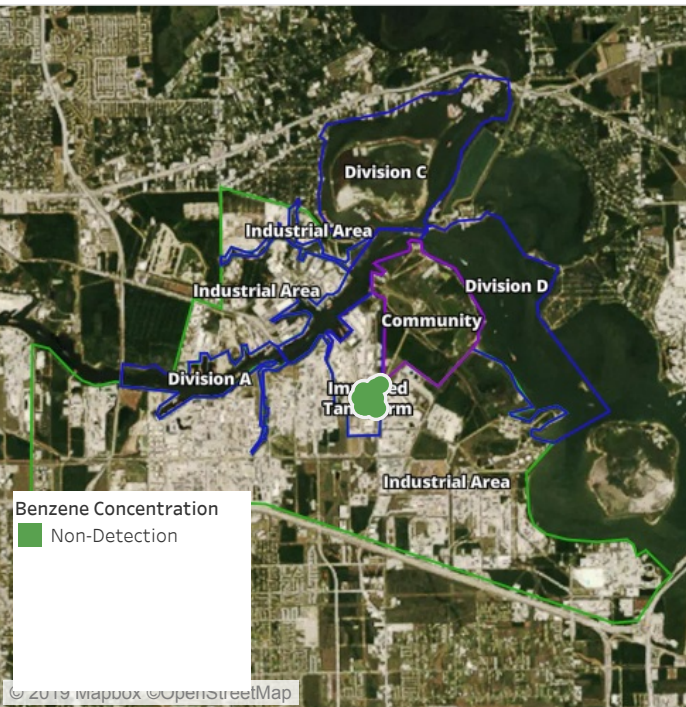
# Preliminary Hand- Held Air Monitoring Locations | ITC Deer Park Tank Fire

Reading Date  
7/28/2019 12:00:00 PM to 7/28/2019 1:00:00 PM

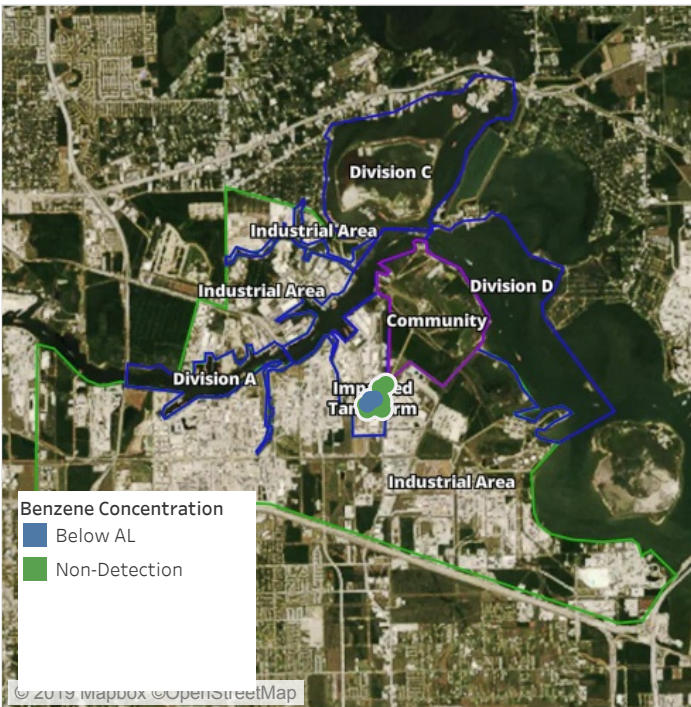
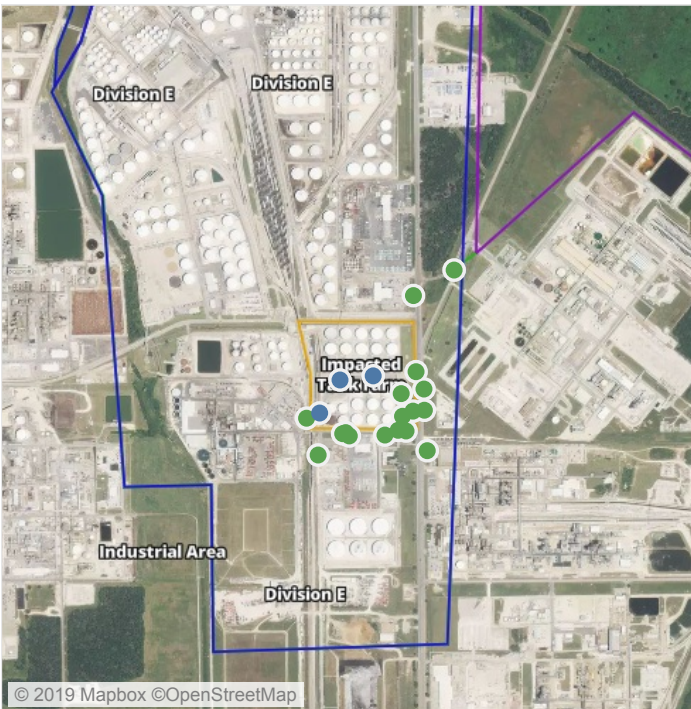
Reading Date  
7/28/2019 1:00:00 PM to 7/28/2019 2:00:00 PM

# Preliminary Hand- Held Air Monitoring Locations | ITC Deer Park Tank Fire

Location Category	Reading Date	Range of Detections
Impacted Tank Farm	7/28/2019 13:20:30	0.05000 ppm
	7/28/2019 13:25:12	0.06000 ppm
	7/28/2019 13:29:36	0.03000 ppm

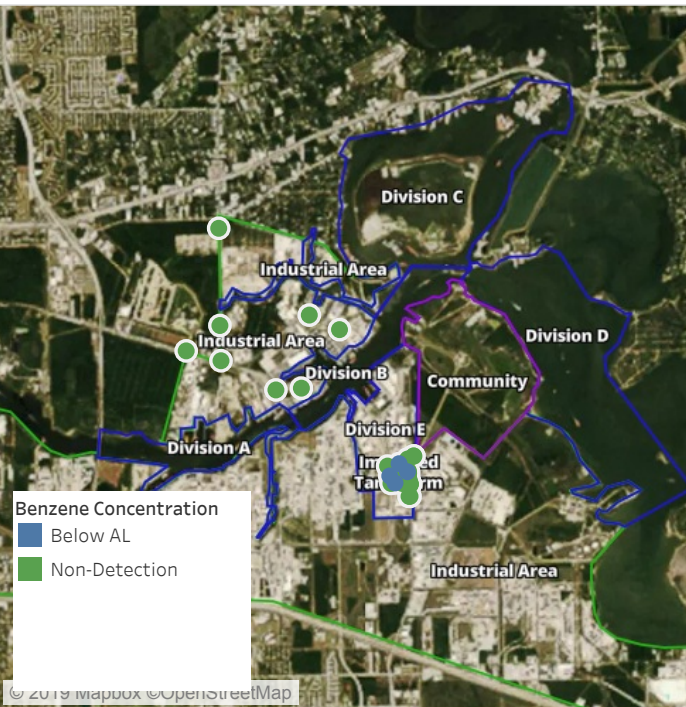
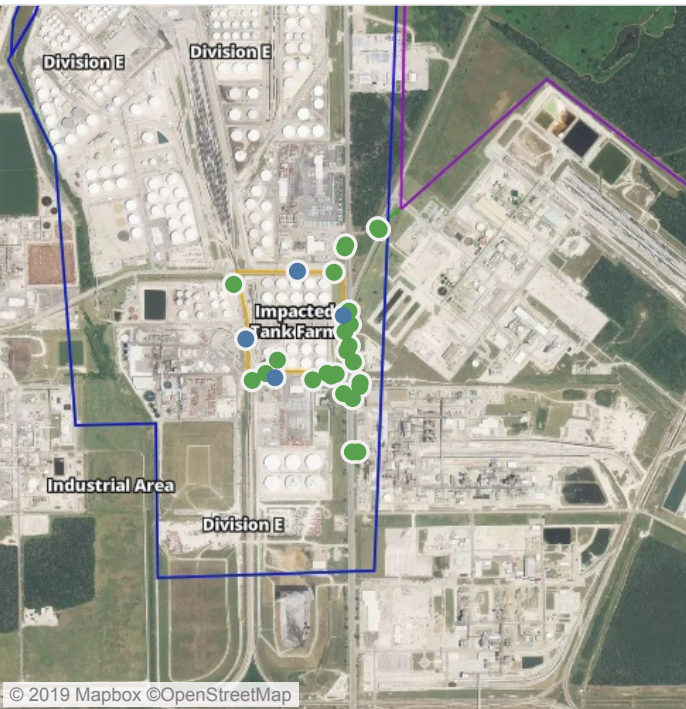
Reading Date  
7/28/2019 2:00:00 PM to 7/28/2019 3:00:00 PM

# Preliminary Hand- Held Air Monitoring Locations | ITC Deer Park Tank Fire

Location Category	Reading Date	Range of Detections
Division E	7/28/2019 14:00:29	0.03000 ppm
	7/28/2019 14:17:57	0.03000 ppm
	7/28/2019 14:57:29	0.02000 ppm
	7/28/2019 14:59:21	0.09000 ppm

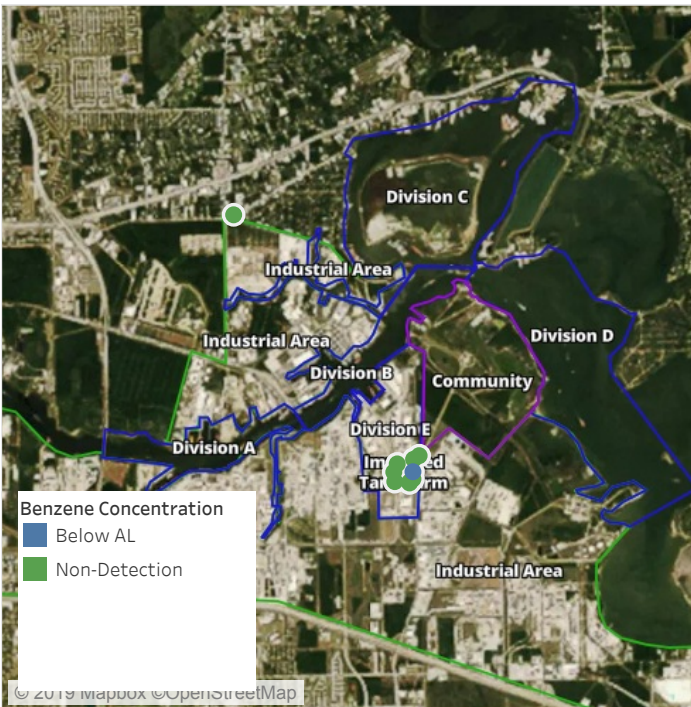
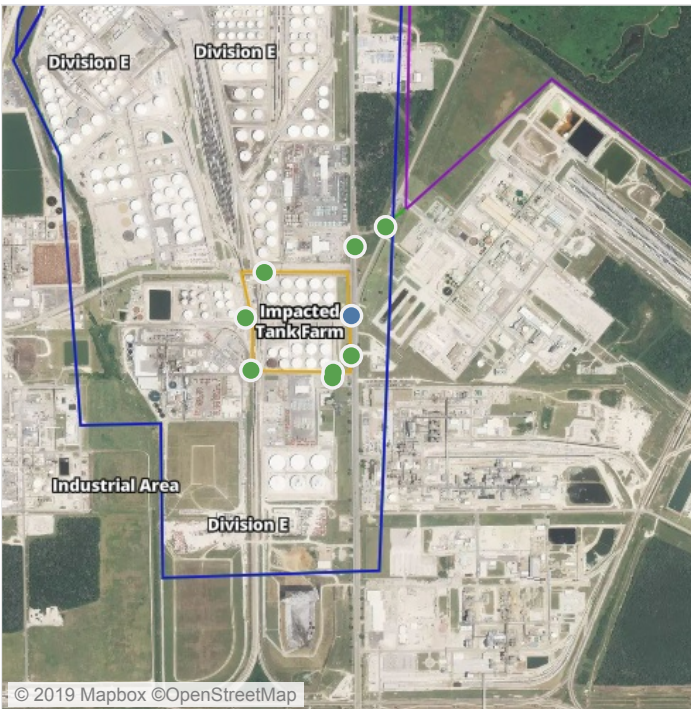
Reading Date  
7/28/2019 3:00:00 PM to 7/28/2019 4:00:00 PM

# Preliminary Hand- Held Air Monitoring Locations | ITC Deer Park Tank Fire

Location Category	Reading Date	Range of Detections
Division E	7/28/2019 15:48:14	0.04000 ppm

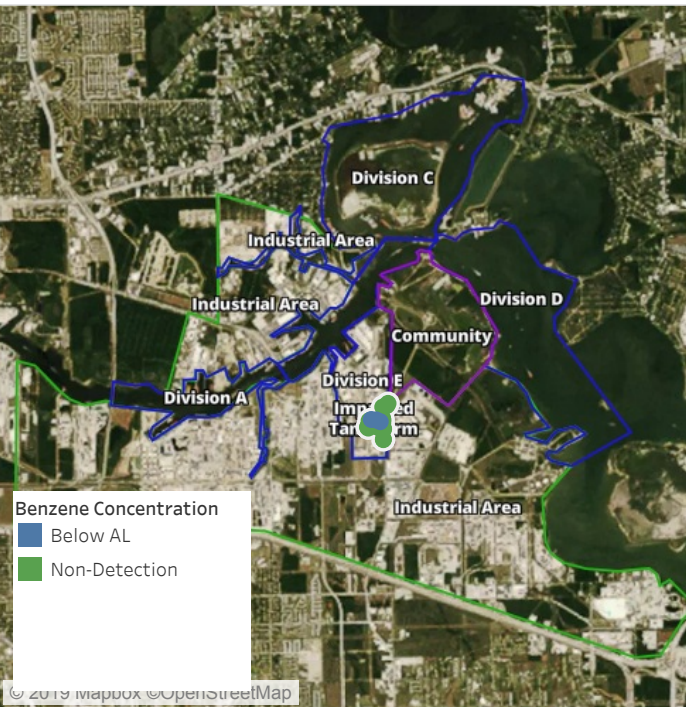
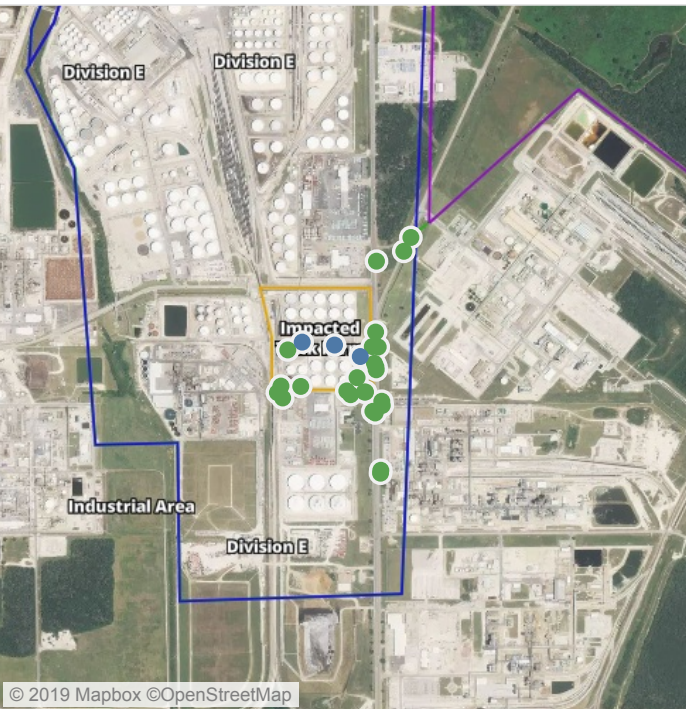
Reading Date  
7/28/2019 4:00:00 PM to 7/28/2019 5:00:00 PM

# Preliminary Hand- Held Air Monitoring Locations | ITC Deer Park Tank Fire

Location Category	Reading Date	Range of Detections
Impacted Tank Farm	7/28/2019 16:20:34	0.0300 ppm
	7/28/2019 16:33:55	0.1100 ppm
	7/28/2019 16:39:35	0.1400 ppm

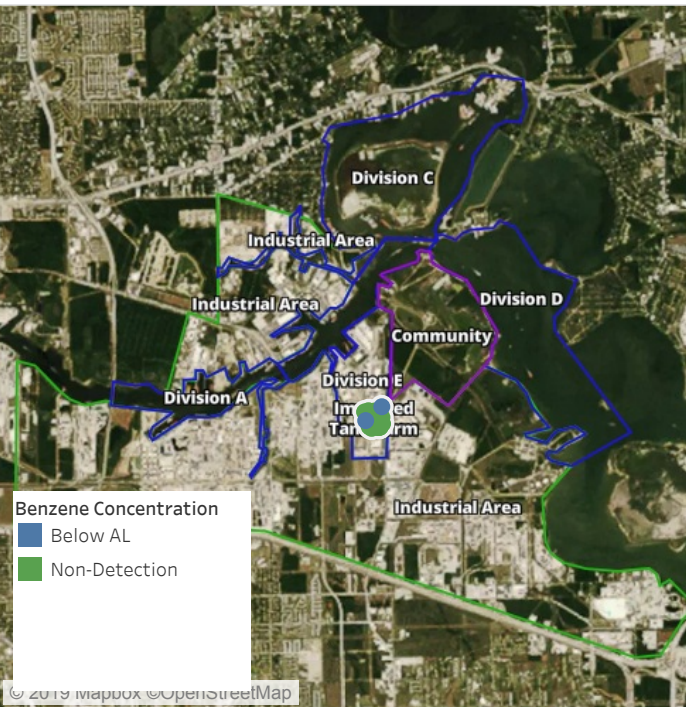
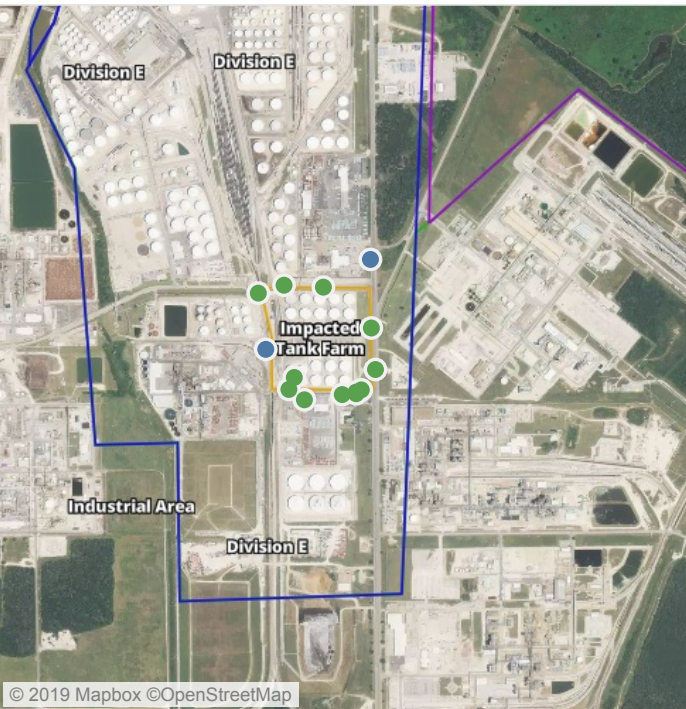
Reading Date  
7/28/2019 5:00:00 PM to 7/28/2019 6:00:00 PM

# Preliminary Hand- Held Air Monitoring Locations | ITC Deer Park Tank Fire

Location Category	Reading Date	Range of Detections
Division E	7/28/2019 17:40:55	0.03000 ppm
Impacted Tank Farm	7/28/2019 17:14:45	0.02000 ppm
