# Preliminary Hand- Held Air Monitoring Locations | ITC Deer Park Tank Fire

Reading Date  
7/29/2019 7:00:00 AM to 7/29/2019 8:00:00 AM

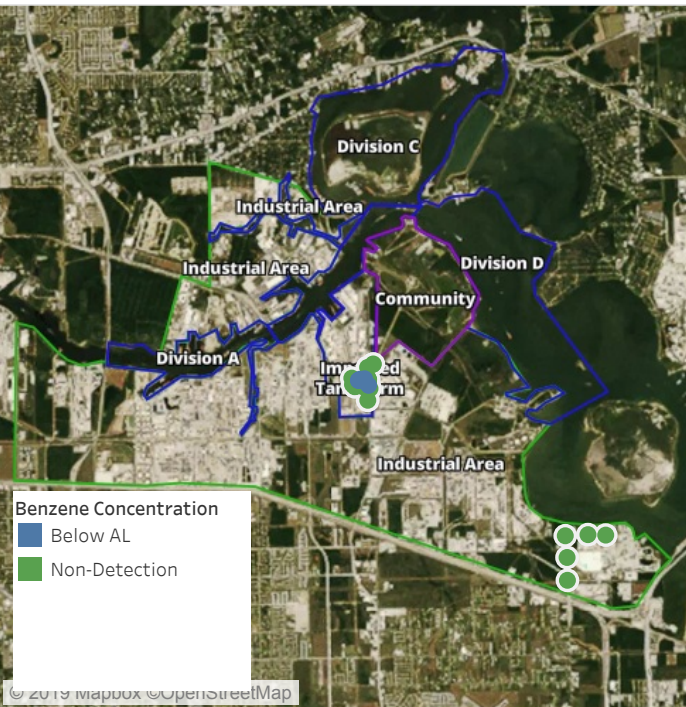
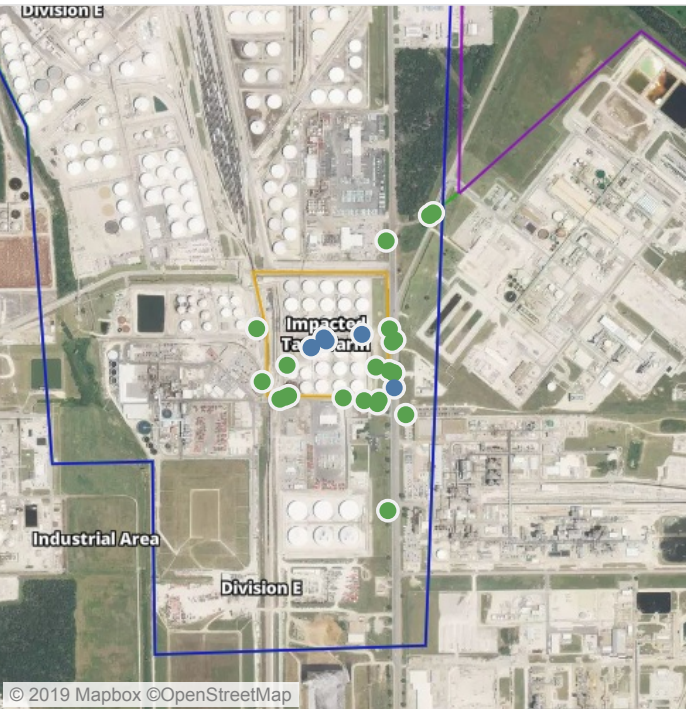
## Recent Benzene Detections

Location Category	Reading Date	Range of Detections
Impacted Tank Farm	7/29/2019 08:19:19	0.03000 ppm
	7/29/2019 08:12:34	0.03000 ppm
	7/29/2019 08:24:43	0.11000 ppm
	7/29/2019 08:20:35	0.02000 ppm
	7/29/2019 08:25:48	0.04000 ppm
	7/29/2019 08:13:50	0.04000 ppm

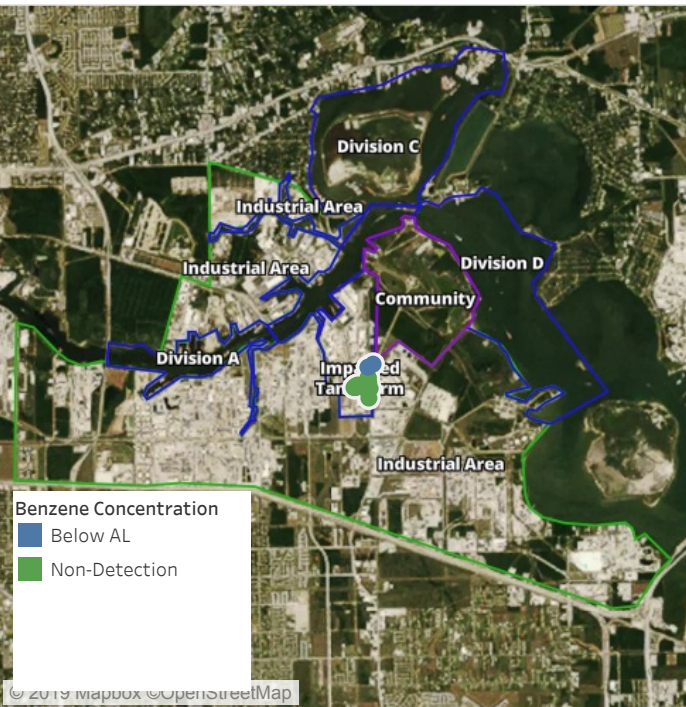
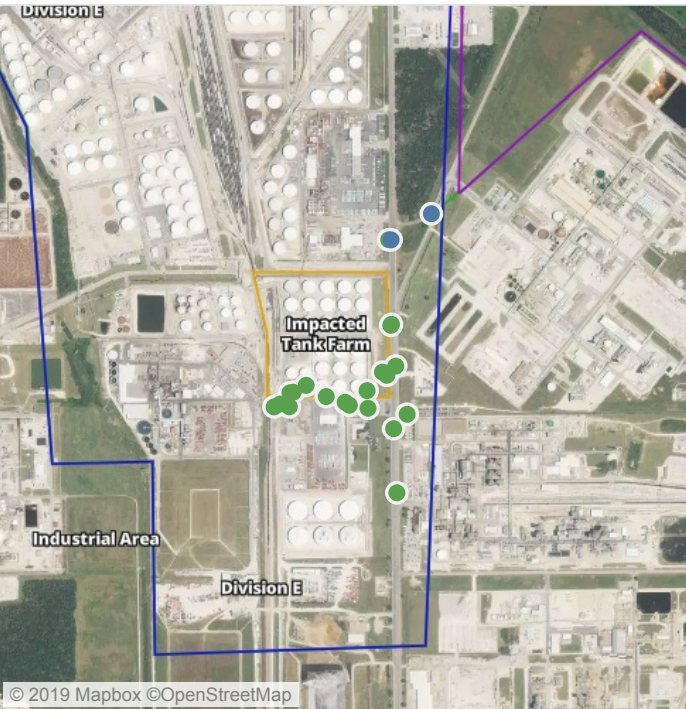
## Recent Benzene Detections

Location Category	Reading Date	Range of Detections
Division E	7/29/2019 09:36:20	0.03000 ppm
	7/29/2019 09:40:38	0.04000 ppm

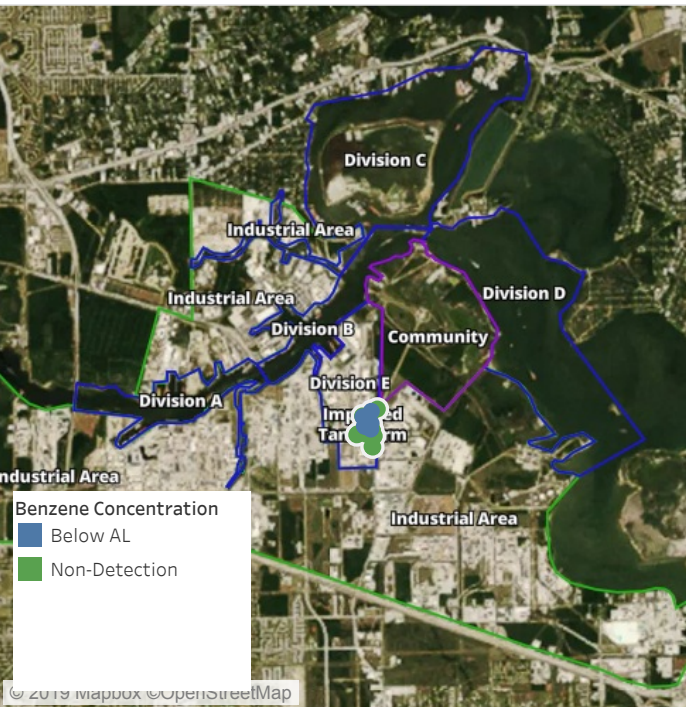
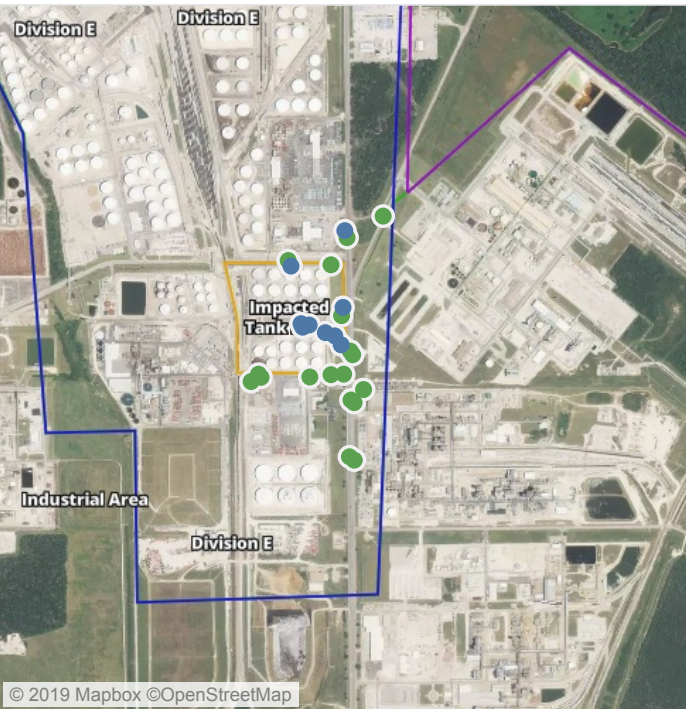
## Recent Benzene Detections

Location Category	Reading Date	Range of Detections
Division E	7/29/2019 10:27:16	0.0300 ppm
	7/29/2019 10:59:36	0.0600 ppm
	7/29/2019 10:57:37	0.0300 ppm
	7/29/2019 10:50:15	0.0200 ppm
Impacted Tank Farm	7/29/2019 10:04:19	0.0600 ppm
	7/29/2019 10:15:30	0.1100 ppm
	7/29/2019 10:13:35	0.0500 ppm
	7/29/2019 10:06:20	0.1200 ppm
	7/29/2019 10:09:54	0.0400 ppm

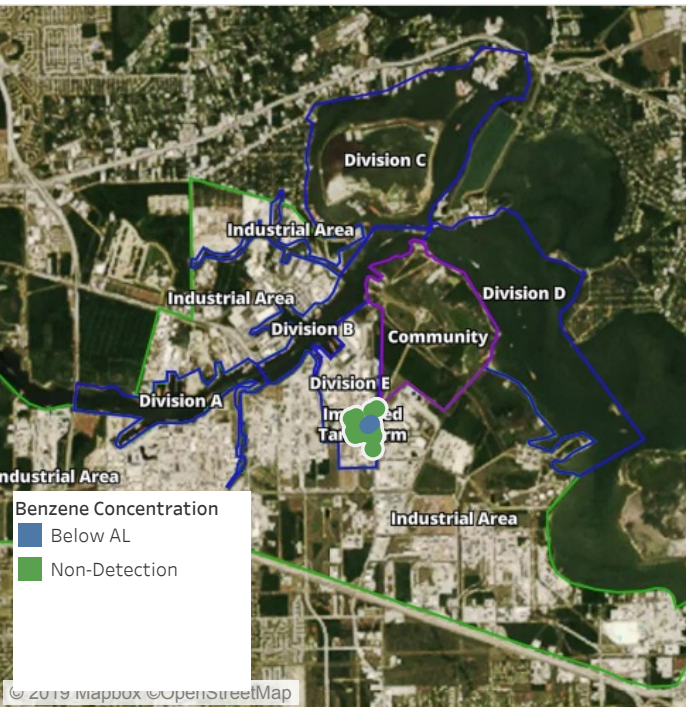
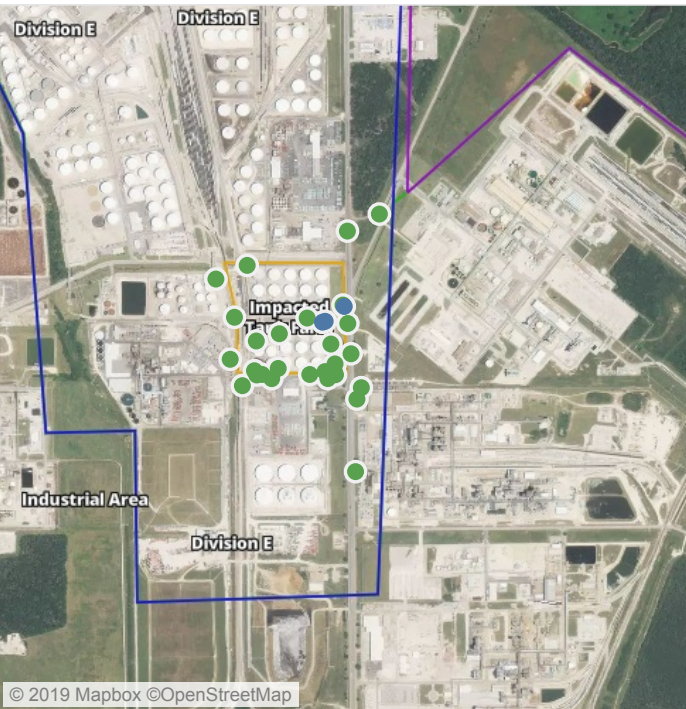
## Recent Benzene Detections

Location Category	Reading Date	Range of Detections
Division E	7/29/2019 11:40:13	0.05000 ppm
Impacted Tank Farm	7/29/2019 11:46:56	0.09000 ppm
	7/29/2019 11:48:10	0.08000 ppm

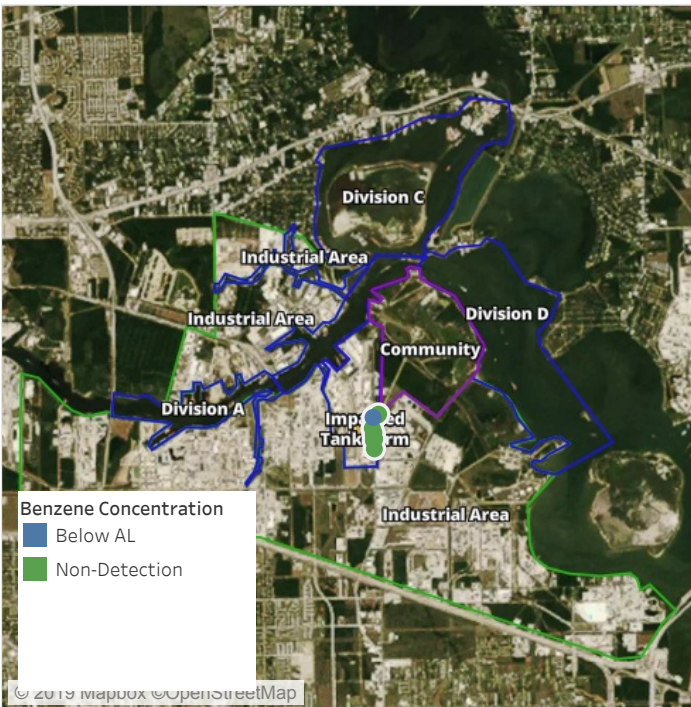
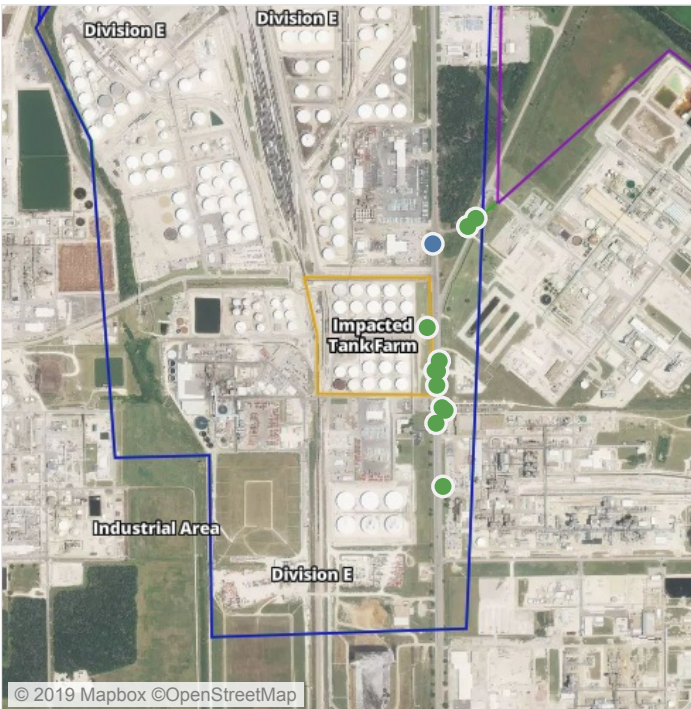
## Recent Benzene Detections

Location Category	Reading Date	Range of Detections
Division E	7/29/2019 12:57:40	0.03000 ppm

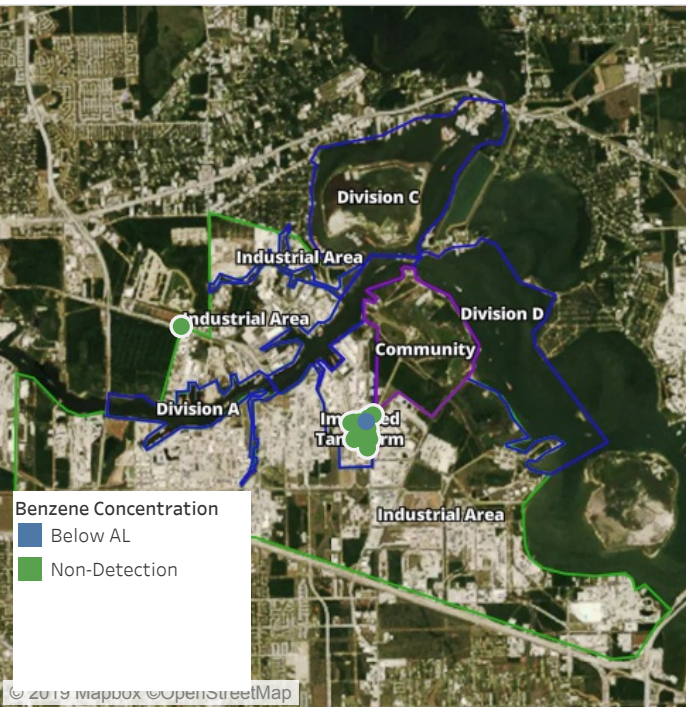
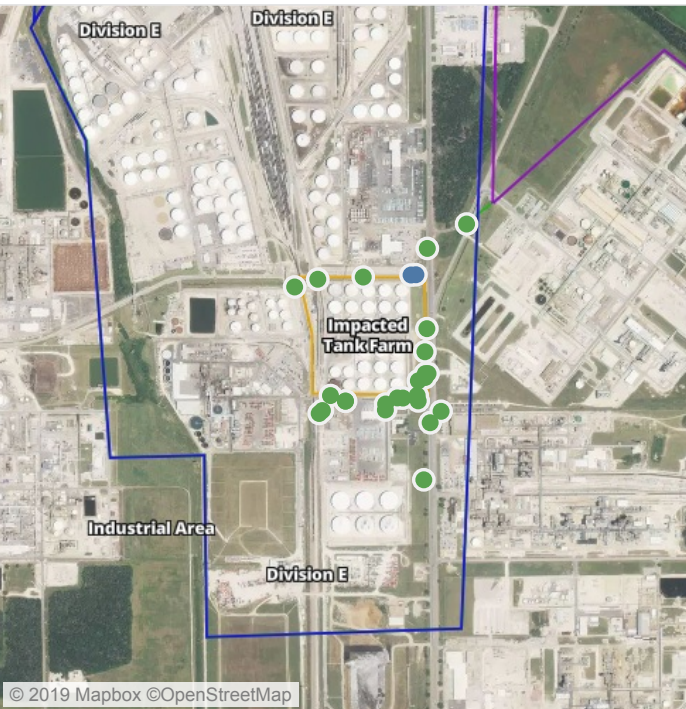
## Recent Benzene Detections

Location Category	Reading Date	Range of Detections
Division E	7/29/2019 13:05:31	0.03000 ppm
	7/29/2019 13:03:09	0.04000 ppm

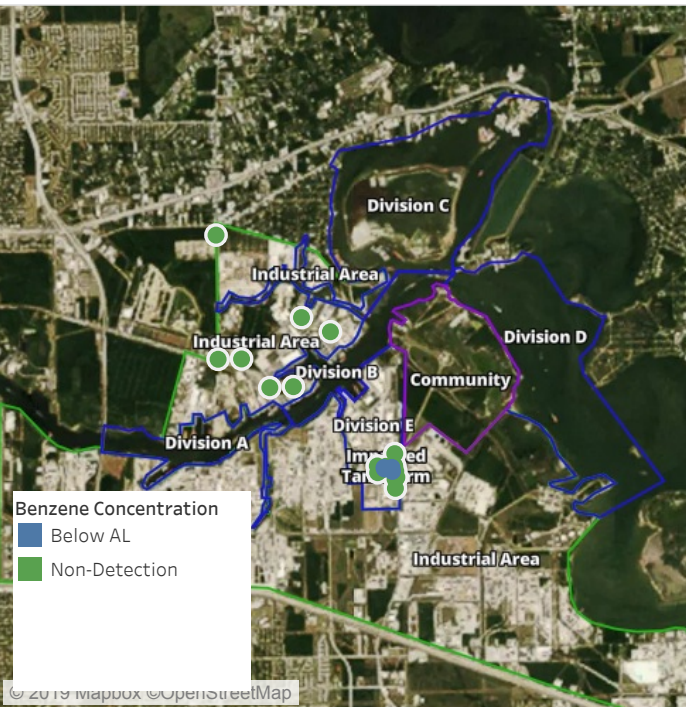
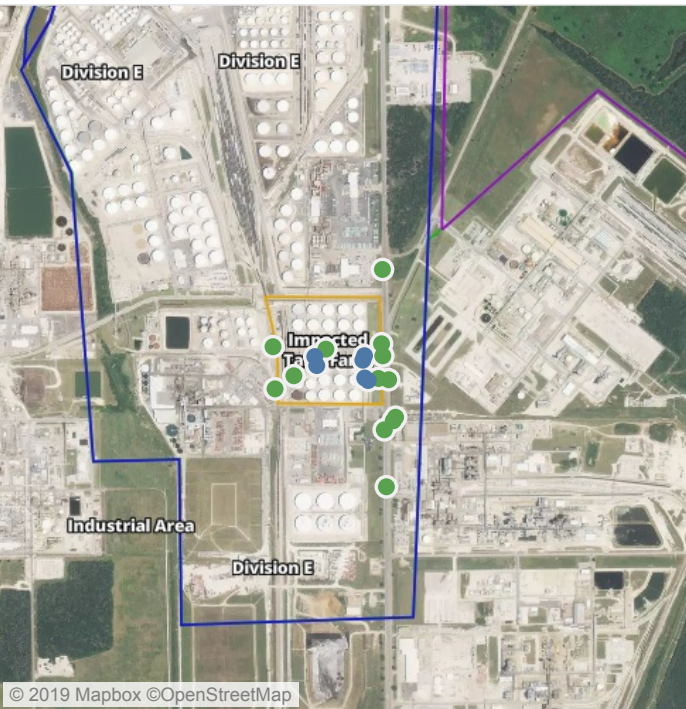
## Recent Benzene Detections

Location Category	Reading Date	Range of Detections
Impacted Tank Farm	7/29/2019 14:48:15	0.1500 ppm
	7/29/2019 14:28:48	0.0200 ppm
	7/29/2019 14:58:22	0.2300 ppm
	7/29/2019 14:26:05	0.0200 ppm
	7/29/2019 14:56:47	0.1900 ppm
	7/29/2019 14:49:36	0.1700 ppm

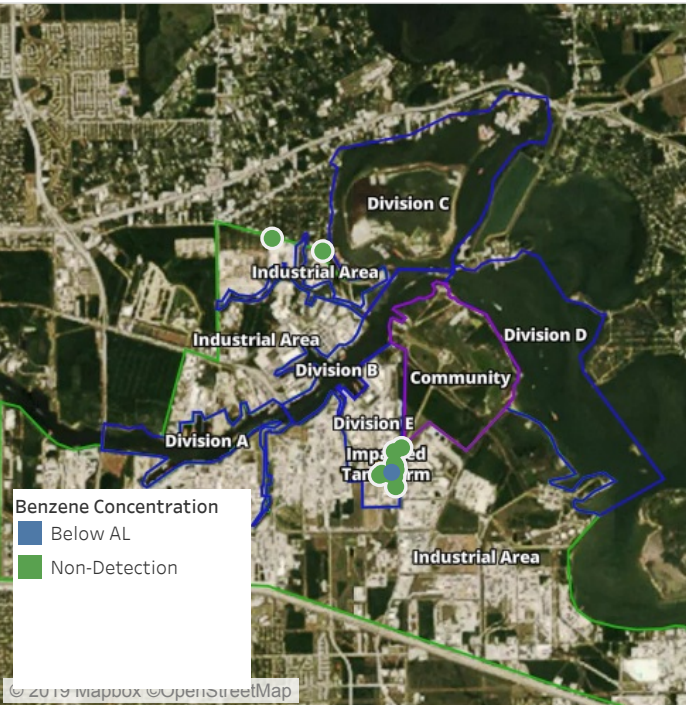
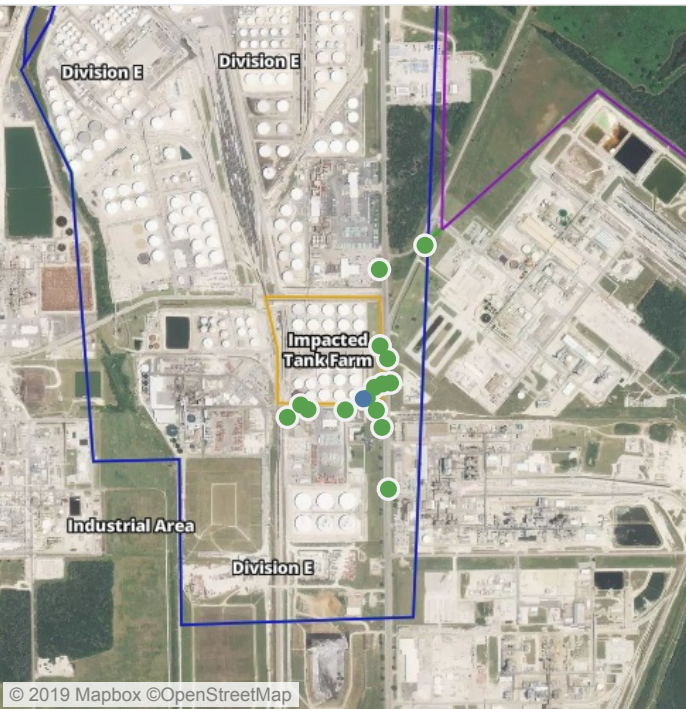
## Recent Benzene Detections

Location Category	Reading Date	Range of Detections
Impacted Tank Farm	7/29/2019 15:03:53	0.05000 ppm

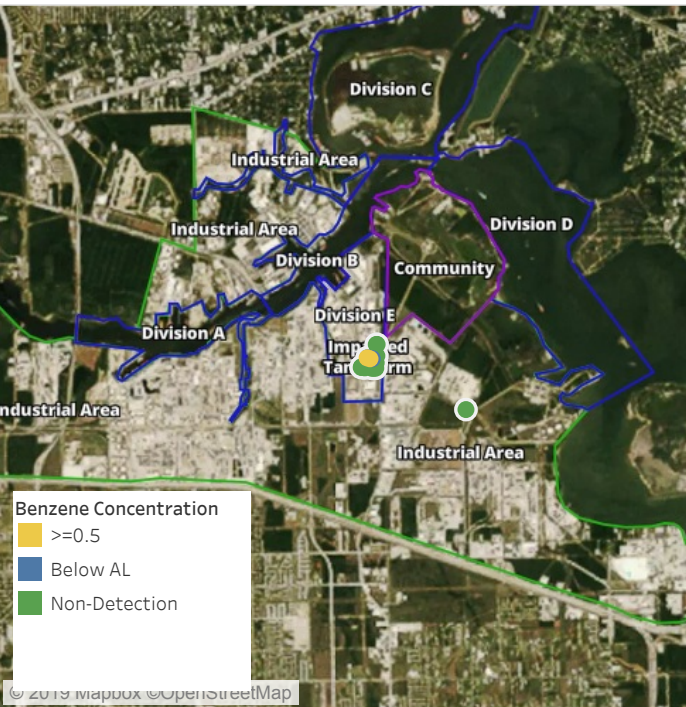
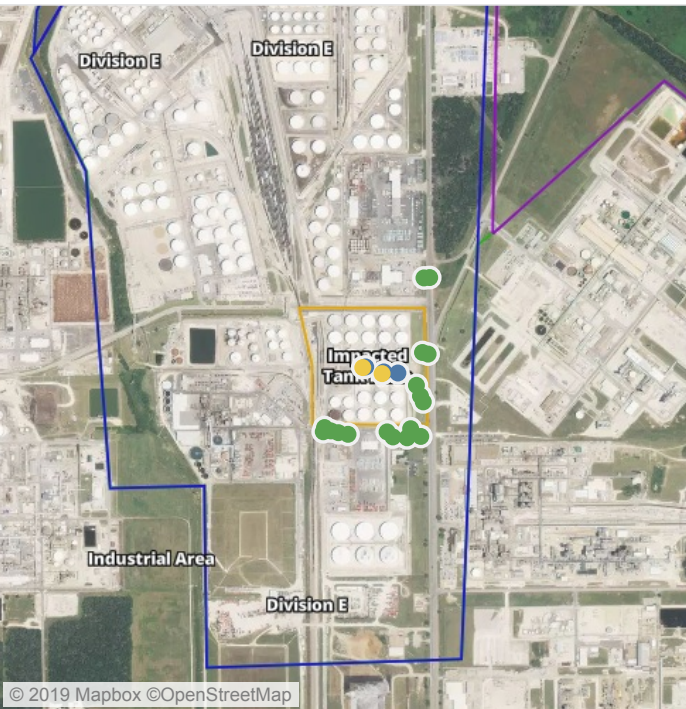
## Recent Benzene Detections

Location Category	Reading Date	Range of Detections
Impacted Tank Farm	7/29/2019 17:03:59	0.6400 ppm
	7/29/2019 17:04:52	0.2500 ppm
	7/29/2019 17:24:53	0.1300 ppm
	7/29/2019 17:30:47	0.0300 ppm
	7/29/2019 17:22:21	0.6900 ppm
