Preliminary Hand- Held Air Monitoring Locations | ITC Deer Park Tank Fire

Reading Date
7/30/2019 7:00:00 AM to 7/30/2019 8:00:00 AM

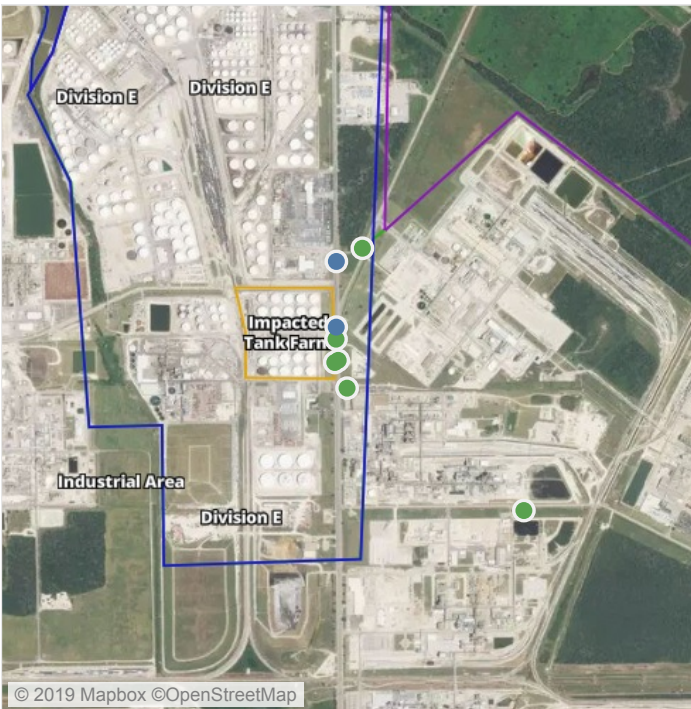
Recent Benzene Detections

Location Category	Reading Date	Range of Detections
Division E	7/30/2019 07:49:04	0.03000 ppm
	7/30/2019 07:43:33	0.06000 ppm

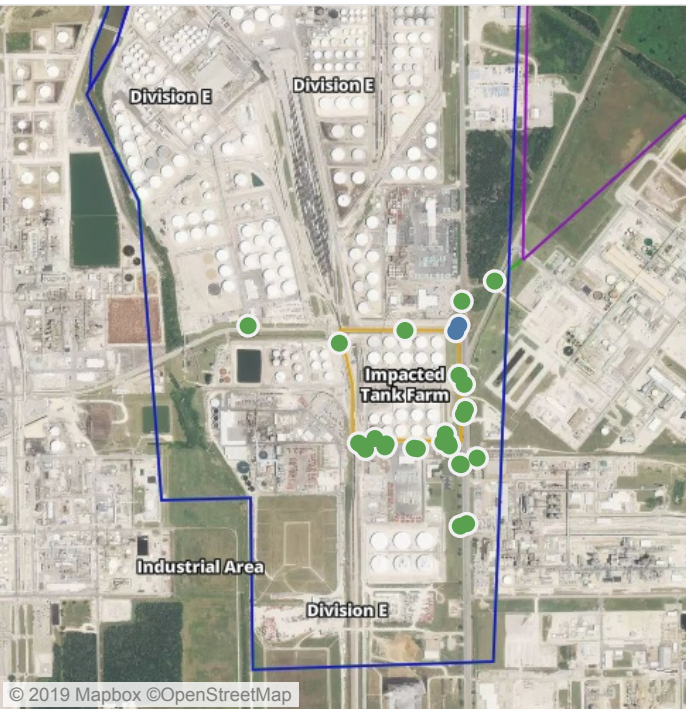
Reading Date
7/30/2019 8:00:00 AM to 7/30/2019 9:00:00 AM

Recent Benzene Detections

Location Category	Reading Date	Range of Detections
Division E	7/30/2019 08:06:52	0.06000 ppm
	7/30/2019 08:07:59	0.04000 ppm

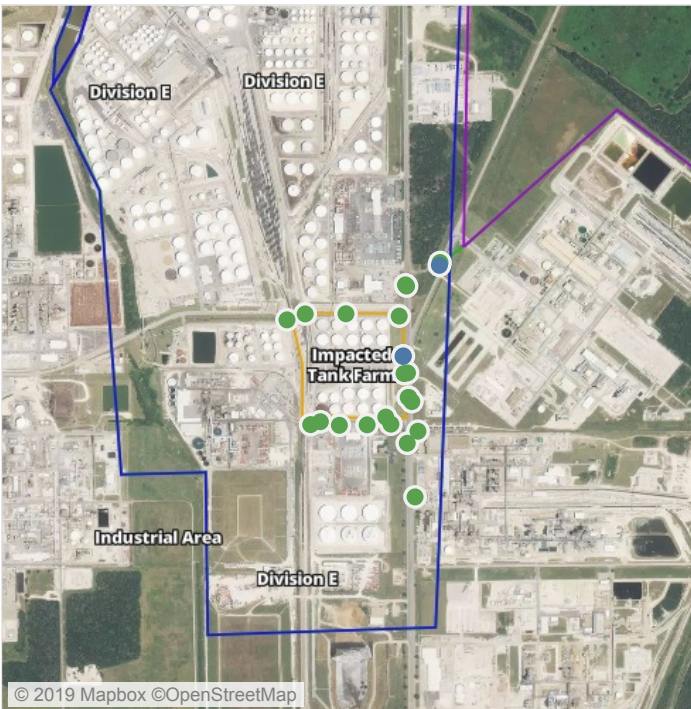
Reading Date
7/30/2019 10:00:00 AM to 7/30/2019 11:00:00 AM

Recent Benzene Detections

Location Category	Reading Date	Range of Detections
Division E	7/30/2019 10:04:37	0.03000 ppm
	7/30/2019 10:09:10	0.04000 ppm
	7/30/2019 10:56:19	0.05000 ppm

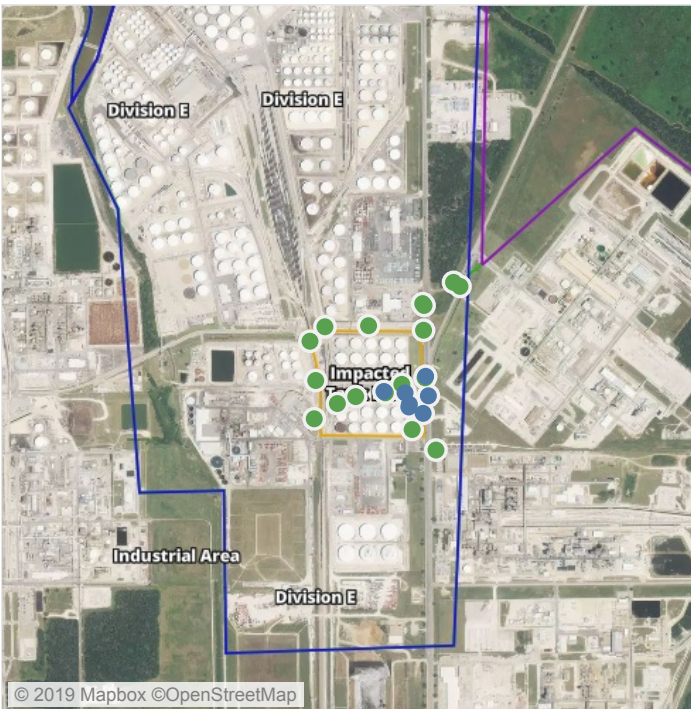
Reading Date
7/30/2019 12:00:00 PM to 7/30/2019 1:00:00 PM

Recent Benzene Detections

Location Category	Reading Date	Range of Detections
Division E	7/30/2019 12:46:21	0.0500 ppm
	7/30/2019 12:44:08	0.0400 ppm
	7/30/2019 12:57:41	0.0600 ppm
Impacted Tank Farm	7/30/2019 12:10:42	0.1400 ppm
	7/30/2019 12:09:02	0.1500 ppm
	7/30/2019 12:06:18	0.0500 ppm
	7/30/2019 12:54:39	0.0300 ppm

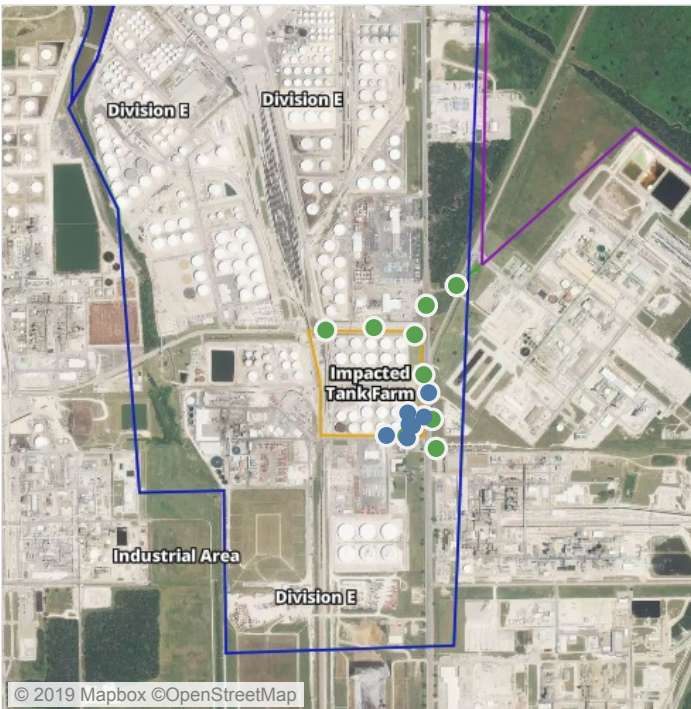
Reading Date
7/30/2019 1:00:00 PM to 7/30/2019 2:00:00 PM

Recent Benzene Detections

Location Category	Reading Date	Range of Detections
Division E	7/30/2019 13:41:24	0.0500 ppm
	7/30/2019 13:52:02	0.0200 ppm
	7/30/2019 13:55:54	0.0600 ppm
	7/30/2019 13:59:26	0.2000 ppm
Impacted Tank Farm	7/30/2019 13:10:20	0.0600 ppm
	7/30/2019 13:26:42	0.0200 ppm
	7/30/2019 13:25:09	0.0400 ppm

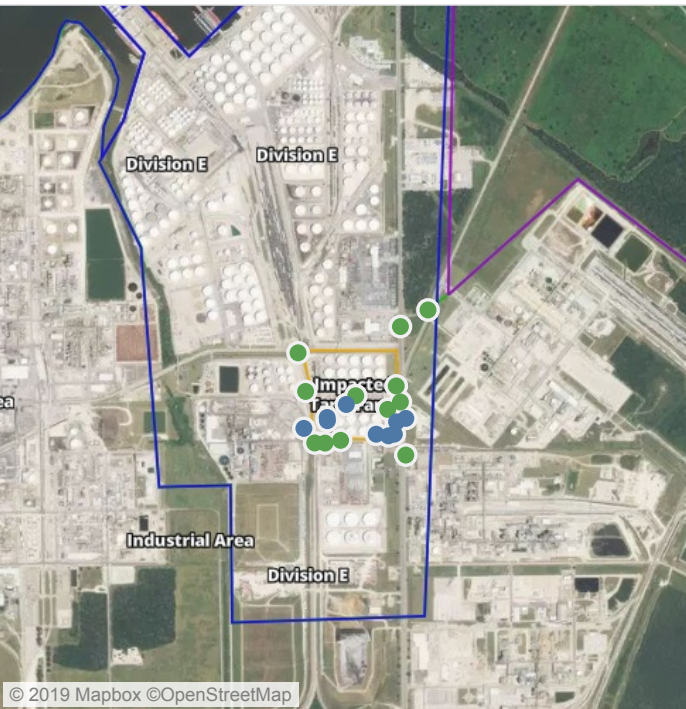
Reading Date
7/30/2019 2:00:00 PM to 7/30/2019 3:00:00 PM

Recent Benzene Detections

Location Category	Reading Date	Range of Detections
Division E	7/30/2019 14:10:23	0.05000 ppm
	7/30/2019 14:28:50	0.07000 ppm
	7/30/2019 14:09:19	0.03000 ppm
	7/30/2019 14:44:43	0.06000 ppm
	7/30/2019 14:54:57	0.05000 ppm
Impacted Tank Farm	7/30/2019 14:20:33	0.03000 ppm
	7/30/2019 14:23:20	0.02000 ppm
	7/30/2019 14:17:21	0.04000 ppm
	7/30/2019 14:38:50	0.07000 ppm
