# Preliminary Hand- Held Air Monitoring Locations | ITC Deer Park Tank Fire

Reading Date  
8/2/2019 7:00:00 AM to 8/2/2019 8:00:00 AM

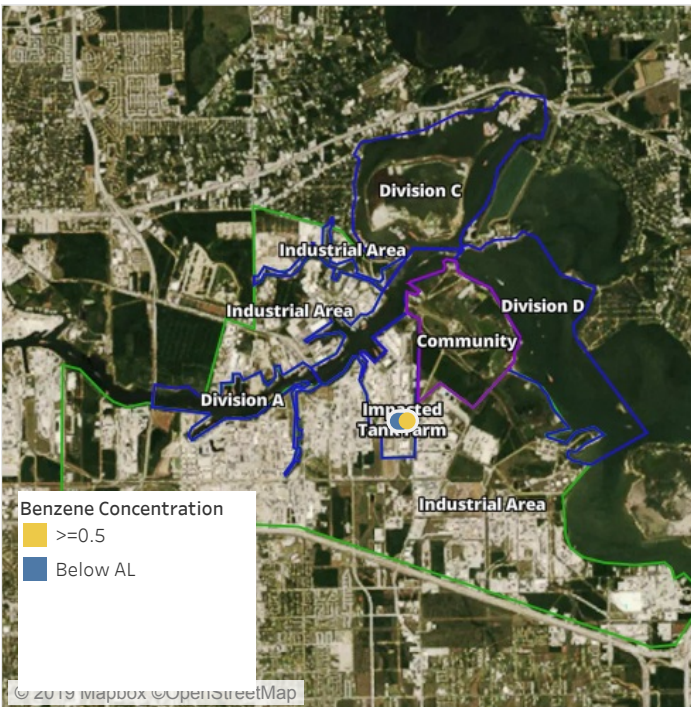
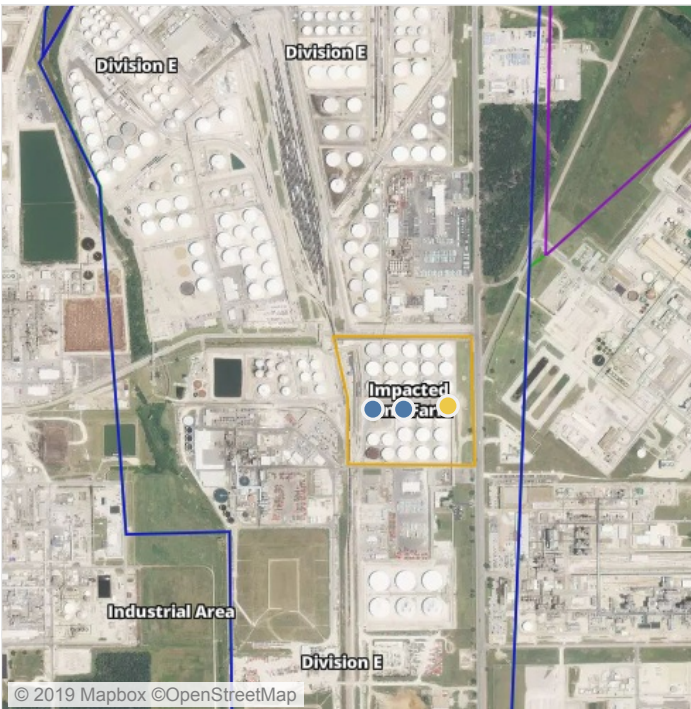
Location Category	Reading Date	Range of Detections
Impacted Tank Farm	8/2/2019 07:48:15	0.0300 ppm
	8/2/2019 07:52:03	0.0300 ppm
	8/2/2019 07:00:21	0.6000 ppm

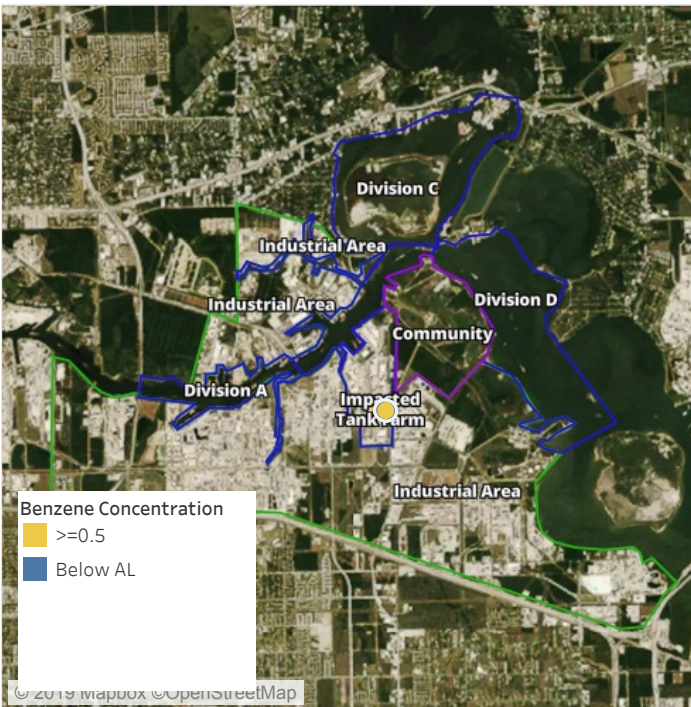
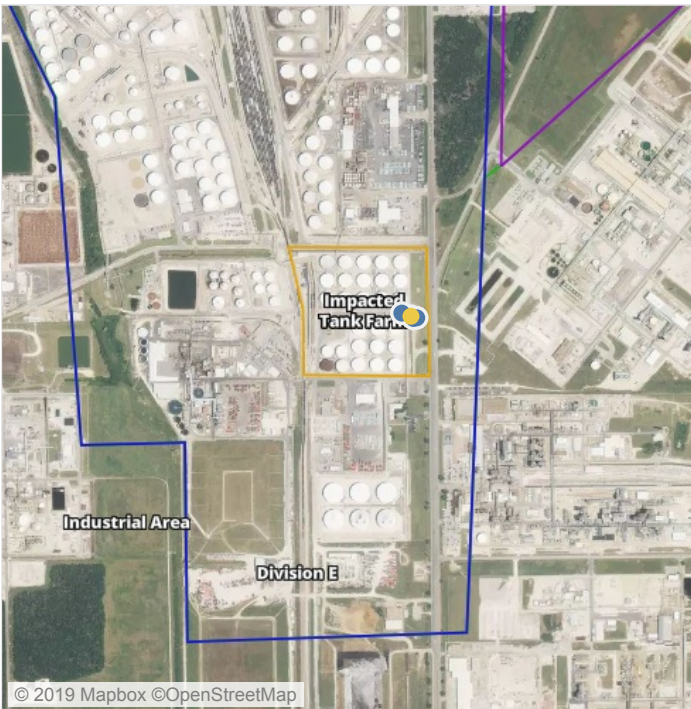
Reading Date  
8/2/2019 8:00:00 AM to 8/2/2019 9:00:00 AM

Location Category	Reading Date	Range of Detections
Impacted Tank Farm	8/2/2019 08:04:34	0.2500 ppm
	8/2/2019 08:21:34	0.1200 ppm
	8/2/2019 08:24:24	0.2500 ppm
	8/2/2019 08:01:34	0.6100 ppm

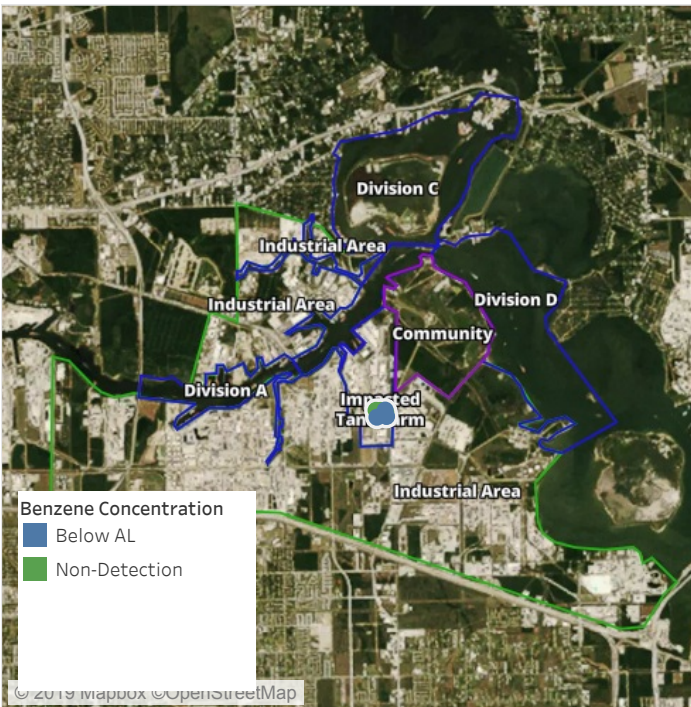
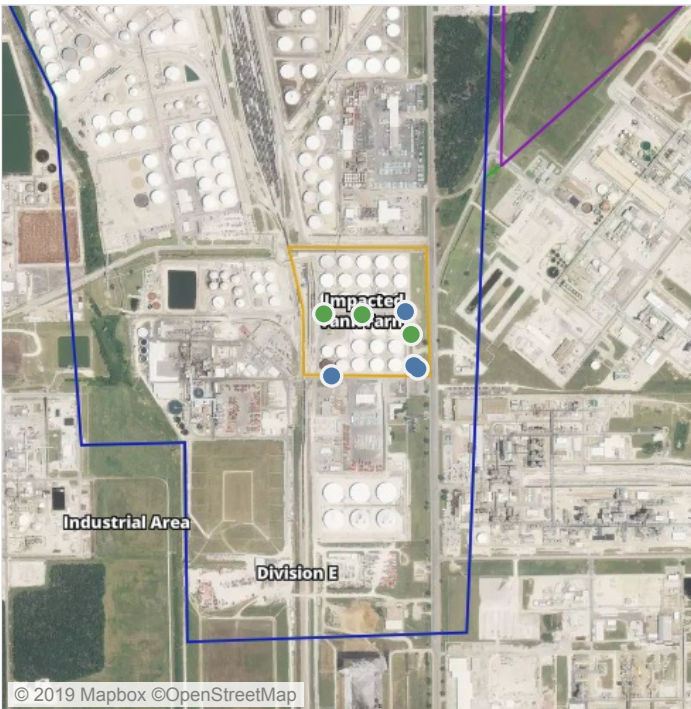
Reading Date  
8/2/2019 9:00:00 AM to 8/2/2019 10:00:00 AM

Location Category	Reading Date	Range of Detections
Division E	8/2/2019 09:15:45	0.0300 ppm
Impacted Tank Farm	8/2/2019 09:42:05	0.1800 ppm
	8/2/2019 09:31:19	0.0200 ppm
	8/2/2019 09:09:54	0.1100 ppm

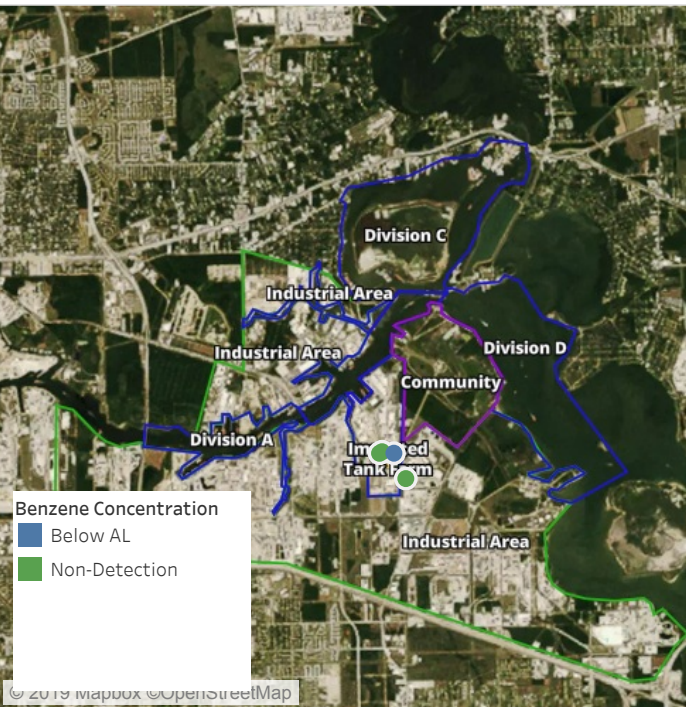
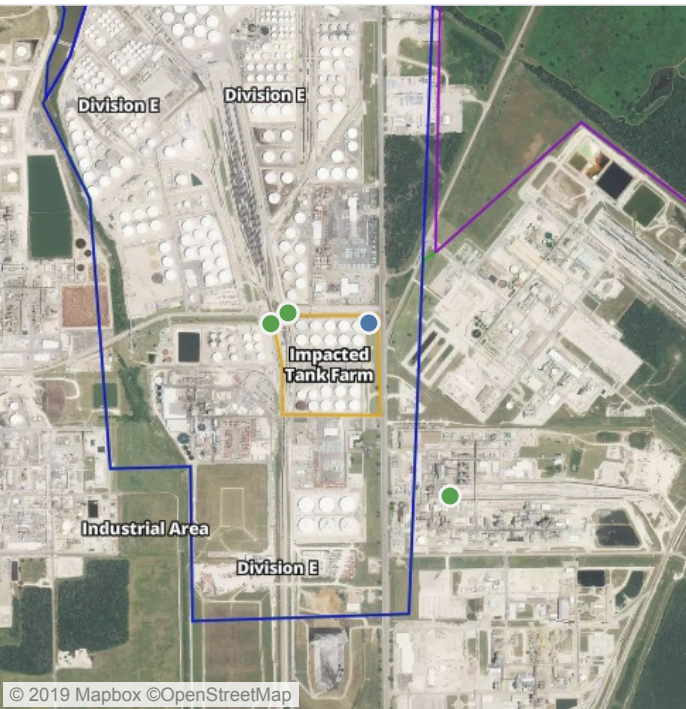
Reading Date  
8/2/2019 10:00:00 AM to 8/2/2019 11:00:00 AM

Location Category	Reading Date	Range of Detections
Division E	8/2/2019 10:30:51	0.03000 ppm

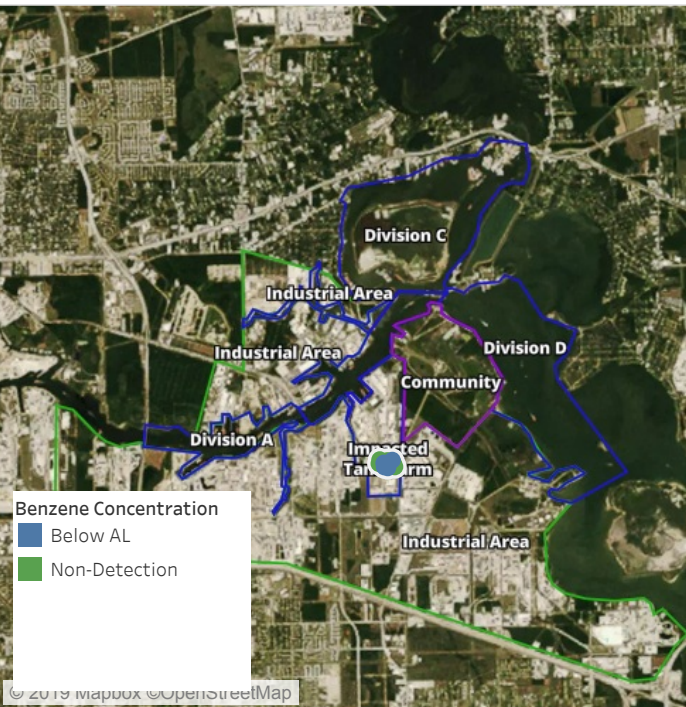
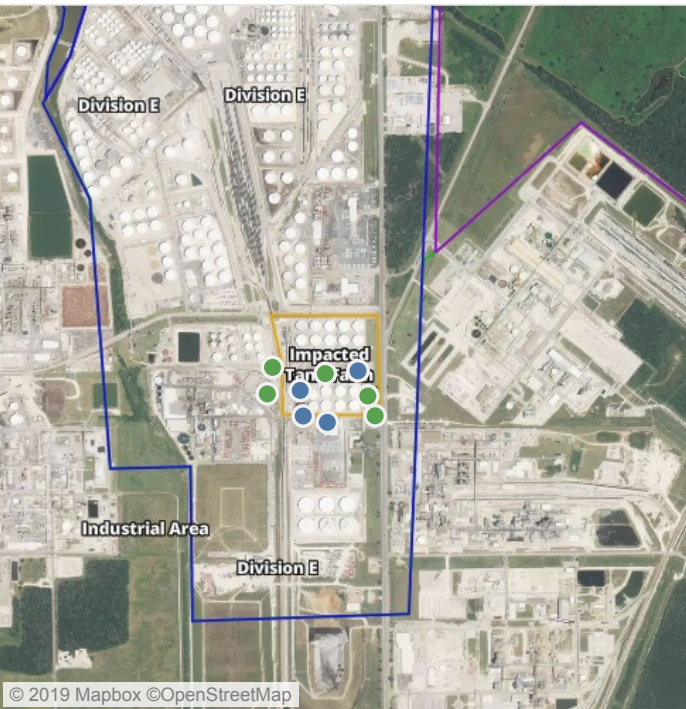
Reading Date  
8/2/2019 11:00:00 AM to 8/2/2019 12:00:00 PM

Location Category	Reading Date	Range of Detections
Division E	8/2/2019 11:18:15	0.1800 ppm
	8/2/2019 11:36:37	0.0900 ppm
	8/2/2019 11:50:15	0.0300 ppm
	8/2/2019 11:40:22	0.1100 ppm

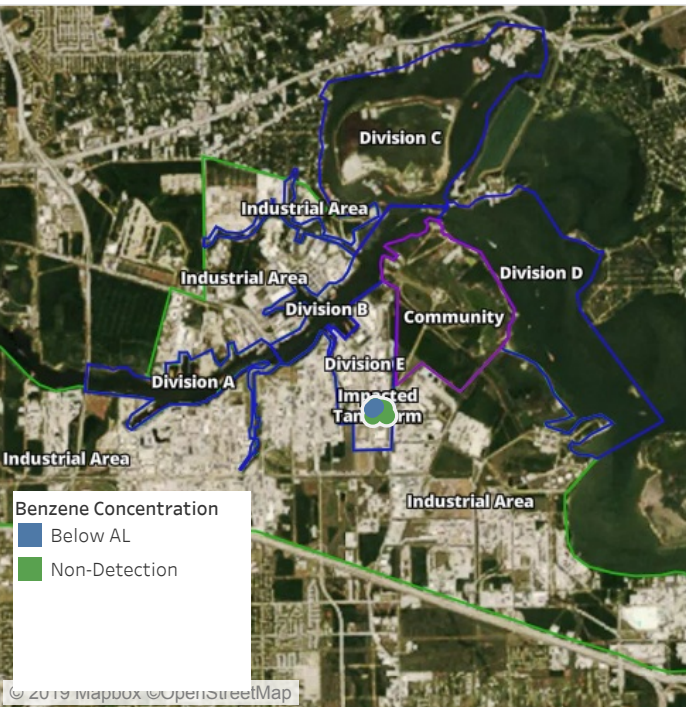
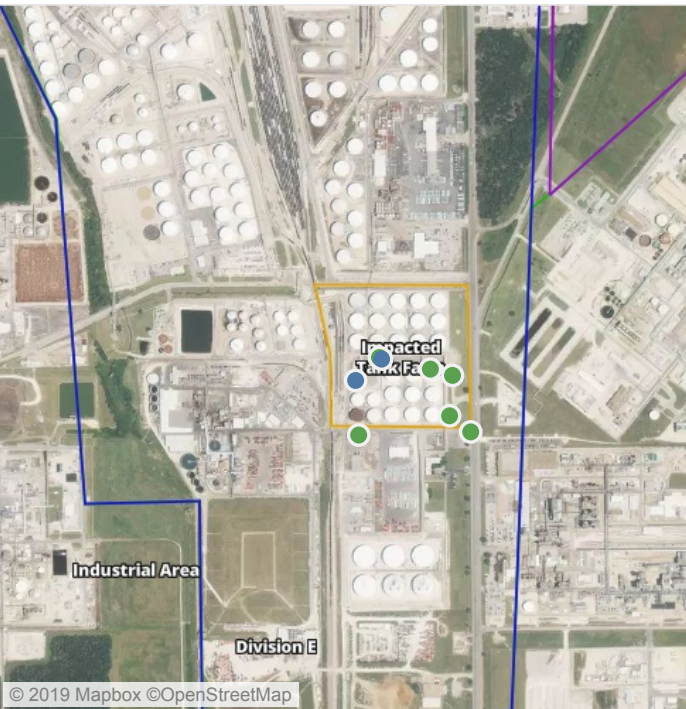
Reading Date  
8/2/2019 1:00:00 PM to 8/2/2019 2:00:00 PM

Location Category	Reading Date	Range of Detections
Impacted Tank Farm	8/2/2019 13:15:17	0.02000 ppm
	8/2/2019 13:13:05	0.02000 ppm

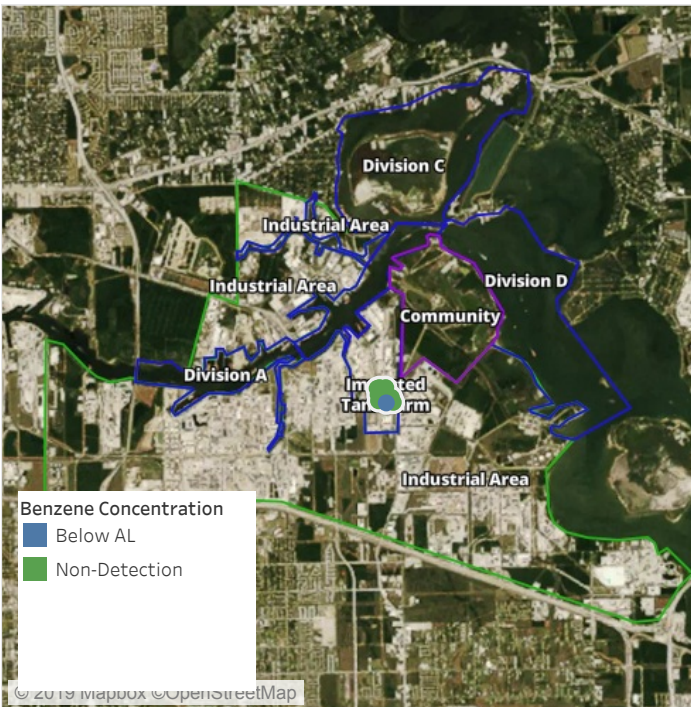
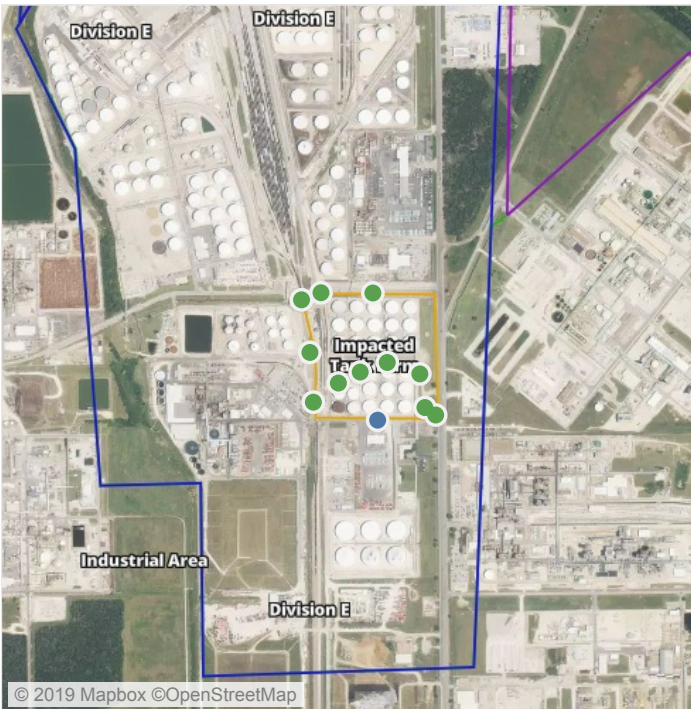
Reading Date  
8/2/2019 3:00:00 PM to 8/2/2019 4:00:00 PM

Location Category	Reading Date	Range of Detections
Division E	8/2/2019 16:00:00	0.1800 ppm

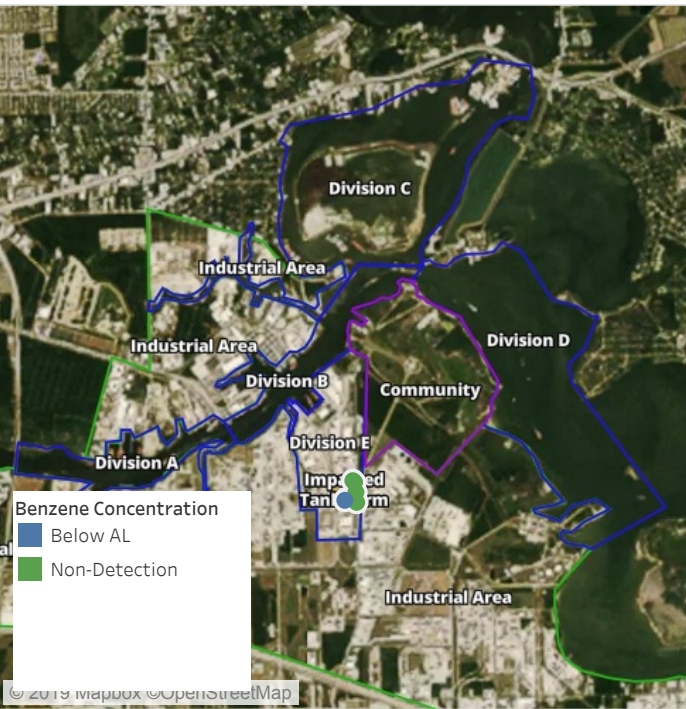
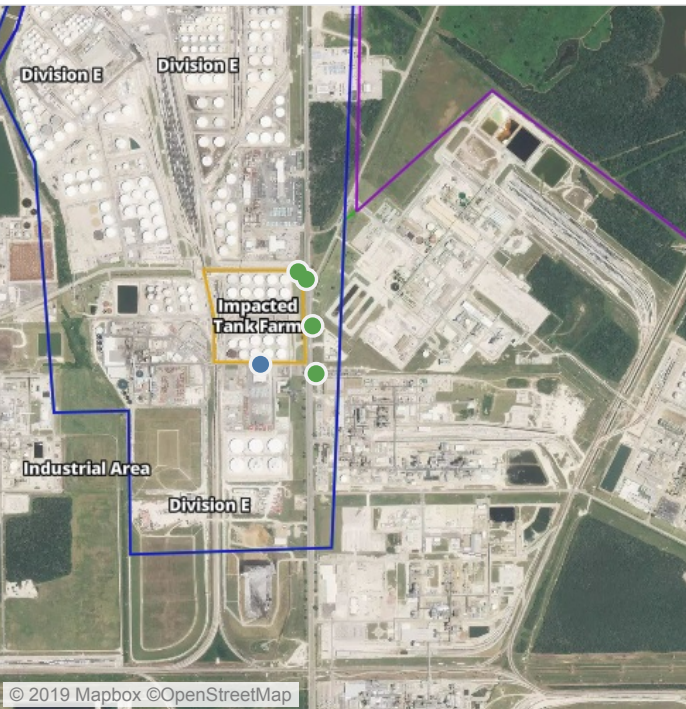
Reading Date  
8/2/2019 4:00:00 PM to 8/2/2019 5:00:00 PM

Location Category	Reading Date	Range of Detections
Division E	8/2/2019 16:00:00	0.1800 ppm

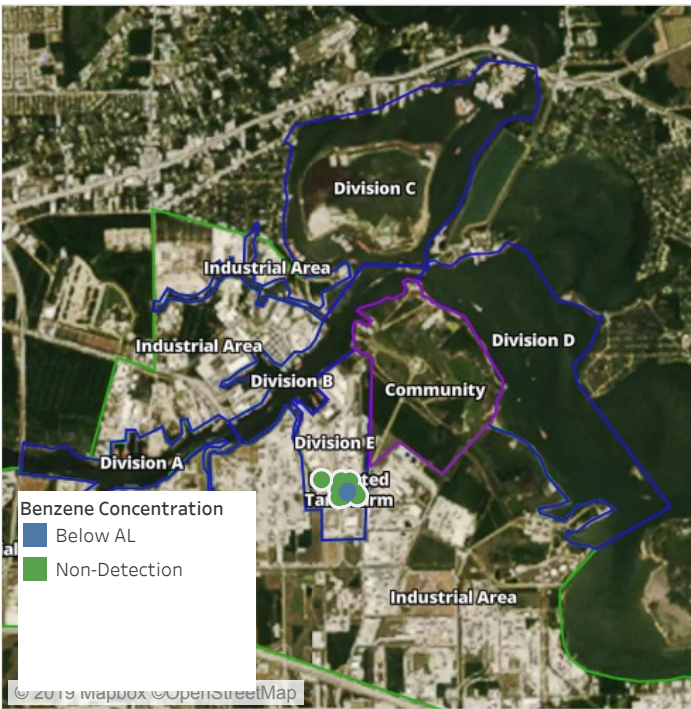
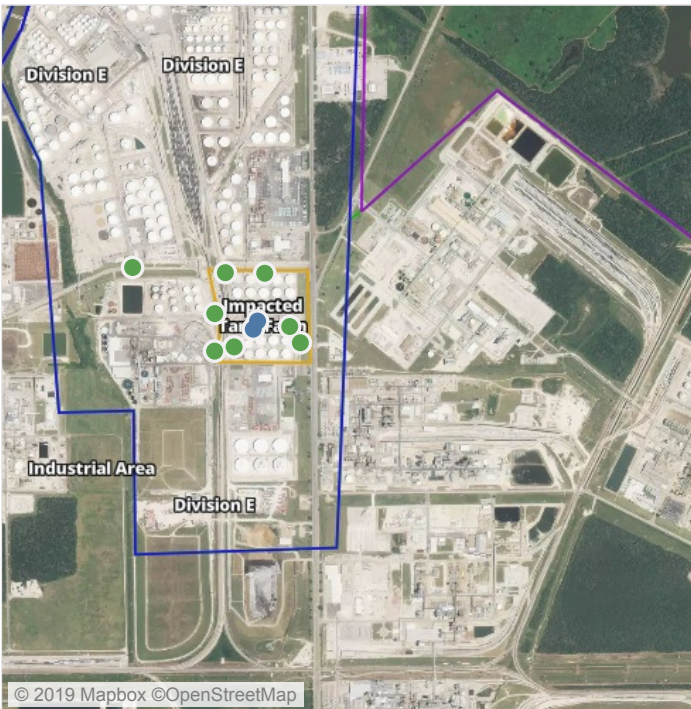
Reading Date  
8/2/2019 5:00:00 PM to 8/2/2019 6:00:00 PM

Location Category	Reading Date	Range of Detections
Impacted Tank Farm	8/2/2019 17:39:11	0.11000 ppm
	8/2/2019 17:49:07	0.05000 ppm
