Preliminary Hand- Held Air Monitoring Locations | ITC Deer Park Tank Fire

Reading Date
8/4/2019 7:00:00 AM to 8/4/2019 8:00:00 AM

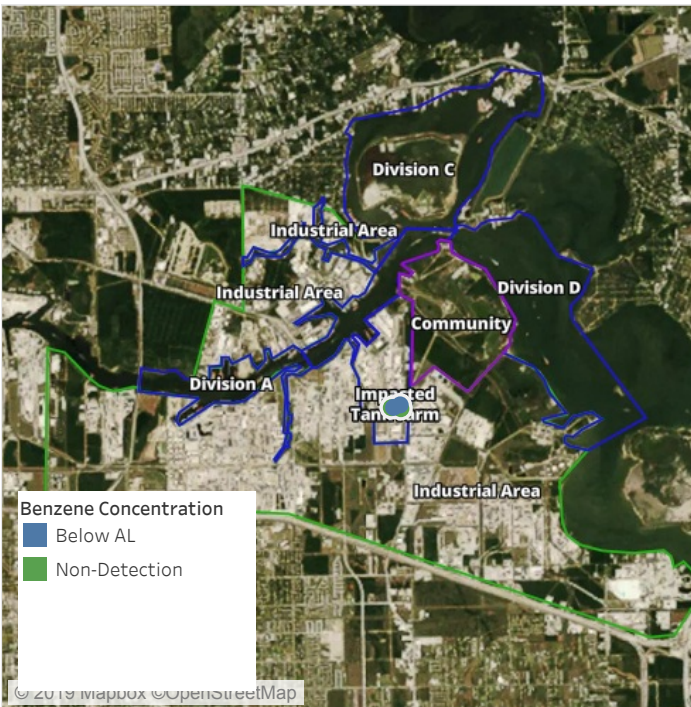
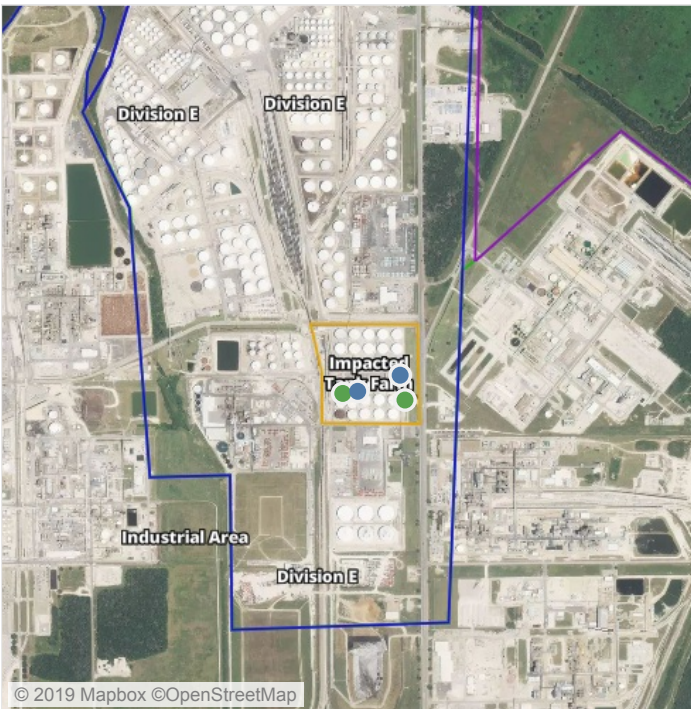
Recent Benzene Detections

Location Category	Reading Date	Range of Detections
Impacted Tank Farm	8/4/2019 07:44:13	0.1700 ppm
	8/4/2019 07:48:08	0.0400 ppm

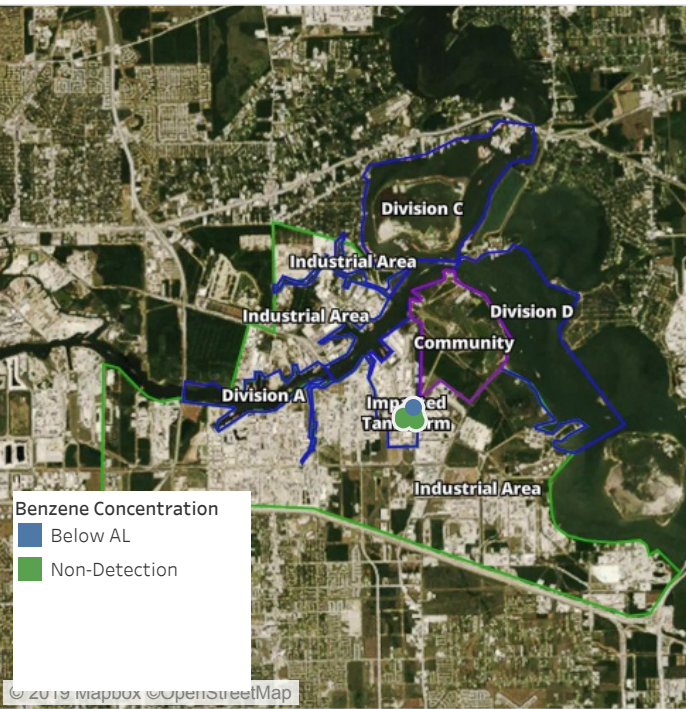
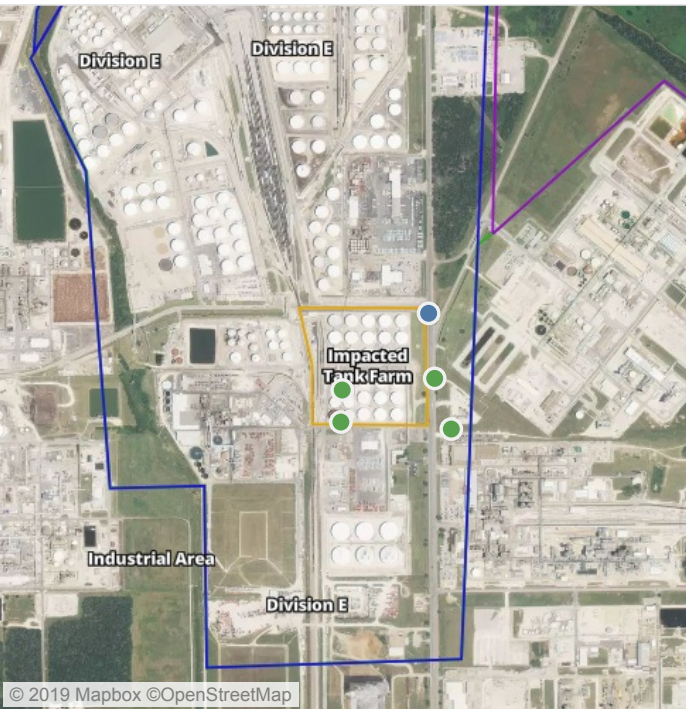
Recent Benzene Detections

Location Category	Reading Date	Range of Detections
Division E	8/4/2019 08:46:35	0.07000 ppm

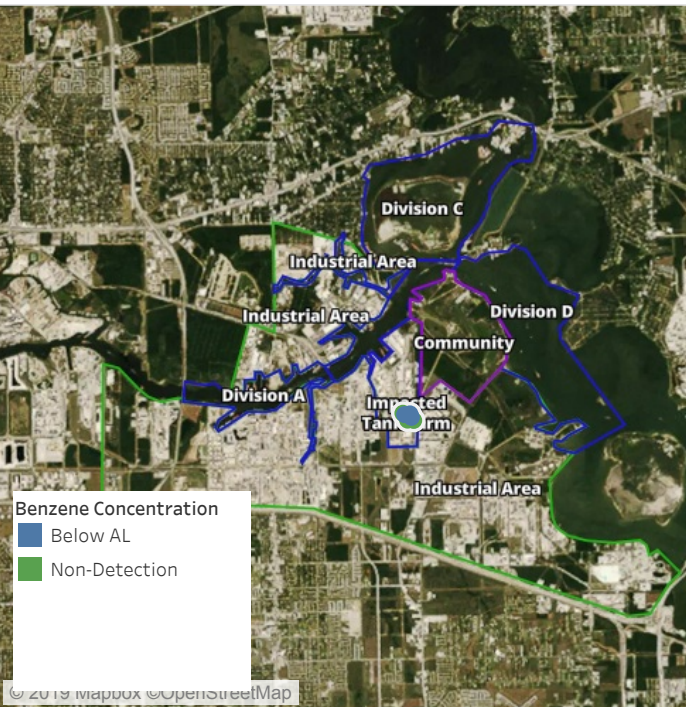
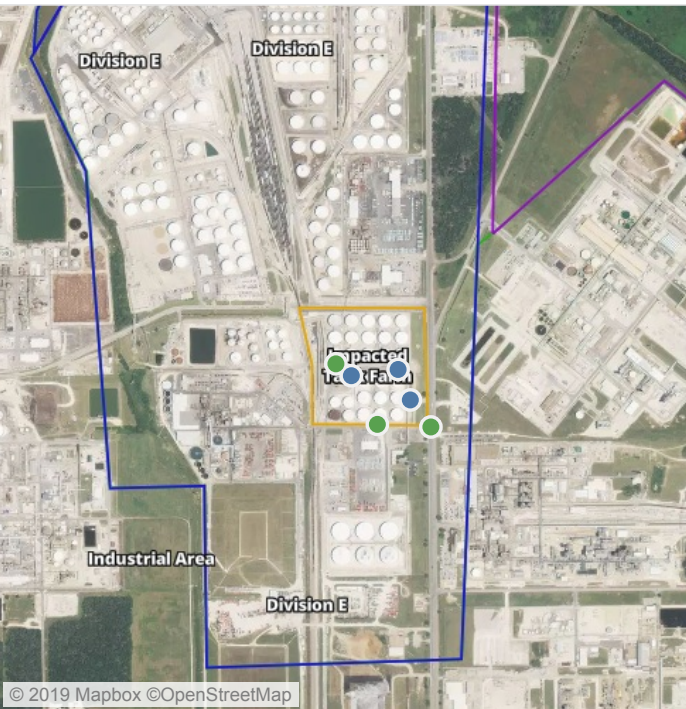
Recent Benzene Detections

Location Category	Reading Date	Range of Detections
Division E	8/4/2019 09:44:16	0.1200 ppm
Impacted Tank Farm	8/4/2019 09:06:03	0.1200 ppm
	8/4/2019 09:51:07	0.0200 ppm

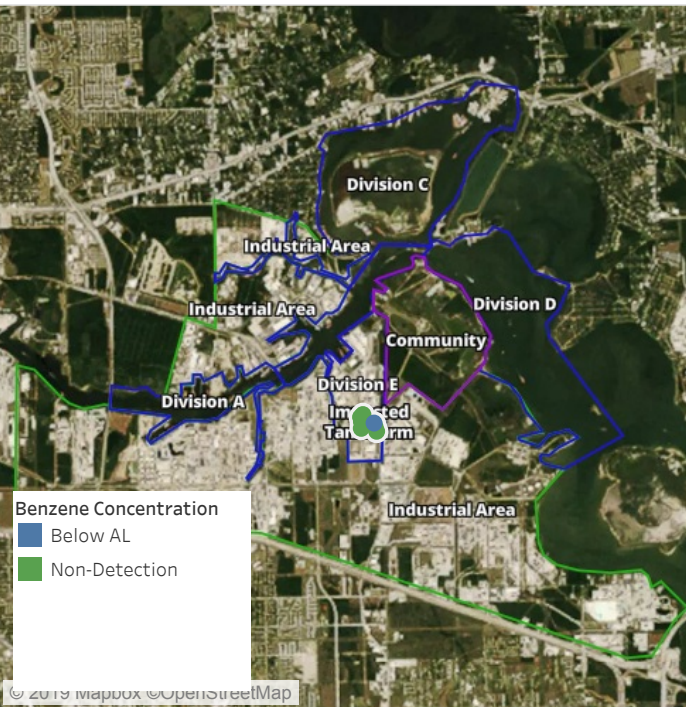
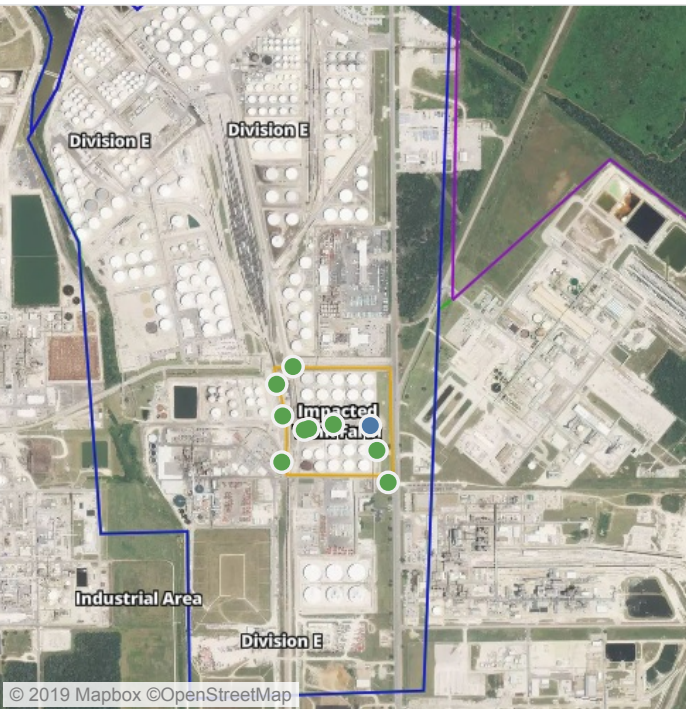
Recent Benzene Detections

Location Category	Reading Date	Range of Detections
Impacted Tank Farm	8/4/2019 11:47:15	0.1300 ppm

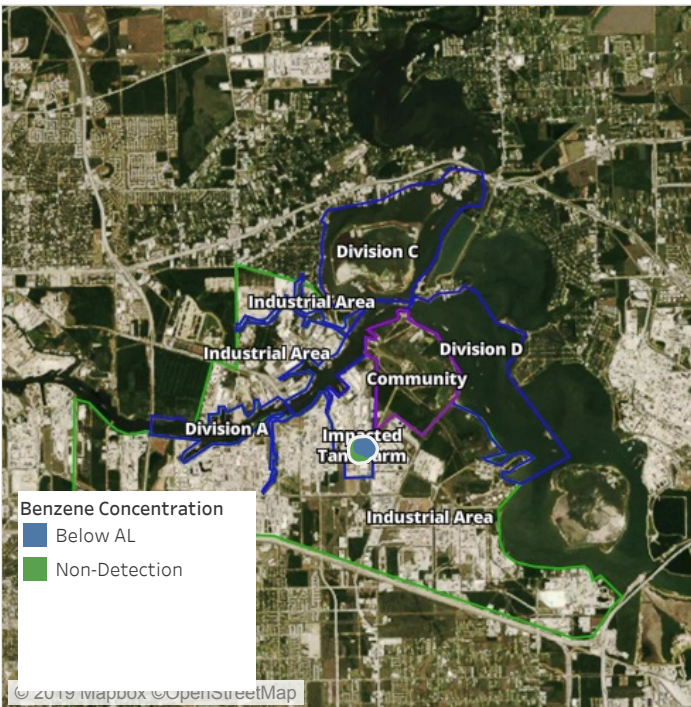
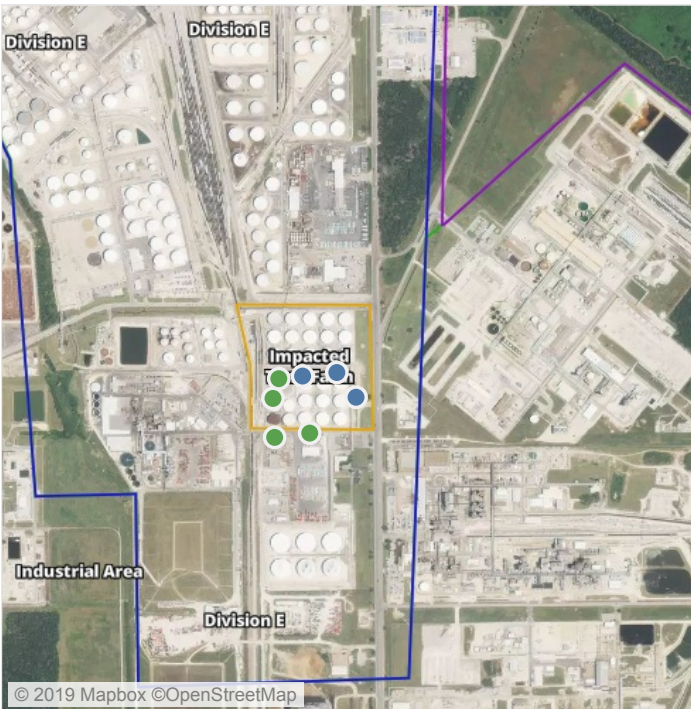
Recent Benzene Detections

Location Category	Reading Date	Range of Detections
Impacted Tank Farm	8/4/2019 13:41:00	0.1200 ppm
	8/4/2019 13:47:50	0.0500 ppm
	8/4/2019 13:52:31	0.0200 ppm

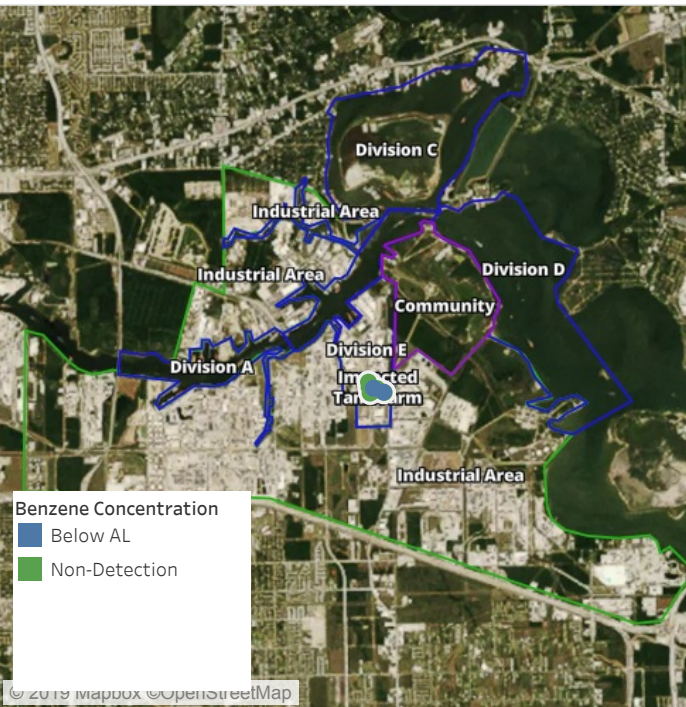
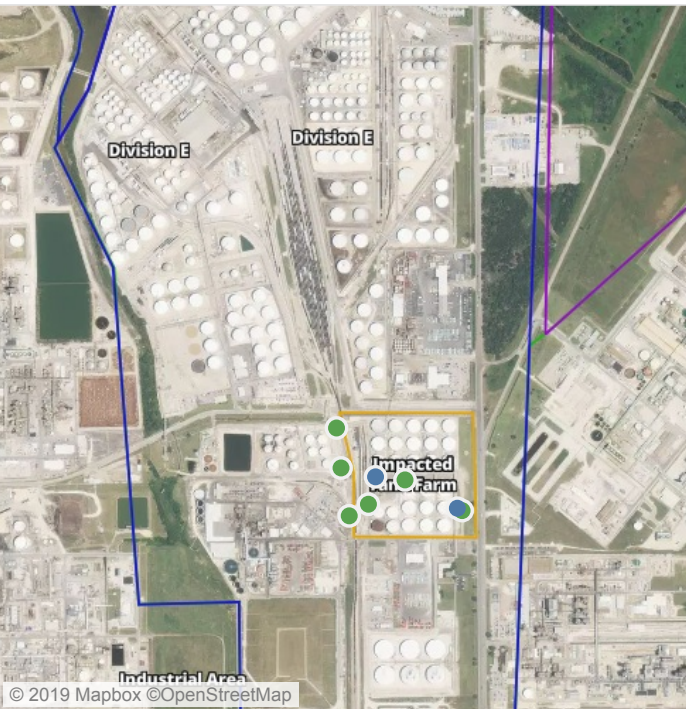
Recent Benzene Detections

Location Category	Reading Date	Range of Detections
Impacted Tank Farm	8/4/2019 15:30:59	0.02000 ppm
	8/4/2019 15:49:07	0.03000 ppm
