# Appendix C: Example FPR

FILTER PROFILE REPORT FOR INDIVIDUAL FILTERS			
FOR PUBLIC WATER SYSTEMS THAT ARE USING SURFACE WATER SOURCES OR GROUND WATER SOURCES UNDER THE INFLUENCE OF SURFACE WATER THAT ARE REQUIRED TO CONDUCT ADDITIONAL INDIVIDUAL FILTER MONITORING			
<b>PUBLIC WATER SYSTEM NAME:</b> <u>City of Example</u> <b>PWS ID No.:</b> <u>1234567</u>	<b>PLANT NAME OR NUMBER:</b> <u>Treatment Plant</u> <b>Month:</b> <u>February</u> <b>Year:</b> <u>2002</u>		
OBVIOUS REASONS			
	<b>FILTER NO.:</b> <u>1</u> <b>DATE:</b> <u>02-04-02</u> <b>TIME:</b> <u>10:00 AM</u> <b>DURATION:</b> <u>45:00</u> <b>TURBIDITY:</b> <u>1.23</u>	<b>FILTER NO.:</b> <u>1</u> <b>DATE:</b> <u>02-04-02</u> <b>TIME:</b> <u>4:15 PM</u> <b>DURATION:</b> <u>15:00</u> <b>TURBIDITY:</b> <u>0.57</u>	<b>FILTER NO.:</b> <u>5</u> <b>DATE:</b> <u>02-04-02</u> <b>TIME:</b> <u>11:45 AM</u> <b>DURATION:</b> <u>15:00</u> <b>TURBIDITY:</b> <u>1.05</u>
<b>OBVIOUS REASONS</b> (Check all that apply) NONE IDENTIFIED - A Filter Profile must be submitted <input type="checkbox"/> (See Profile No. <u>    </u> ) <input type="checkbox"/> (See Profile No. <u>    </u> ) <input type="checkbox"/> (See Profile No. <u>    </u> )

### Fi

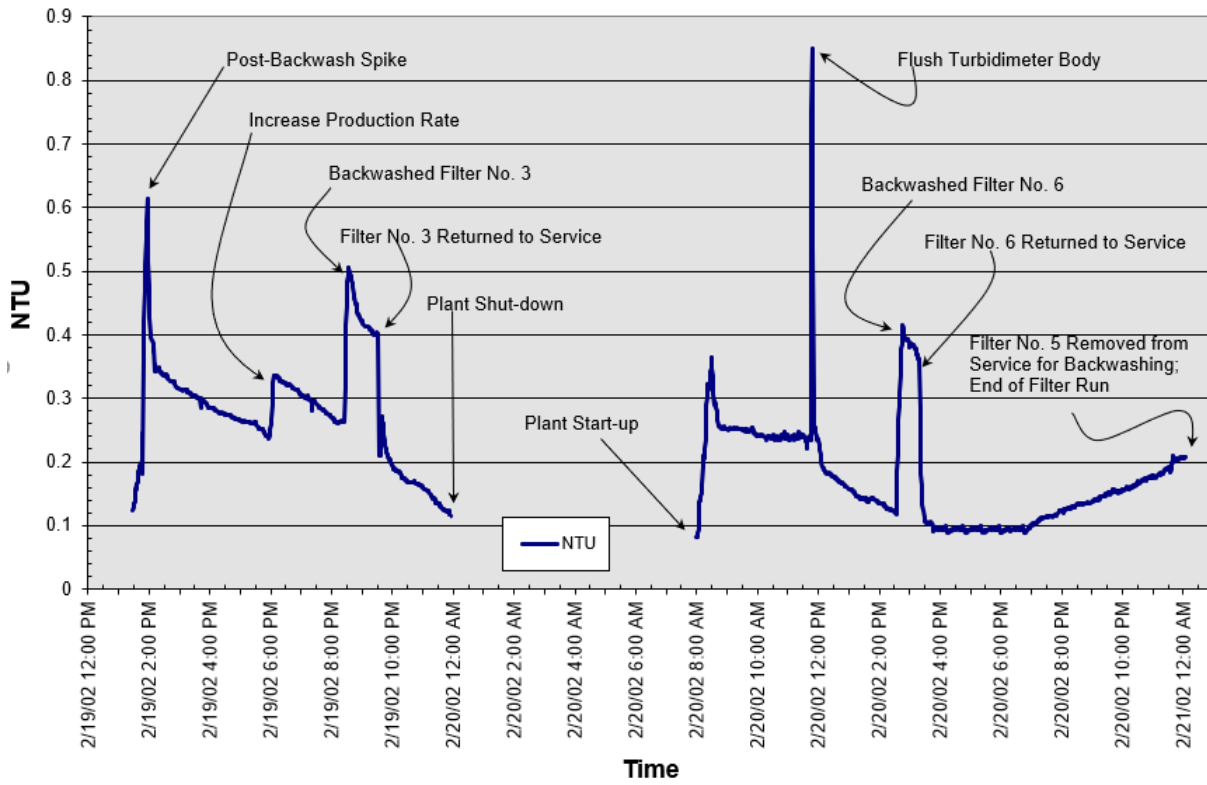
1) there was a significant increase in the IFE turbidity level at 6:00 pm on the 19th when the plant's production rate was increased from 9.6 MGD to 13.2 MGD. 2) the 4-hr IFE turbidity level on Filter No. 5 was recorded at 12:20 pm and was 0.262 NTU. 3) a turbidity spike was observed when Filter No. 3 was taken offline and backwashed at 8:28 pm on the 8th. 4) the maximum daily 15-minute IFE reading from Filter No. 5 occurred at 8:30 pm on the 19th while we were backwashing Filter No. 3 5) the plant was shut off for the night at 11:55 pm and was not started up again until 8:00 am on Wednesday, February 20th. 6) the short, but severe, turbidity spike that occurred at 11:46 am on the 20th was an unusual reading that occurred when we flushed the turbidimeter body as part of our routine maintenance. 7) the 4-hr IFE reading for Filter No. 5 occurred at 12:00 pm and was 0.235 NTU 8) at 2:35 pm on the 20th, we took Filter No. 6 offline for backwashing 9) the maximum daily 15-minute reading for the 20th (on Filter No. 5) was 0.394 NTU and occurred while Filter No. 6 was still offline.

<b>FILTER PROFILE REPORT FOR INDIVIDUAL FILTERS</b> <small>FOR PUBLIC WATER SYSTEMS THAT ARE USING SURFACE WATER SOURCES OR GROUND WATER SOURCES UNDER THE INFLUENCE OF SURFACE WATER THAT ARE REQUIRED TO CONDUCT ADDITIONAL INDIVIDUAL FILTER MONITORING</small>		
<b>PUBLIC WATER SYSTEM NAME:</b> <u>City of Example</u>	<b>PLANT NAME OR NUMBER:</b> <u>Treatment Plant</u>	
<b>PWS ID No.:</b> <u>1234567</u>	<b>Month:</b> <u>February</u> <b>Year:</b> <u>2002</u>	
NARRATIVE DESCRIPTION OF FILTER PROFILE		
<b>FILTER NO.:</b> _____ <b>PROFILE NO.:</b> _____	<b>DATE OF PROFILE:</b> _____	
<b>DETAILS:</b> The filter profile on Filter No. 5 began at 1:28 pm on Tuesday, February 19, 2002 following a routine backwash and our typical 45-minute idle time that we allow for filter pre-ripening. The filter profile ended at 12:30 am on Thursday, February 21, 2002, when the plant was taken offline for the day. Filter No.5 was backwashed and returned before the plant was returned to service the following morning. Some specific observations we made during the filter profile include:
