REVISION 3 – APPLICATION FOR DEVELOPMENT PERMIT FOR PROPOSED ENCLOSED STRUCTURE OVER CLOSED MUNICIPAL SOLID WASTE LANDFILL

CAESARS PLAZA 957 W CARTWRIGHT RD MESQUITE, DALLAS COUNTY, TEXAS 75149

PN: 1239.001.001

SQ Environmental, LLC

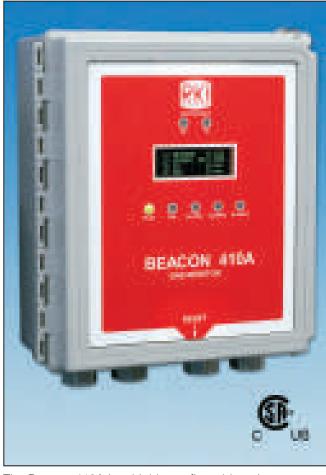
Beacon™ 410A Model

- · Simultaneously control up to 4 gas monitoring channels
- · OLED display of all 4 channels
- LEL / O2 / CO2 / toxic direct connect sensors
- · Accepts any 4-20 mA transmitter, 2 or 3 wire
- · Up to 3 programmable alarm levels per channel
- · Up to 3 configurable alarm relays per channel
- · 4-20 mA analog & Modbus digital output standard
- · 115 / 220 VAC or 24 VDC operation
- · Audible alarm with silence feature
- · RFI / EMI Resistant
- · Alarm reset switch
- · Built in trouble alarm with relay
- · Weather and corrosion resistant NEMA 4X enclosure

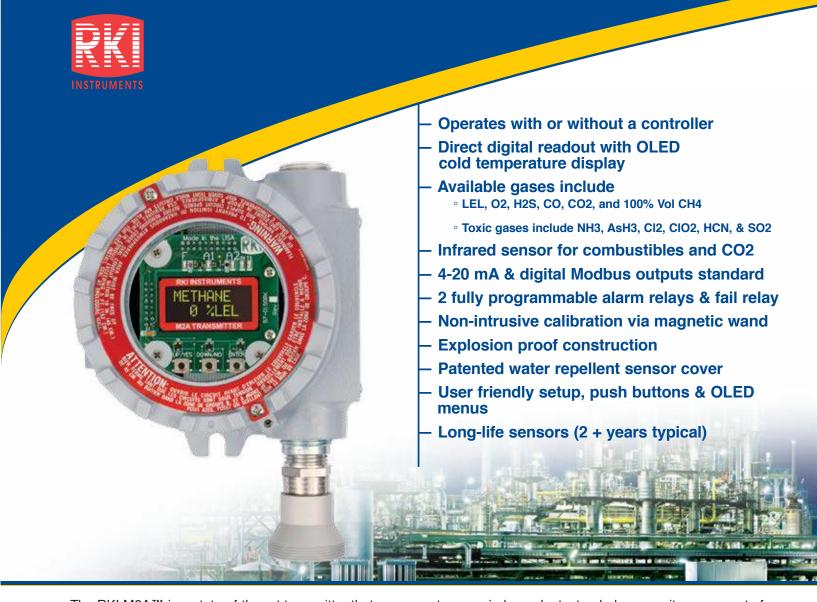
M2A STAND ALONE TRANSMITTER

The RKI M2A™ is a state-of-the-art transmitter that can operate as an independent, stand-alone monitor or as part of an integrated system. The M2A connects with an analog or digital signal to virtually any controller, PLC, or DCS. Setup procedures are simplified with user friendly push buttons and OLED menus. It utilizes a magnetic wand technique for performing non-intrusive calibration. The M2A provides an automatic zero drift correction feature, which results in more stable readings and reduces the need for adjustments due to sensor aging.

The housing of the M2A does not need to be opened for zeroing or calibration, making it unnecessary to declassify the area for routine maintenance. It is designed so that a complete field calibration can be performed by one person. Sensor construction is rated Class I, Div. 1 Groups B, C, D for flammables, CO, H2S, O2, and CO2, and Class I, Div. 2 for all other toxics.
