**Appendix A. Segment 0831 Anecdotal Record**

## **First Supplemental Survey - 26-27 July 2001- Clear Fork Trinity Project**

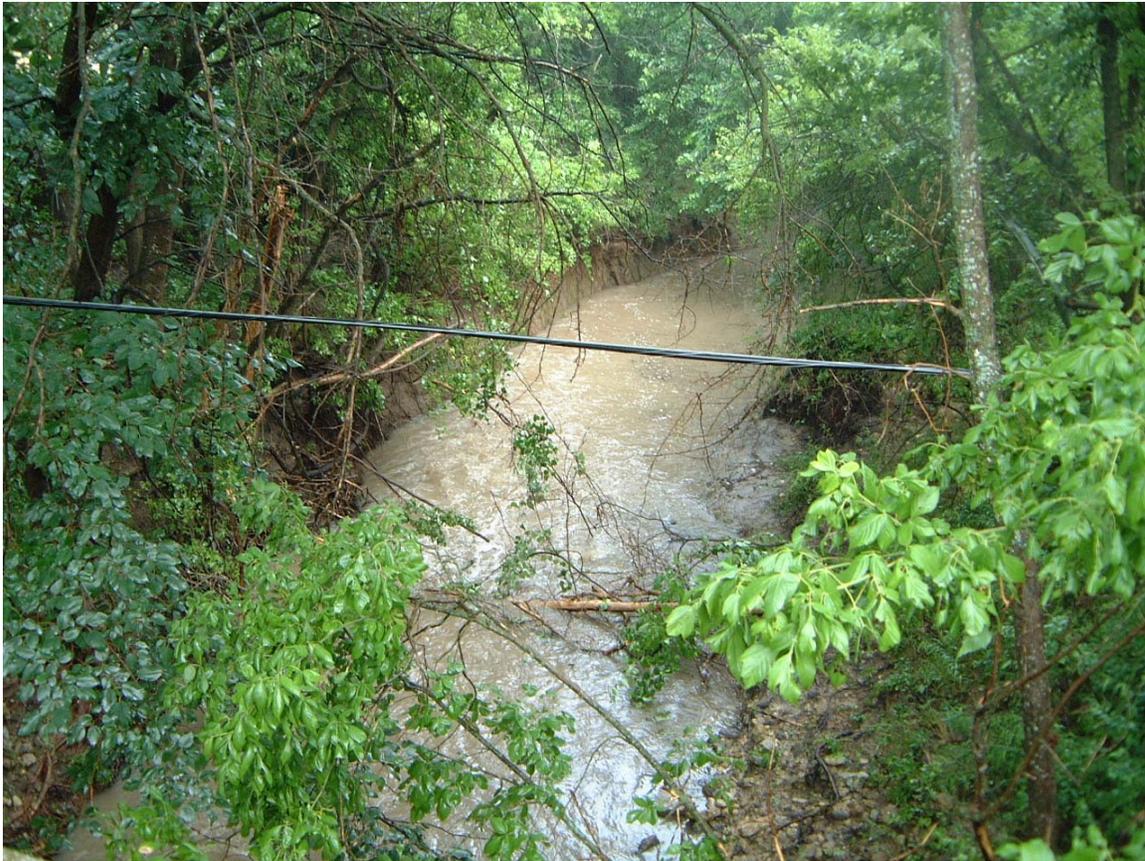
Figure 1. – South Fork at FM5 in Annetta, Texas.

completed at 0810 CDT at 13691 on 25 June. All automated stations worked with out fail and all data were successfully collected. Retrieval of automated equipment was completed at 1330 CDT. Equipment was returned to the motel, recalibrated and reprogrammed for a second deployment in the South Fork of the CFT. At approximately 1600 CDT, a thunderstorm struck the area around Willow Park in the CFT watershed and traveled south across the South Fork between Weatherford and Aledo, concentrating in intensity around Annetta. The storm produced rainfall sufficient enough to cause a substantial rise the water level in the South Fork. This runoff event subsequently resulted in the canceling of the monitoring, scrapping the previous days effort. Prior to discovering the impact on the South Fork, an ISCO sampler and YSI sonde had already been deployed at Station 17449 (City of Weatherford WWTP), as rain had occurred in the city. Traveling through the watershed to deploy an automated system at Station 17454, elevated flow conditions and substantial evidence of heavy runoff was observed (Fig.1).

Upon discovering the change in the water conditions, Dr. Larry Hauck was consulted at TIAER and he made the decision that all facets of the monitoring be scratched, including the time of travel study being conducted by Jeff Stroebel and Thad Scott at Station 17444. This team was contacted and the equipment was removed from the field. The effort has been rescheduled pending subsidence of the water levels and an extended period of no rainfall.
