Approved August 31, 2011

**Implementation Plan for
One Total Maximum Daily Load
for Bacteria in Guadalupe River
Above Canyon Lake
Segment 1806**

Water Quality Planning Division, Office of Water

TEXAS COMMISSION ON ENVIRONMENTAL QUALITY

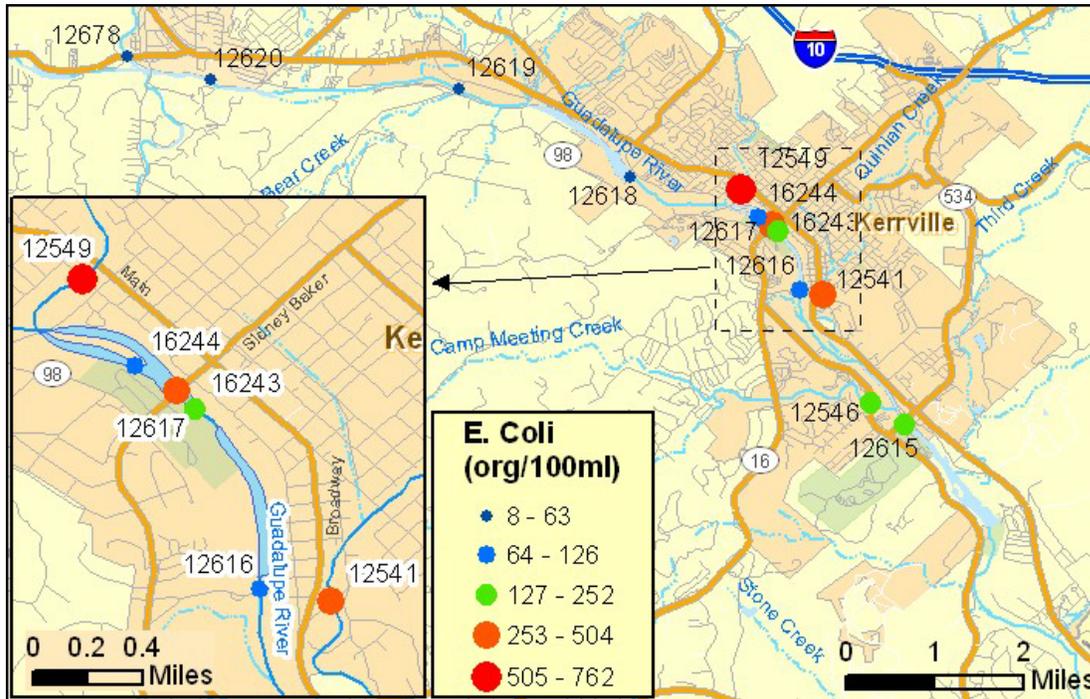
Figure 2: Spatial Variation in Summer Geometric Mean *E. coli* Concentrations 1993-2005

The TMDL examined water quality data and identified spatial trends along the Guadalupe River Above Canyon Lake. A considerable increase in *E. coli* concentrations at water quality station 12617 (Guadalupe River at Louise Hays Park, Hwy 16) suggested that a significant source of bacteria loading exists within the vicinity of this station. *E. coli* concentrations remain relatively high throughout the impaired

reach, through at least Station 12615 (Guadalupe River at Kerrville-Schreiner Park), as shown in Figure 2.

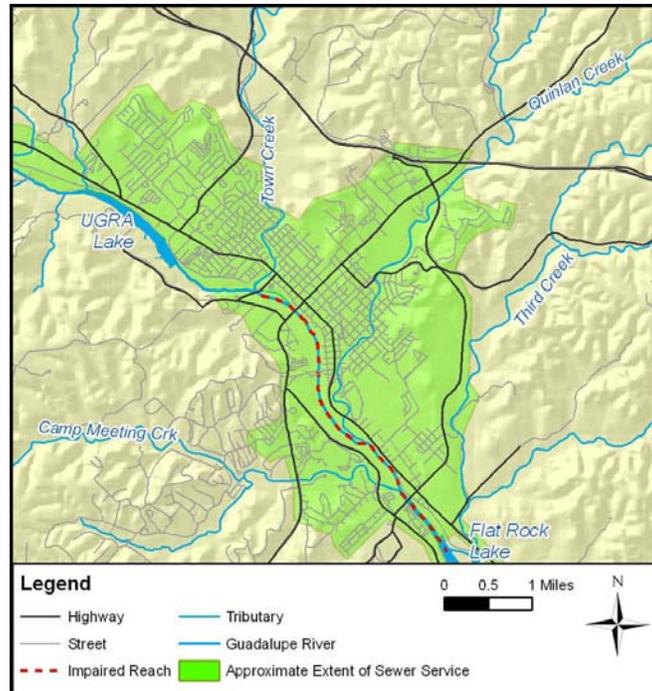
Figure 4: Approximate Extent of Wastewater Collection Service (2006)

The City of Kerrville operates and maintains the area's sewage collection system. The City's collection system is predominantly vitrified clay pipe, though PVC is not uncommon, especially in the newer areas of the city that are further from downtown. Iron pipes are used at stream crossings. The City of Kerrville provided a GIS data set of its sanitary sewer system for use in developing the TMDL. The sewer lines were analyzed for their proximity to the Guadalupe River and its tributaries because lines located along these streams, or crossing them, have a relatively high potential to cause surface water contamination if a leak exists. Figure 4 shows the approximate extent of the City's wastewater service based on the locations of existing sewer mains.
